Yeager Airport RSS Failure Case History

Ryan Berg, P.E., D.GE., F. ASCE

Jim Collin, Ph.D., P.E., D.GE., F. ASCE

- Purpose – Share lessons learned from the forensic evaluation of the largest RSS failure in North America
- The forensic analysis presented in the webinar was performed by The Collin Group and involved an extensive field exploration, and laboratory testing program to supplement the detailed engineering analysis – the entire process took over two years.
- Our client was the West Virginia Regional Airport Authority

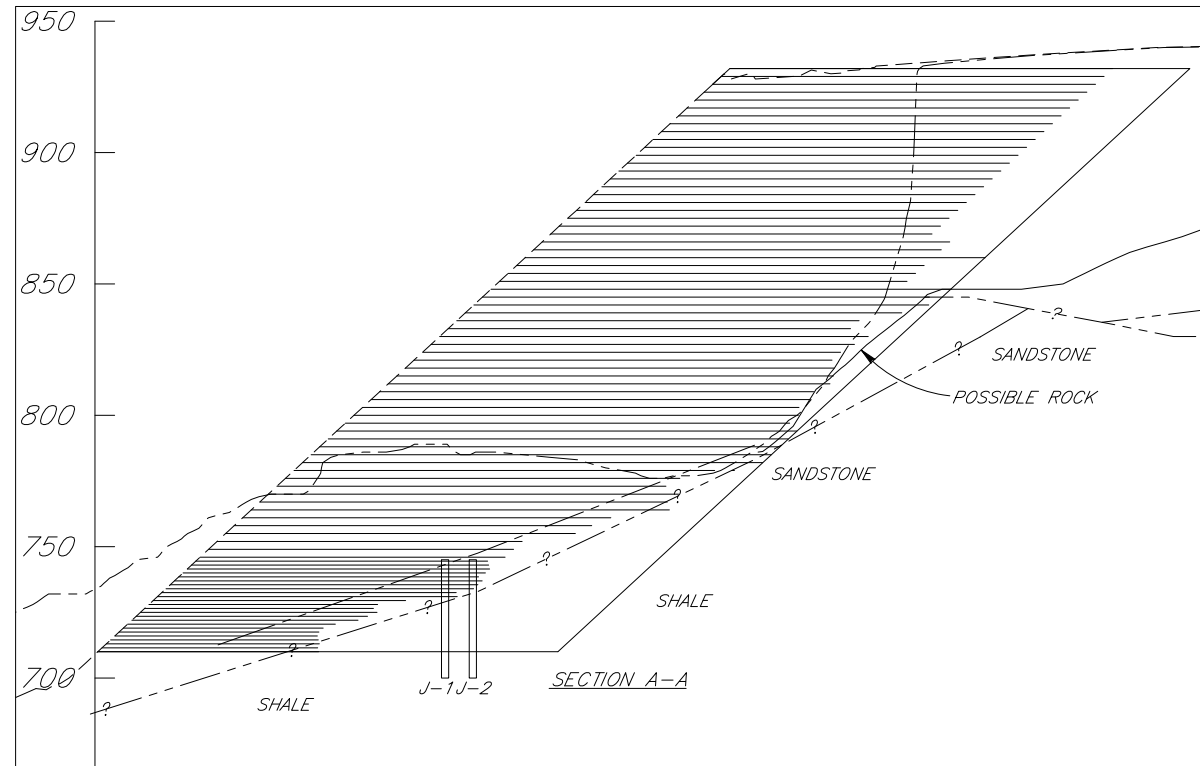
As-Built RSS

- Geogrid lengths shortened to 75 ft in bottom of RSS
- Toe of RSS raised 10 feet
- Rock fill placed below the toe of RSS
- Geogrid Reinforcement alternate geogrid approved by EOR

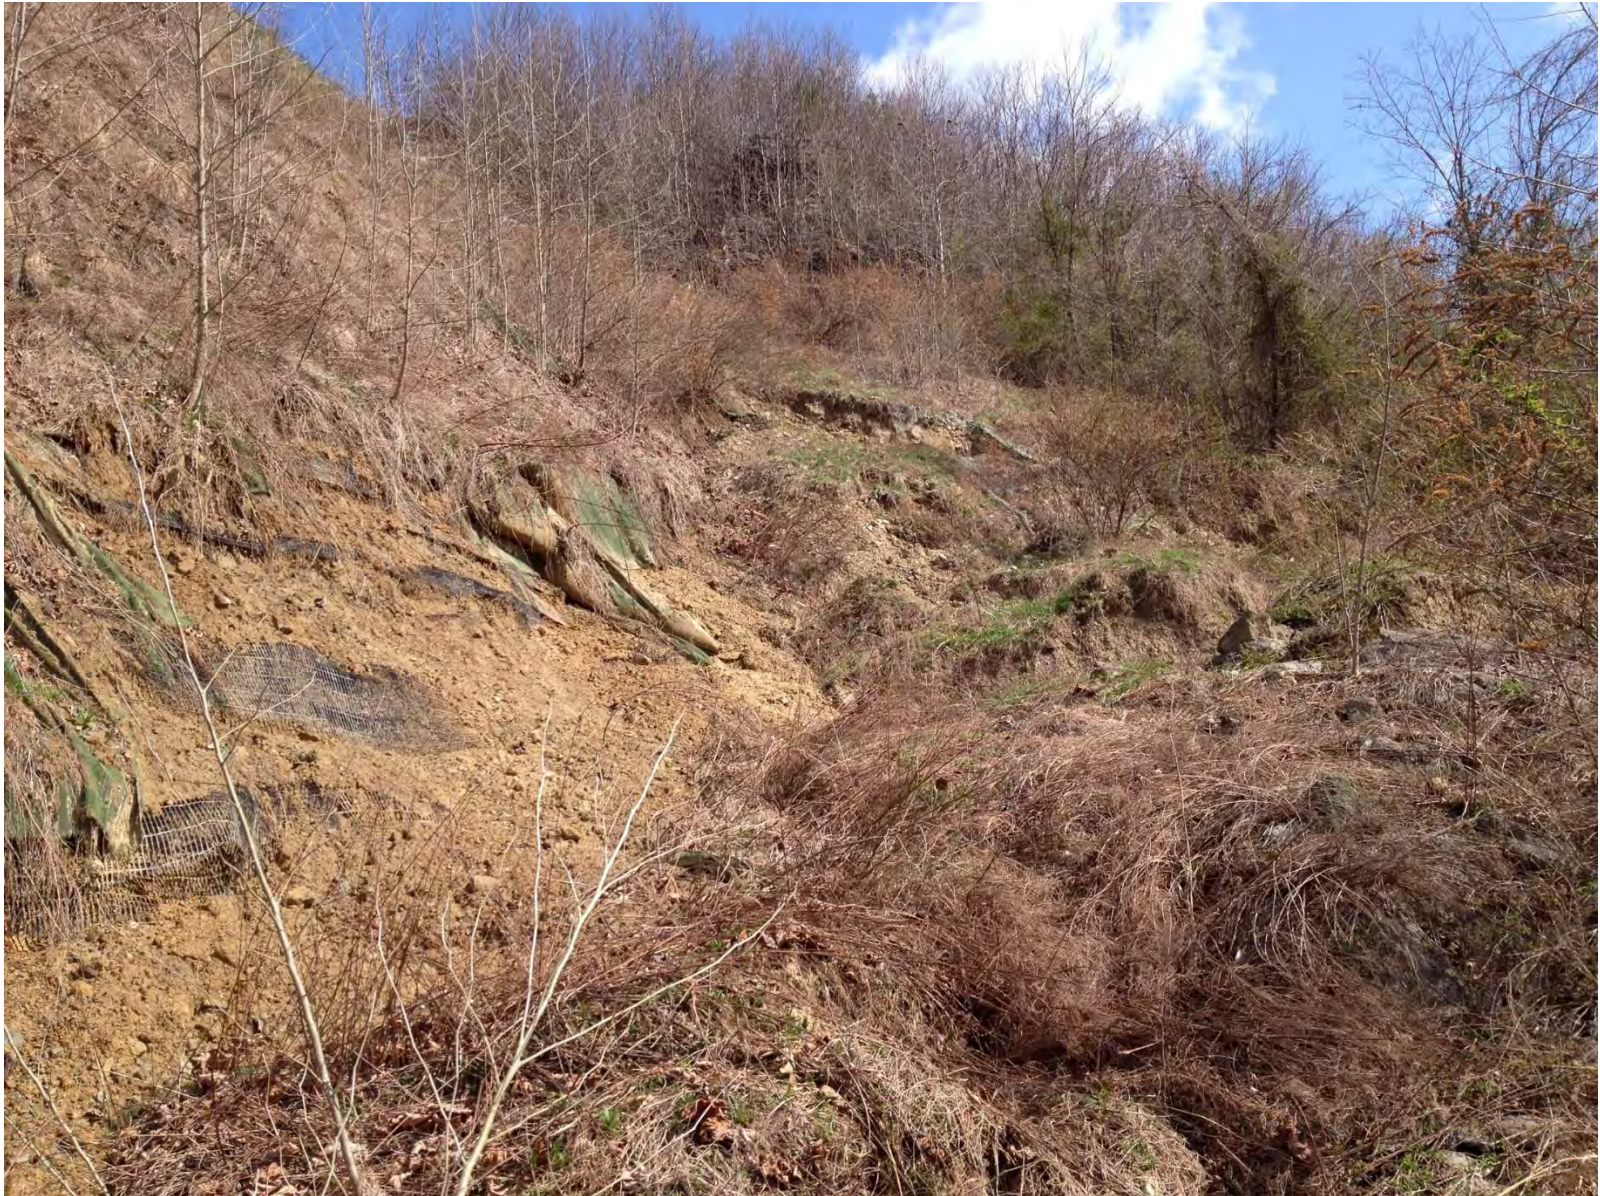
Post Construction Surficial Slide at Toe of RSS – May 2014

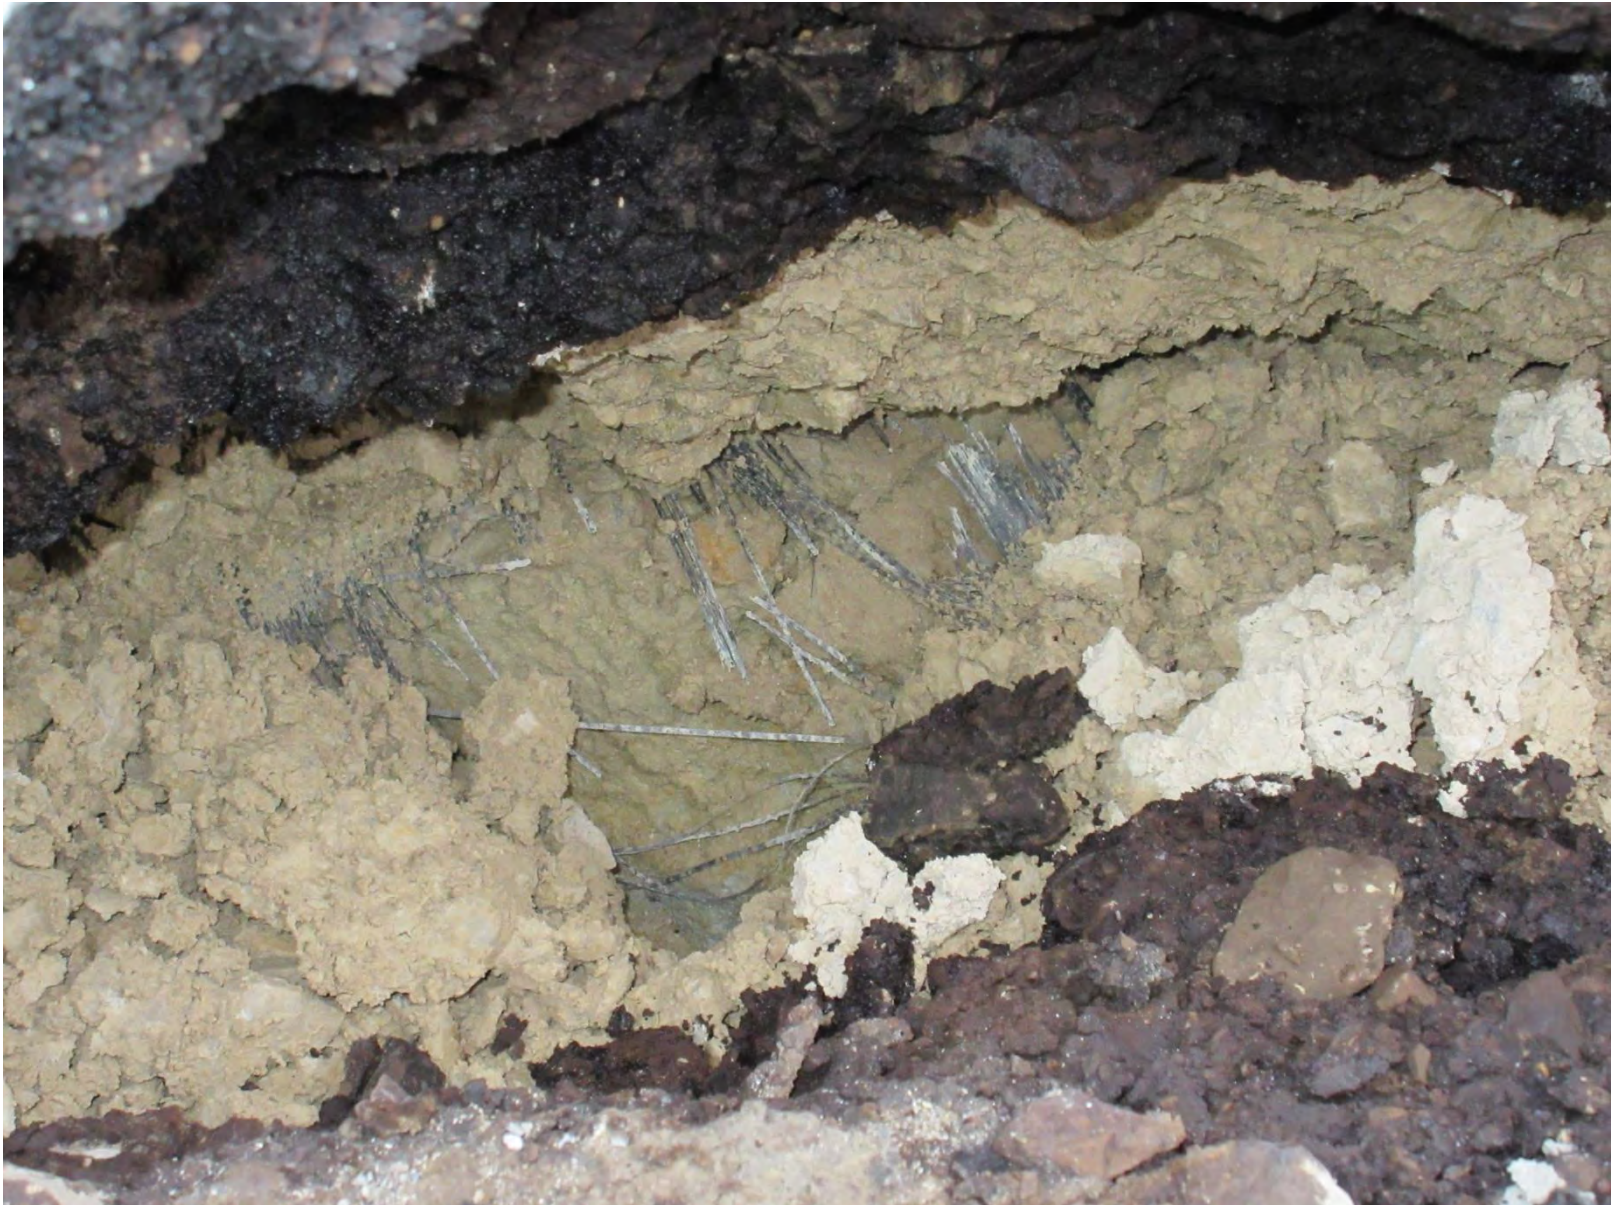
March 2015 Prior to Catastrophic Collapse – Ruptured Geogrid

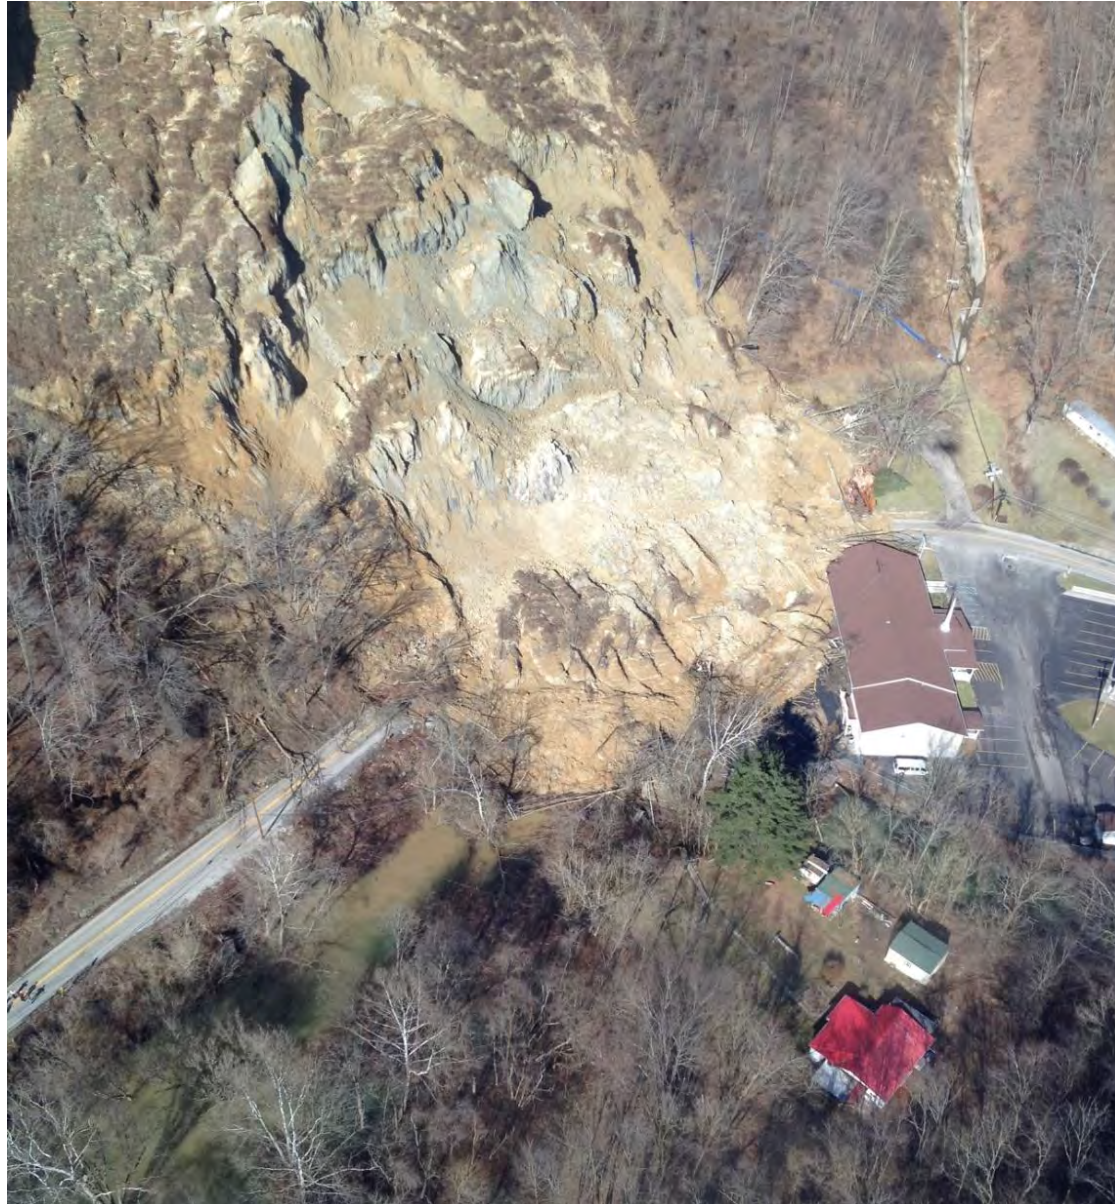
Failure Closed Keystone Drive Below RSS

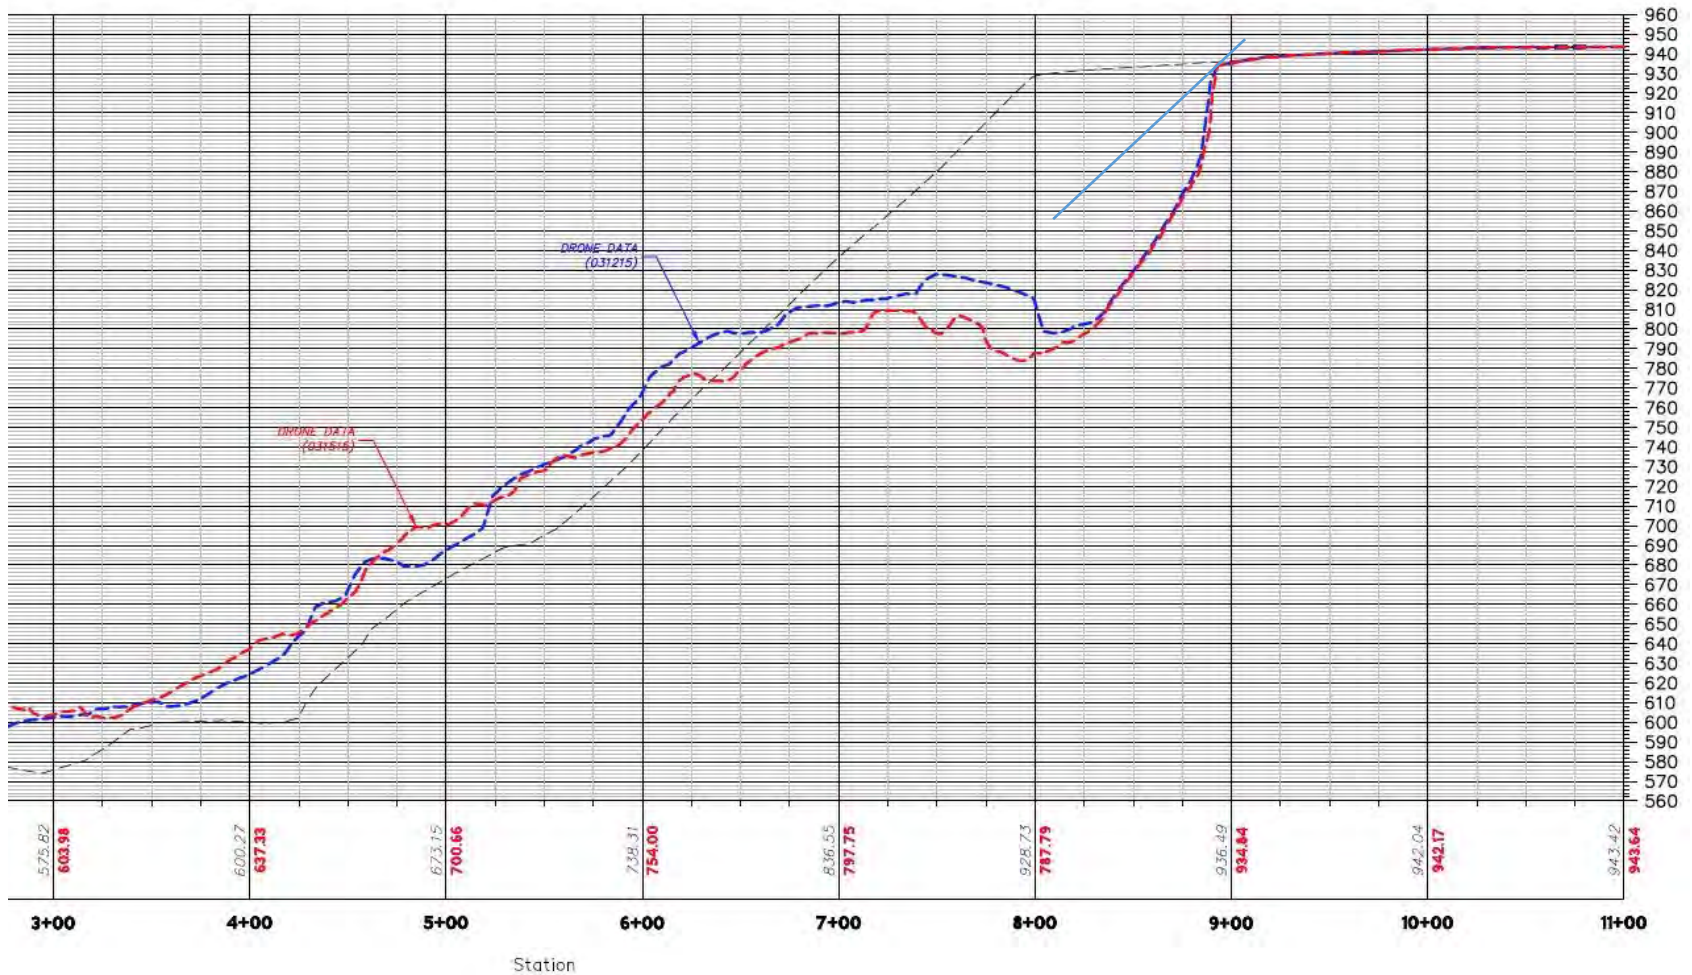
Cross Section Showing Head Scarp and Failure Mass

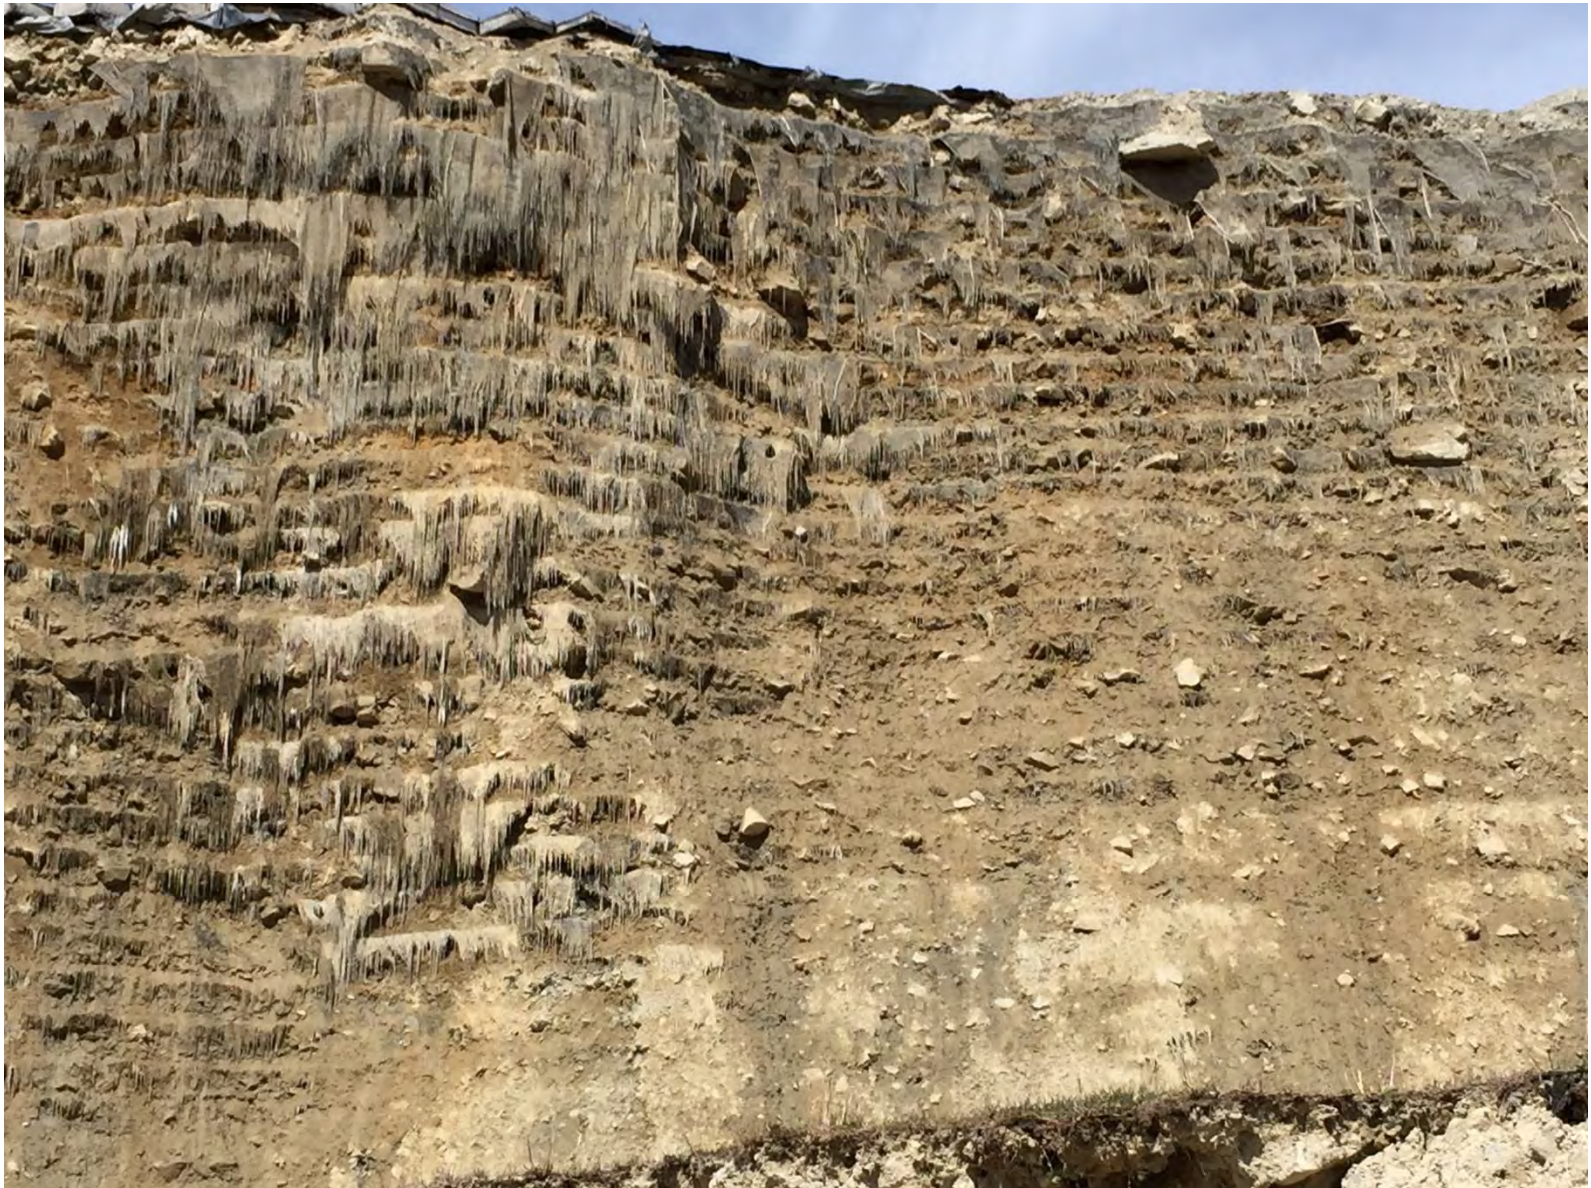
Head Scarp – Rupture of Over 30 Layers of Geogrid

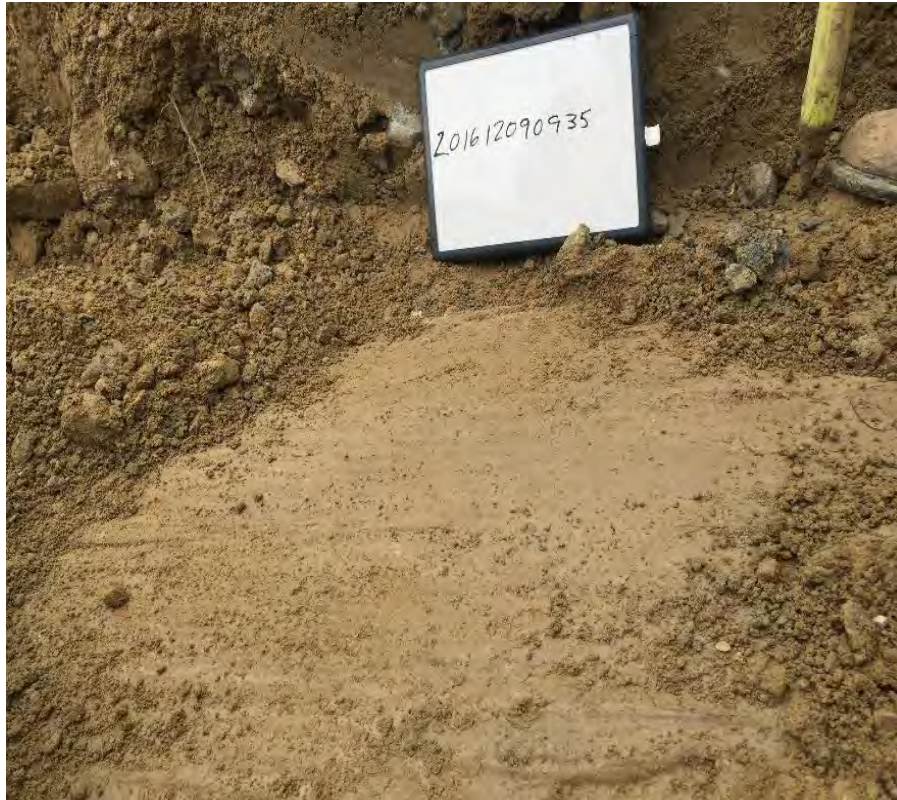
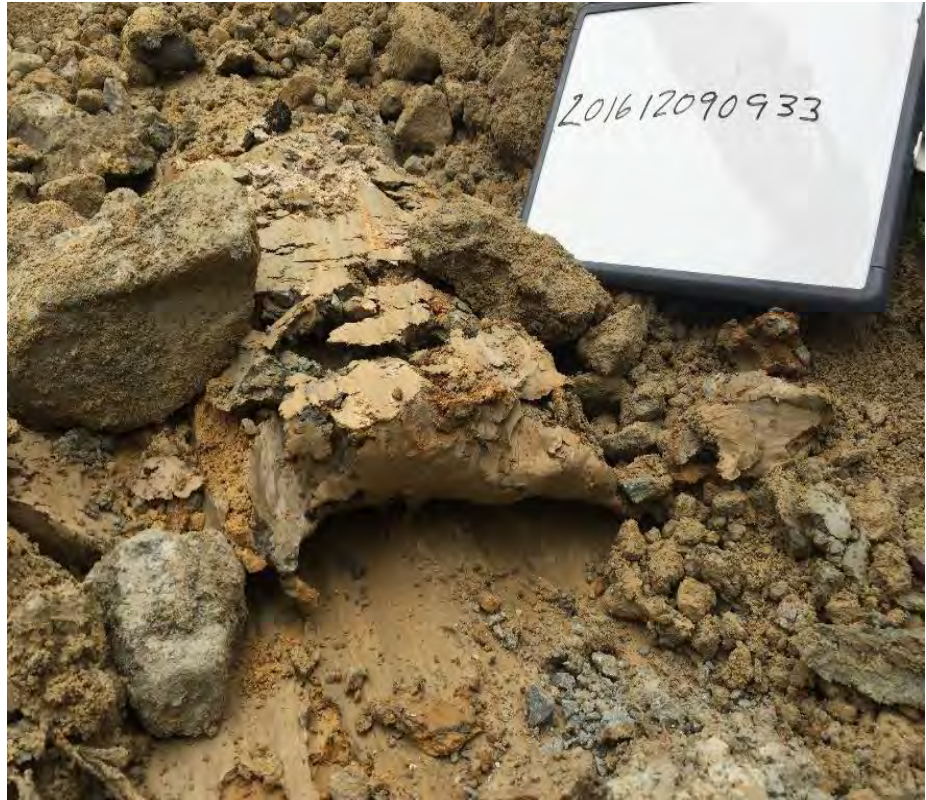
Failure Surface Identified

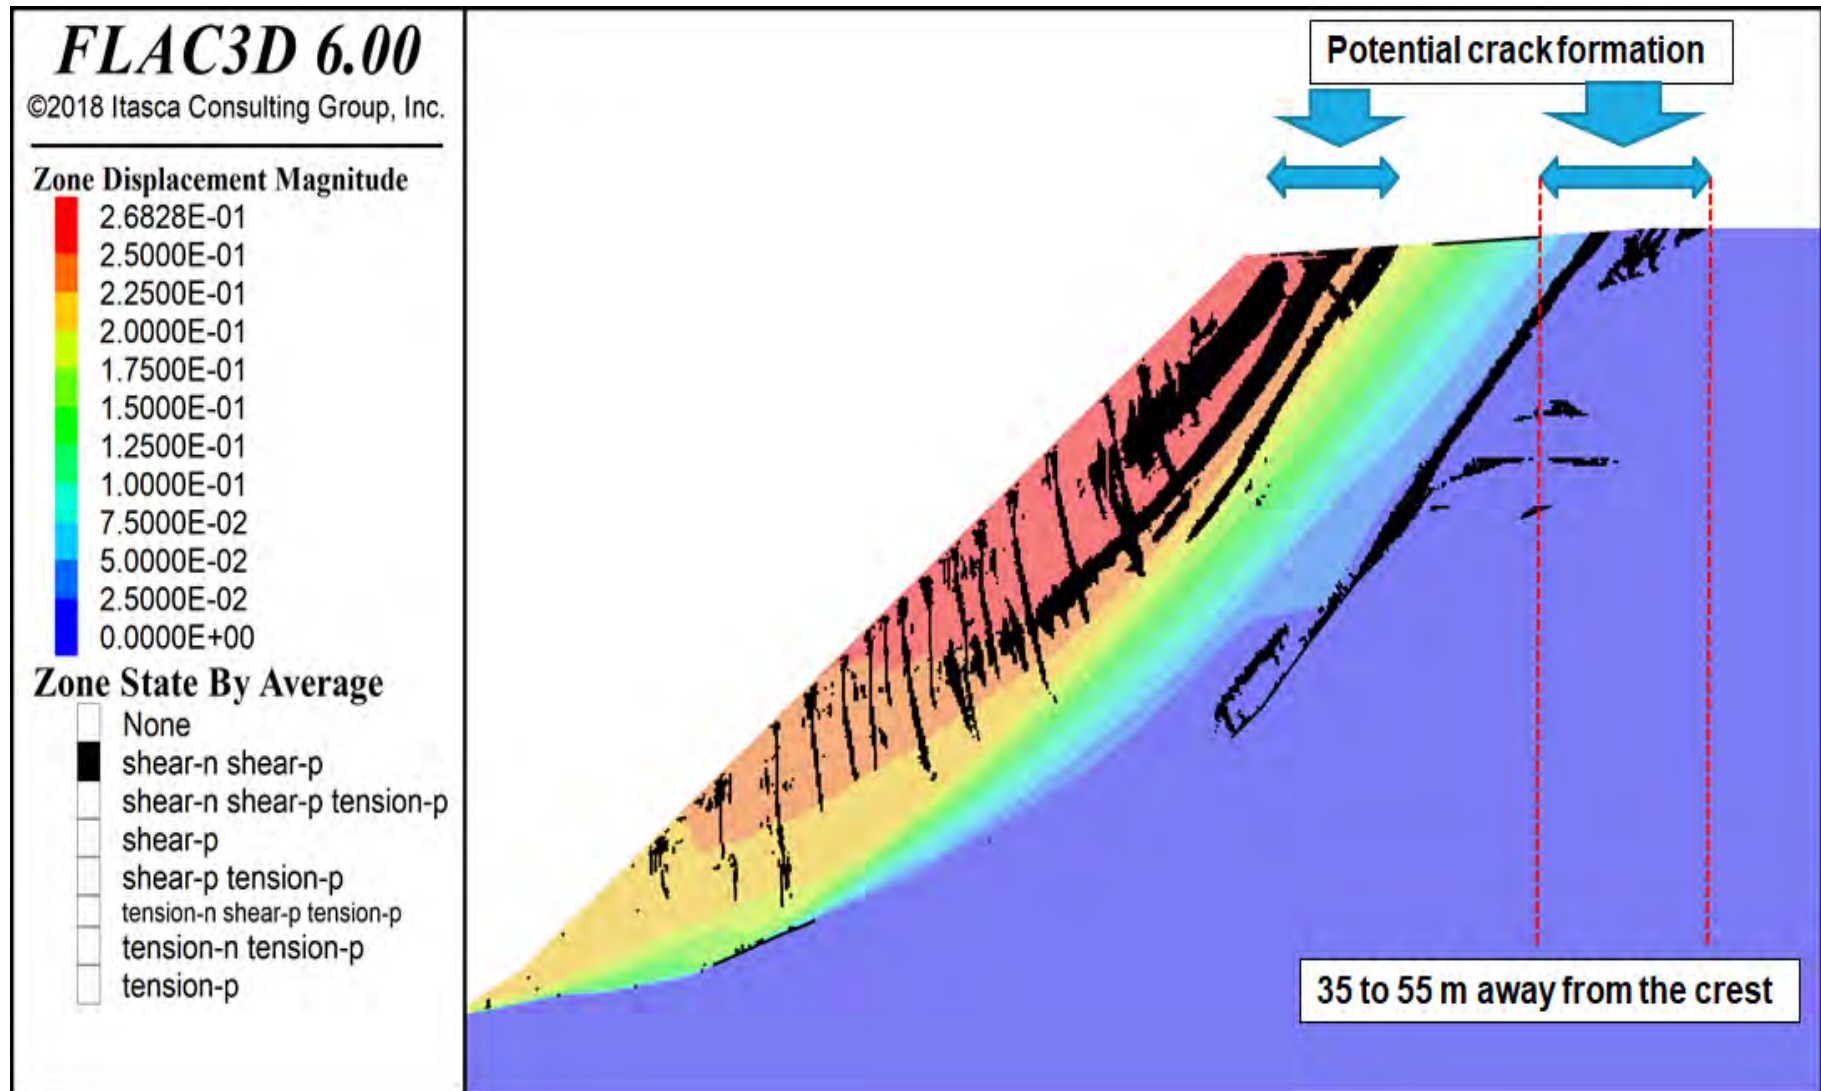
Shear Band development inside RSS at failure using FLAC3D

- Geogrid failure in head scarp and two downslope areas
- Movement occurring behind and below the geogrids in lower portion of RSS where field changes were made to shorten the geogrids
- Deformation analysis results consistent with field observations
