GERALD GENTLEMAN STATION

2017 ANNUAL INSPECTION REPORT GERALD GENTLEMAN STATION ASH DISPOSAL FACILITY

January 5, 2018

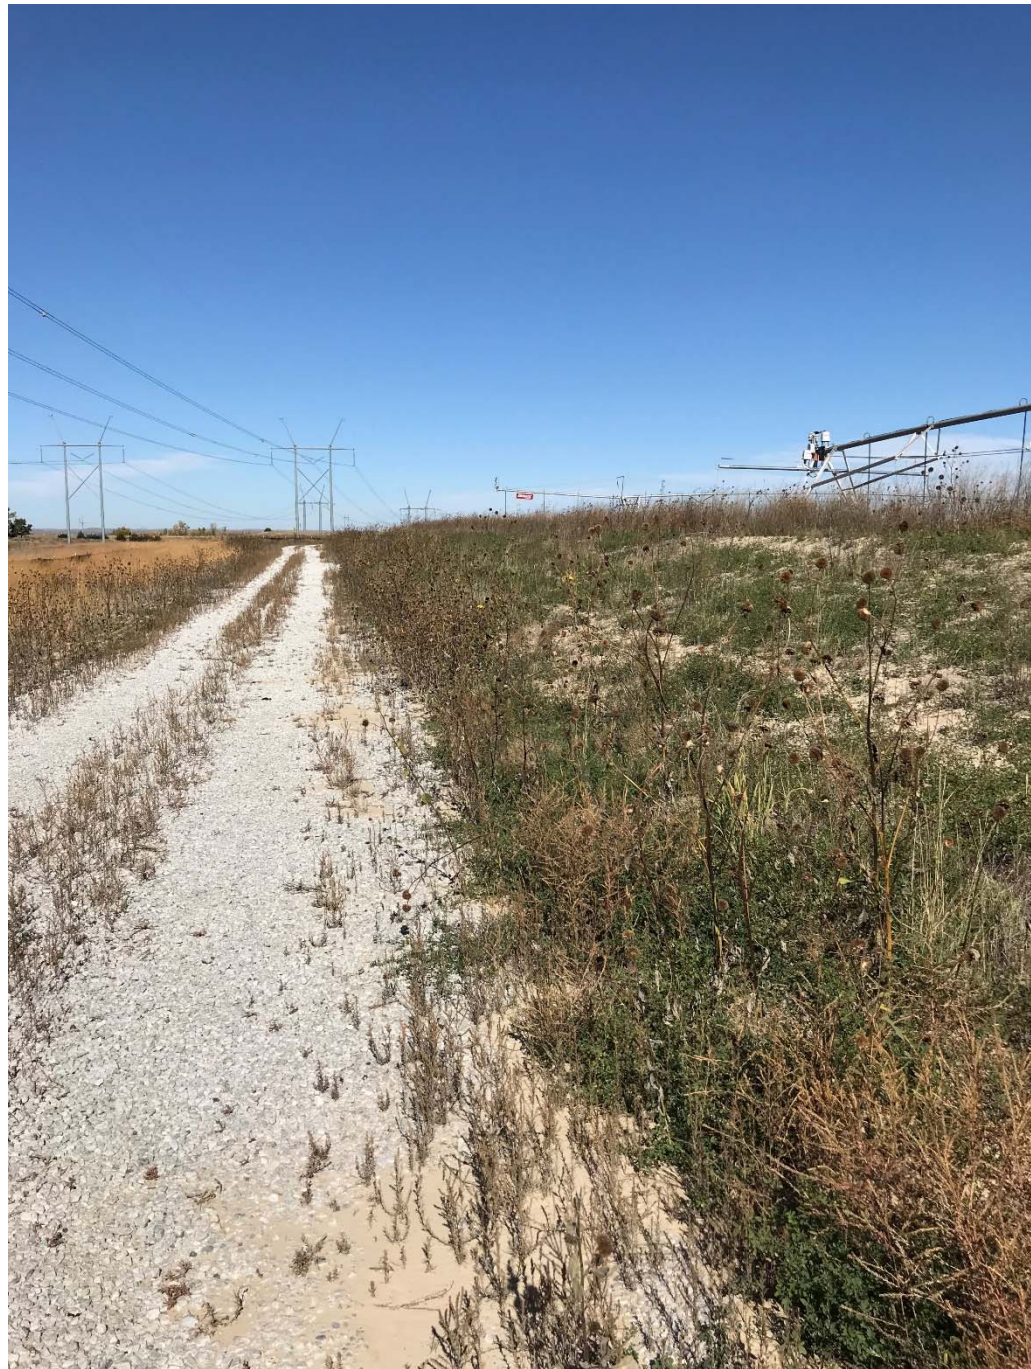
PHOTO 1

Minor erosion was observed on the outer embankment slopes on the west and south sides of Ash Landfill No. 3 and the south side of Ash Landfill No. 4. Erosion of the exterior slopes should be monitored and NPPD should continue to perform routine maintenance on the slopes. NPPD should address areas that are frequently eroded so that appropriate surface water controls can be developed.

West outer
slope of Ash
Landfill No. 3.

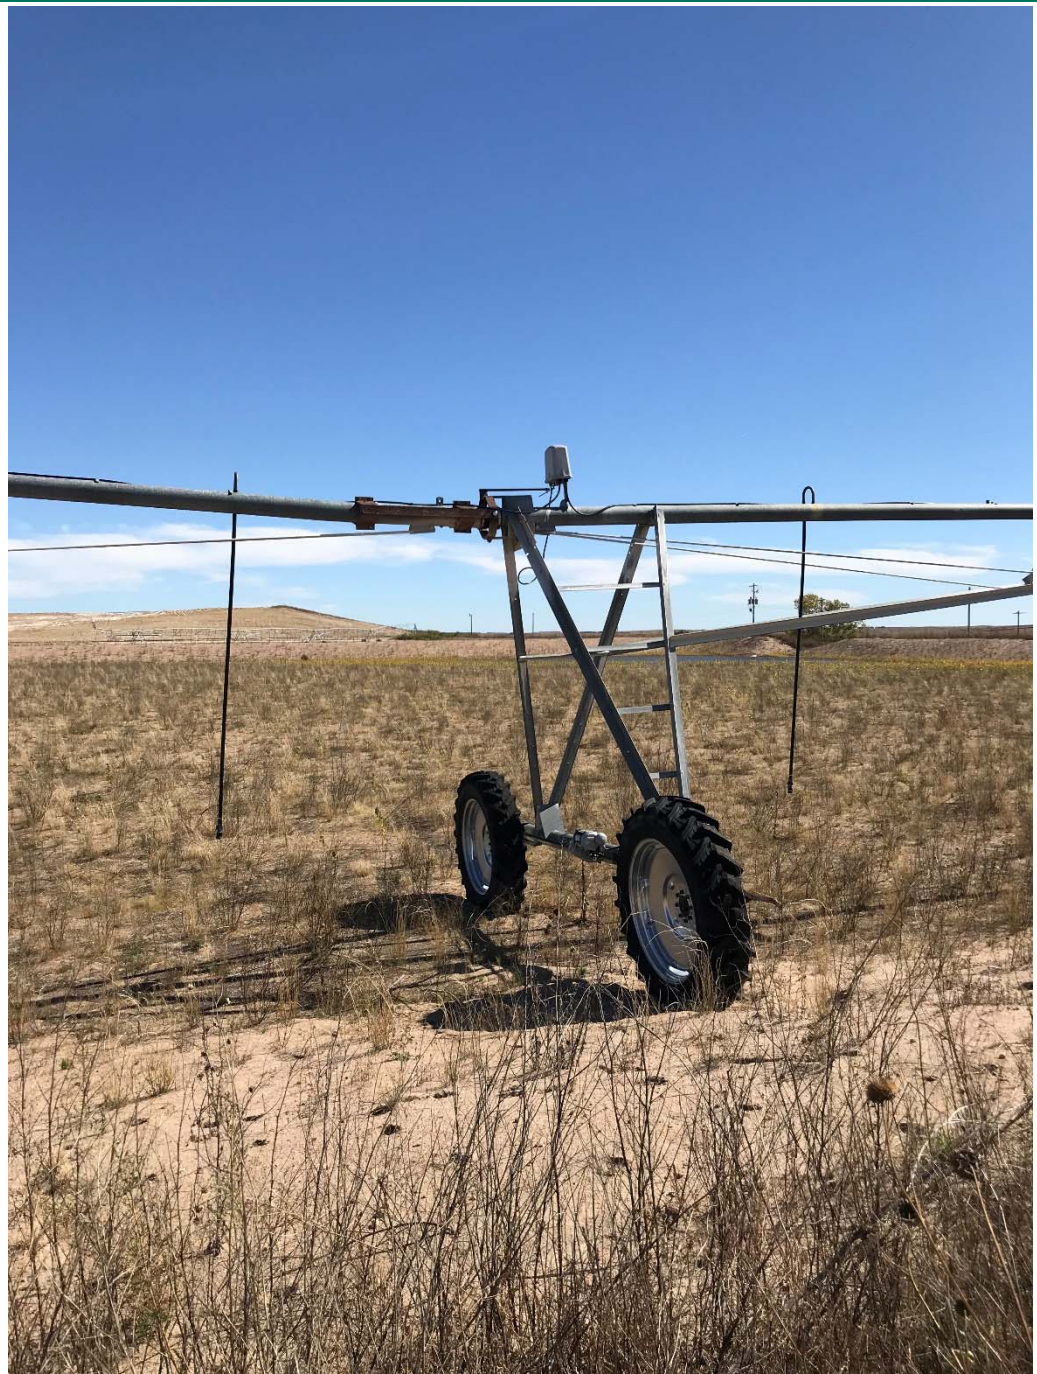
PHOTO 2

Center pivot in
west cell of
Ash Landfill
No. 3.

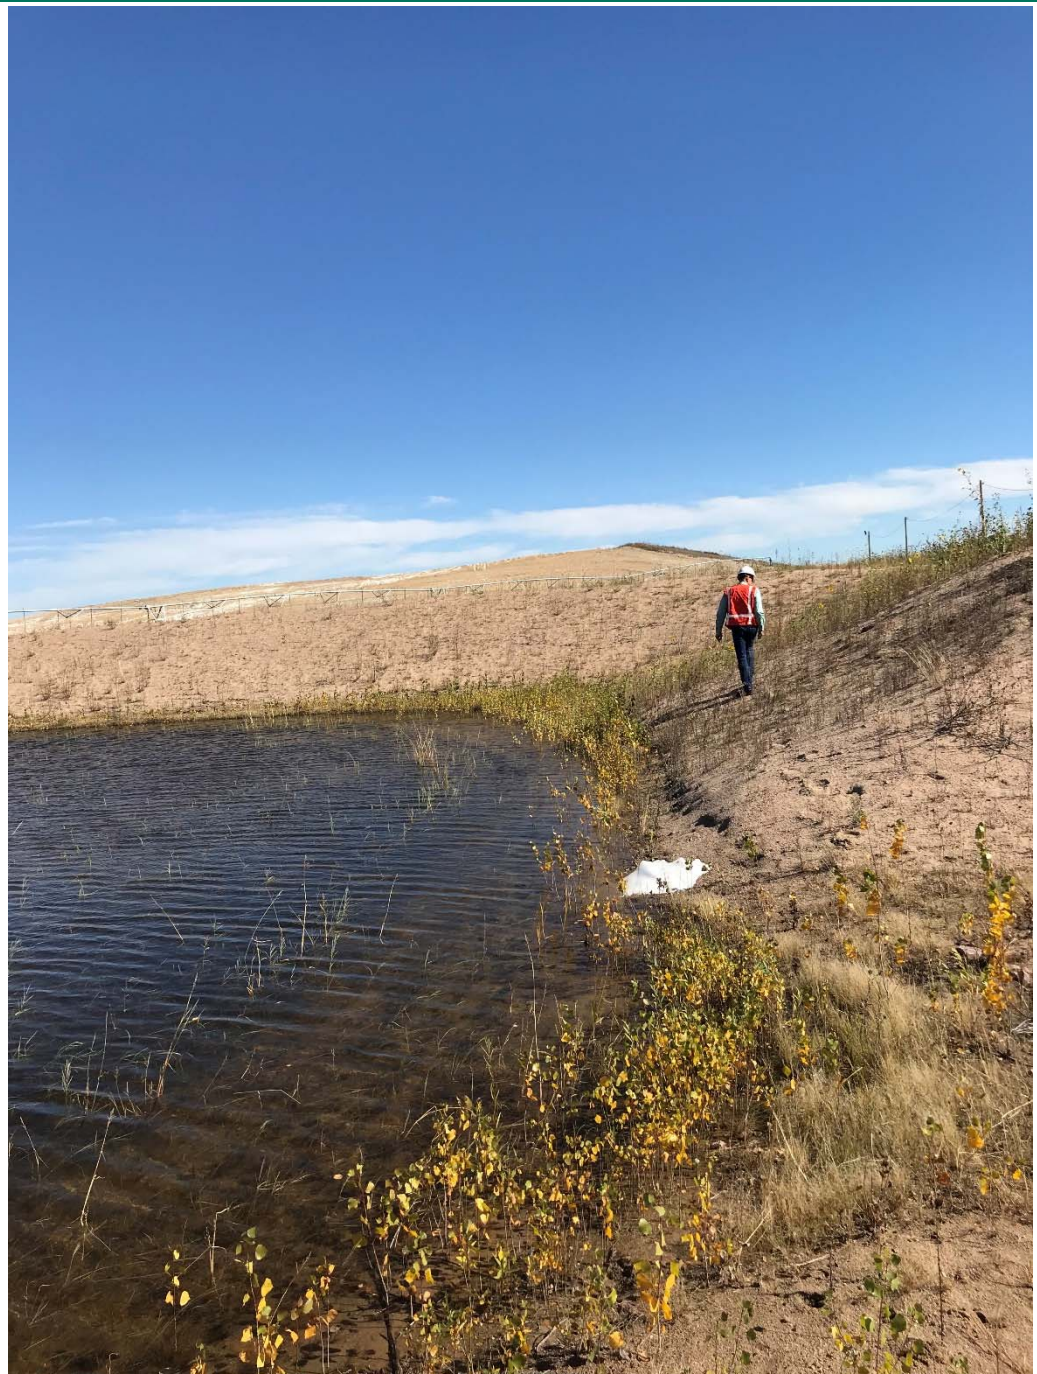
PHOTO 3

Ponded non-contact water in west cell of Ash Landfill No. 3.

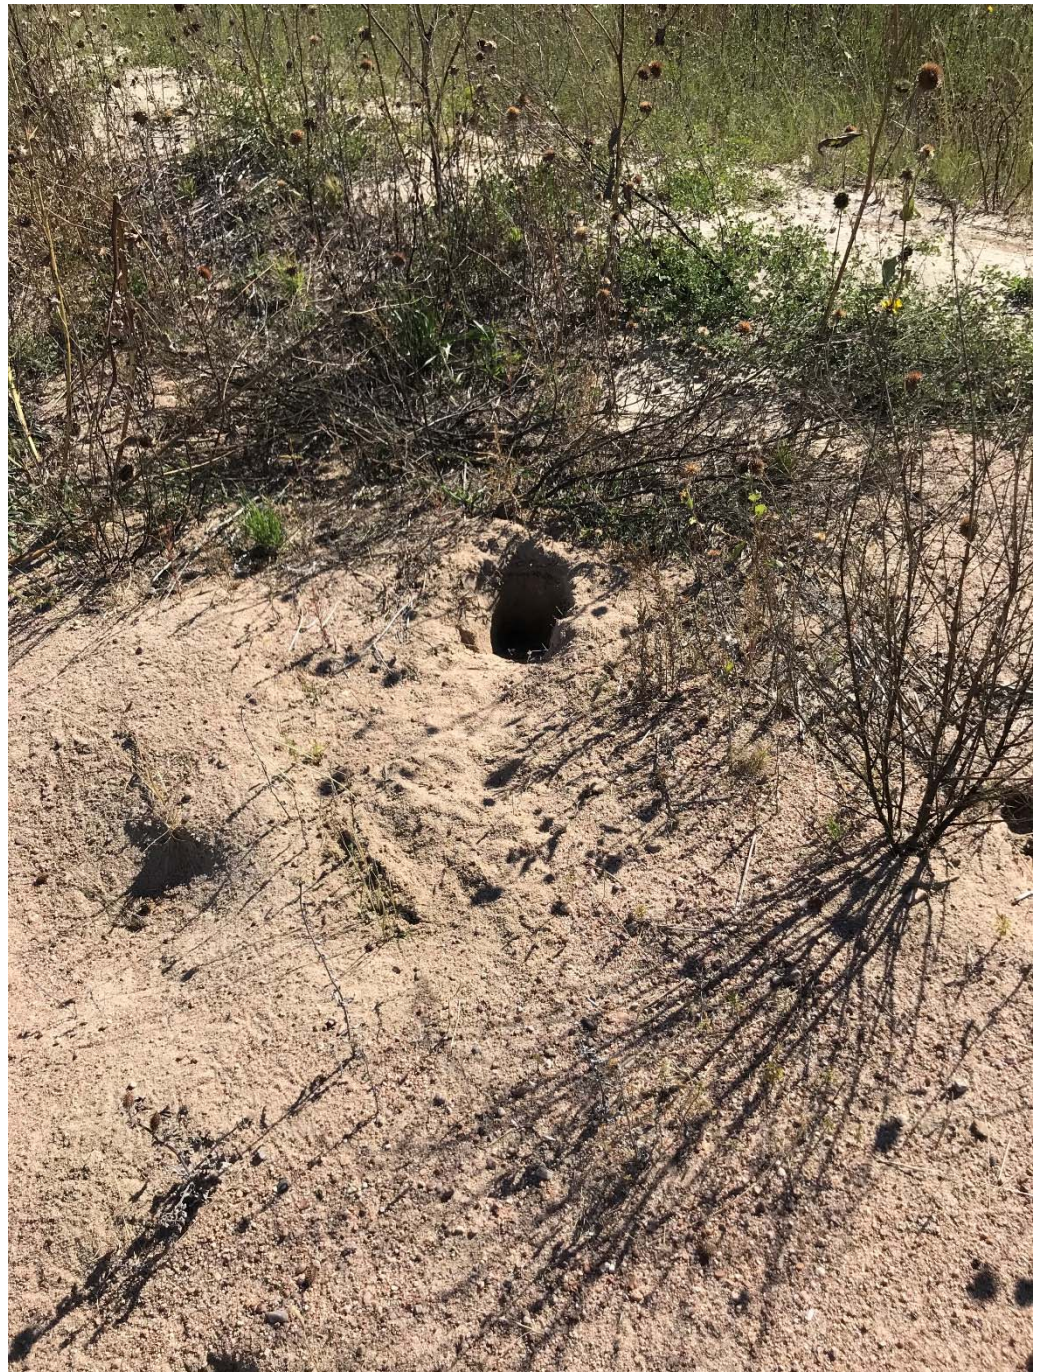
PHOTO 4

Some evidence of burrowing animals was observed both along the top of the perimeter road (primarily small rodent holes) and at the toe of the outer slopes (likely badger holes). The number of animal burrows

observed was consistent with the 2016 inspection, and has been reduced significantly from the 2015 inspection. NPPD inspects the embankments weekly, and signs of burrowing animals are documented. Animal burrows on the embankment slopes are addressed and repaired as necessary. NPPD trapped and relocated three badgers in 2017.

Animal burrow
on south side
of Ash Pit No
3.

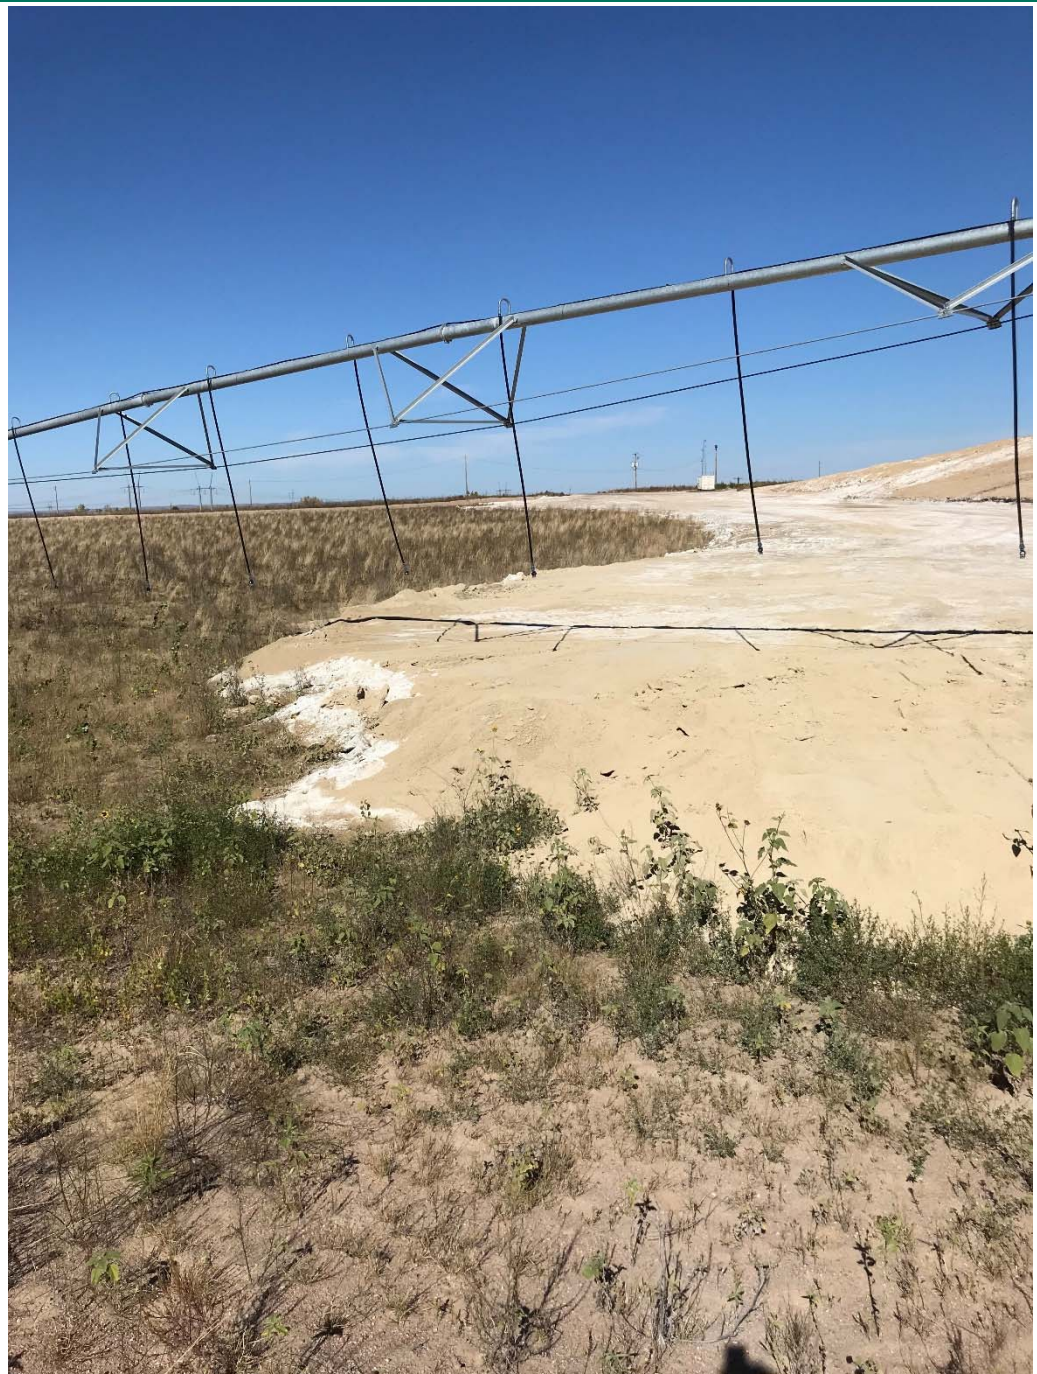
PHOTO 5

Fly ash
deposition in
east cell of Ash
Landfill No. 3.

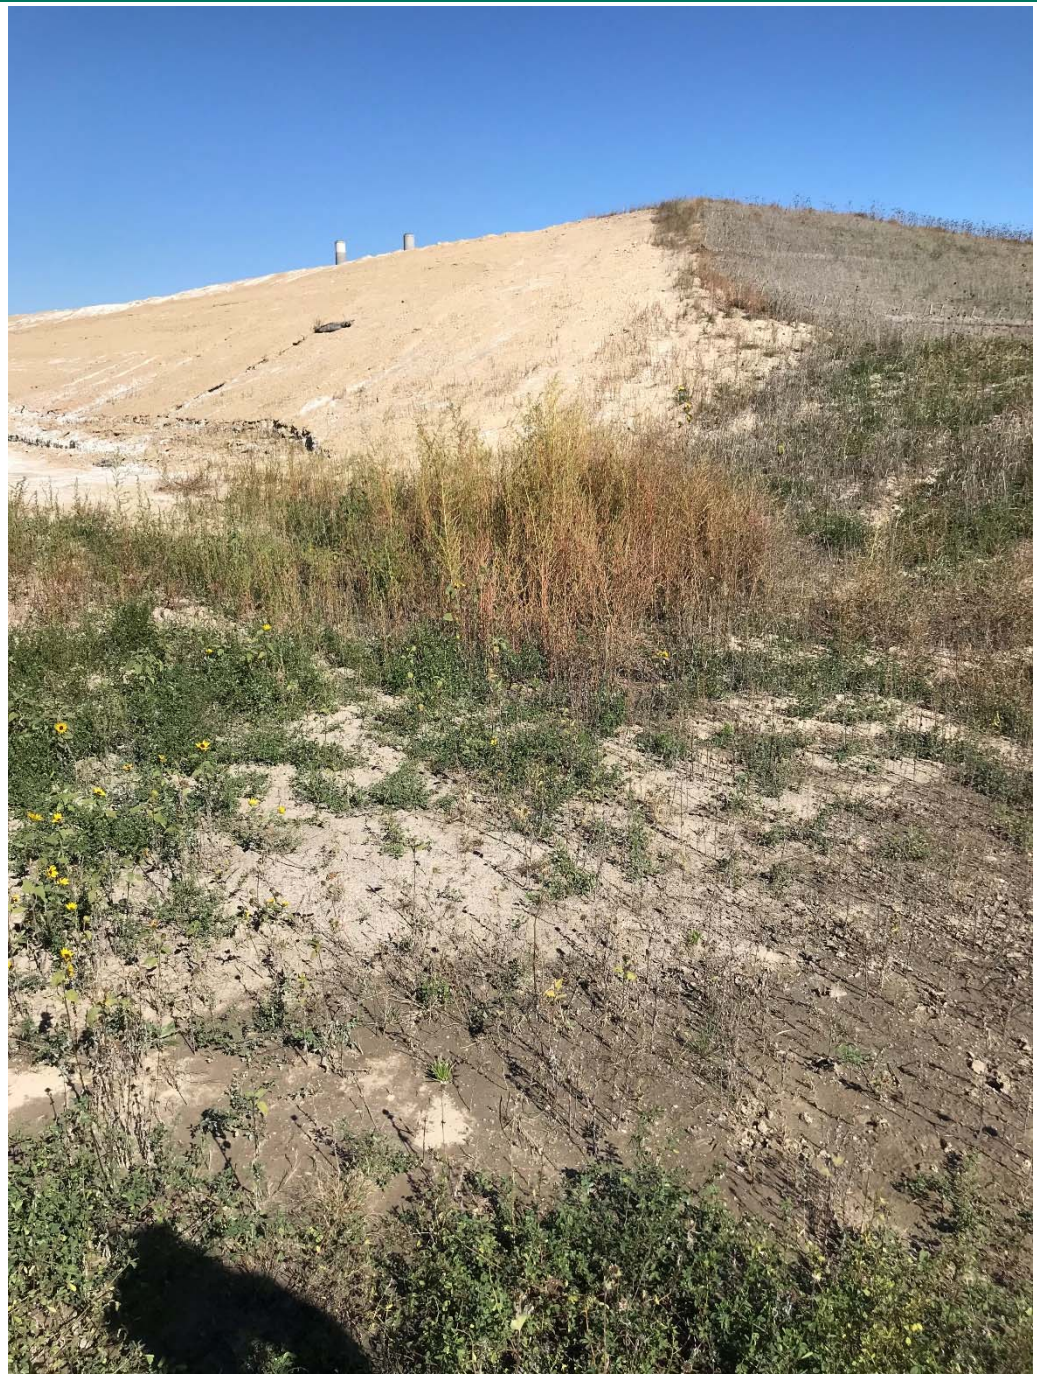
PHOTO 6

West edge of
final cover on
Ash Landfill
No. 4.

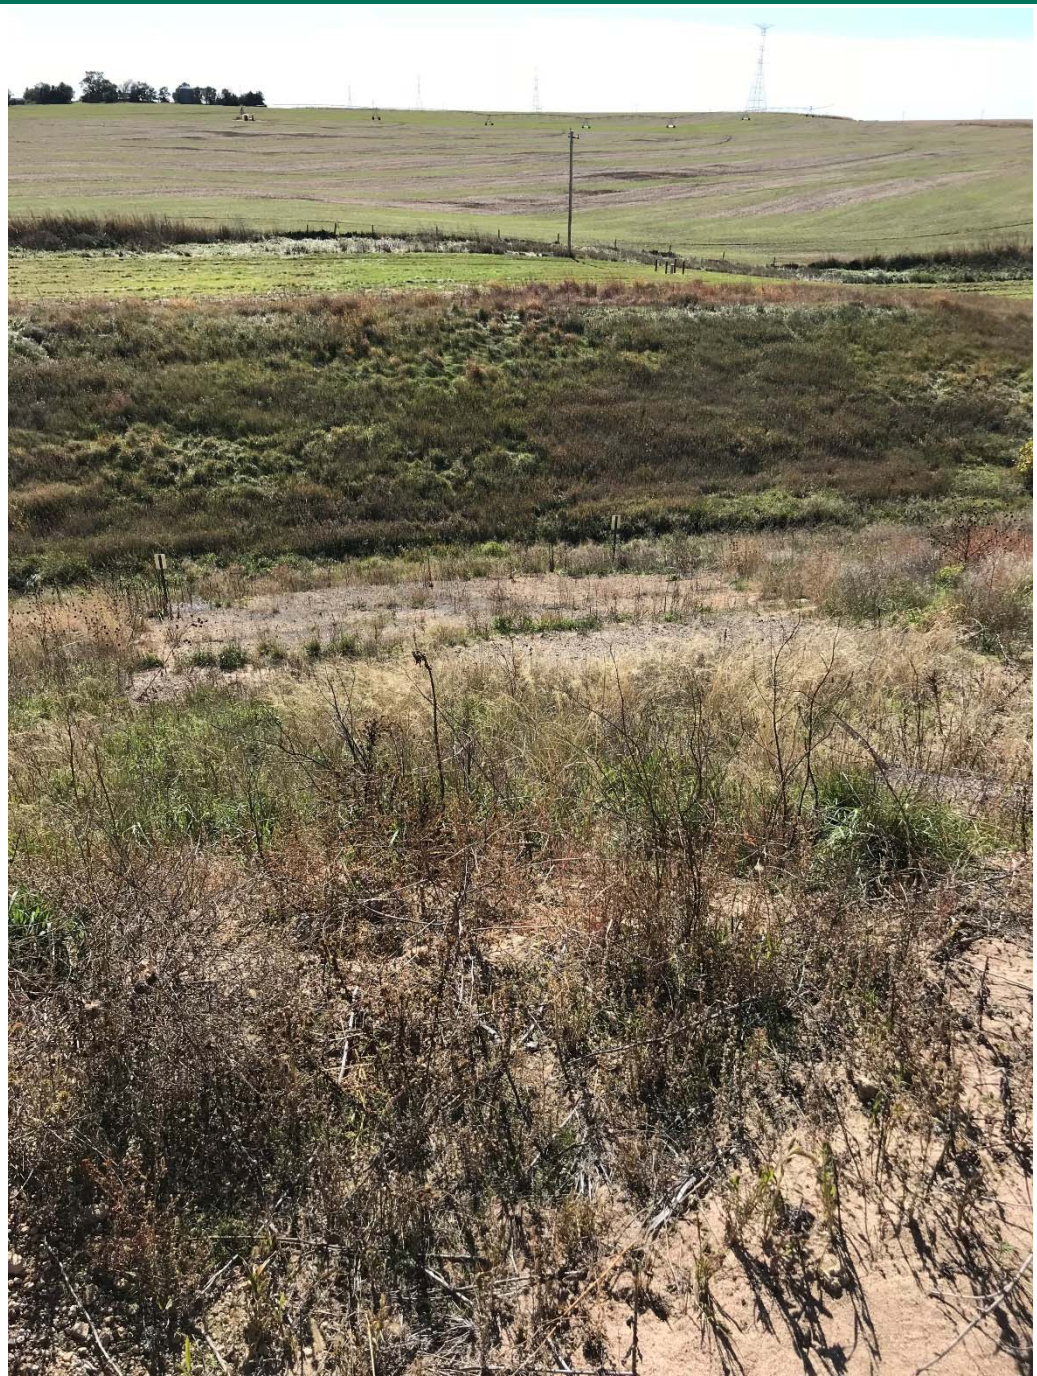
PHOTO 7

Sparse
vegetation on
south slopes of
Ash Landfill
No. 3.

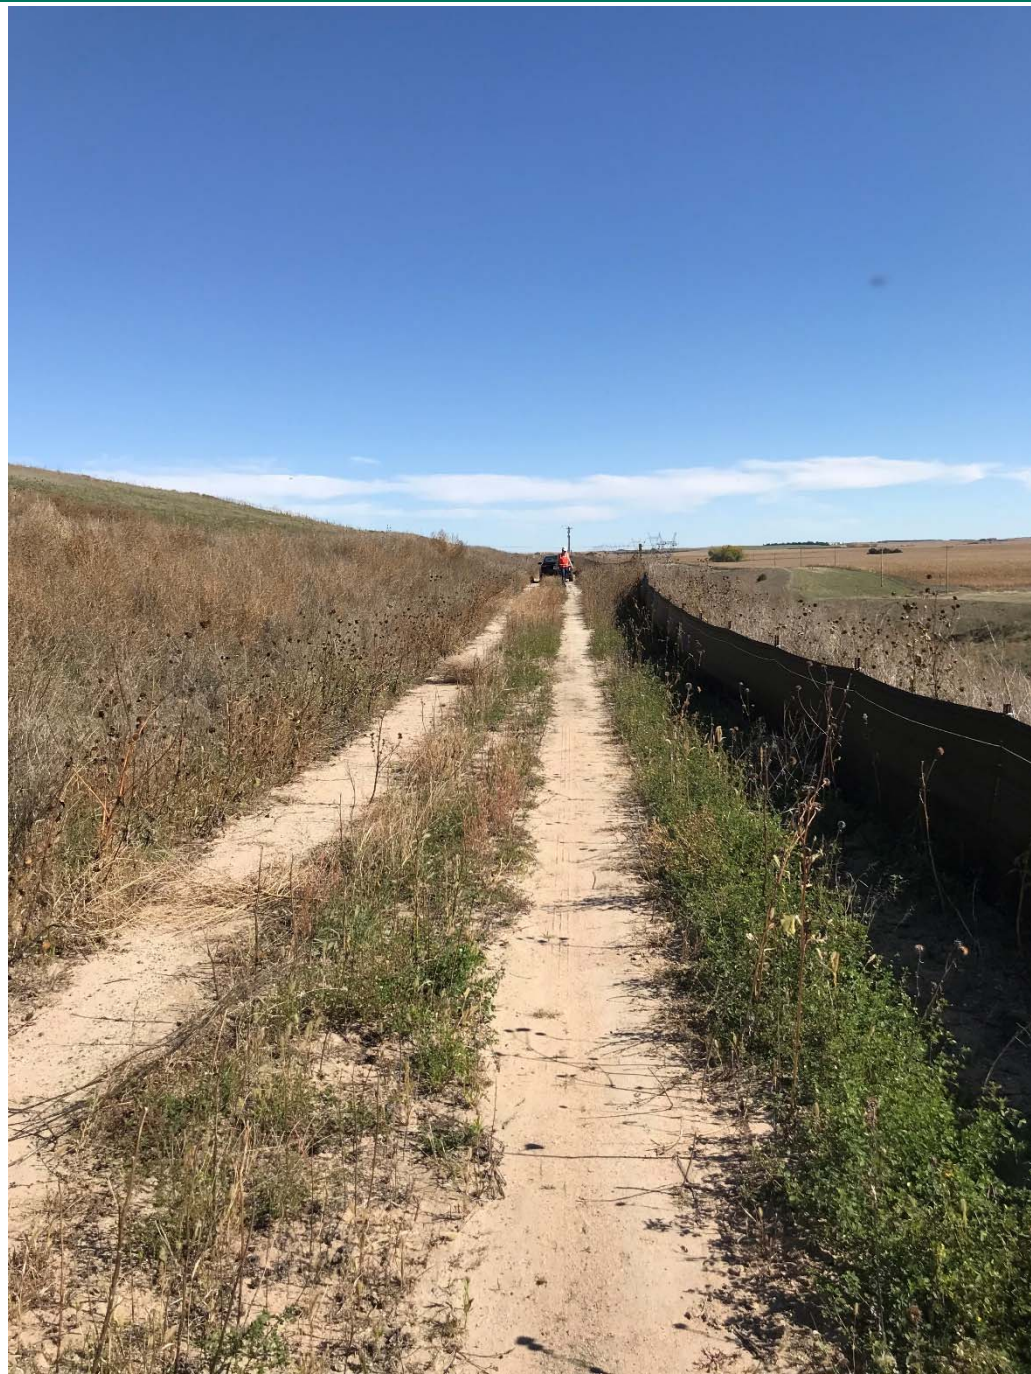
PHOTO 8

Perimeter road
south of Ash
Landfill No. 4.

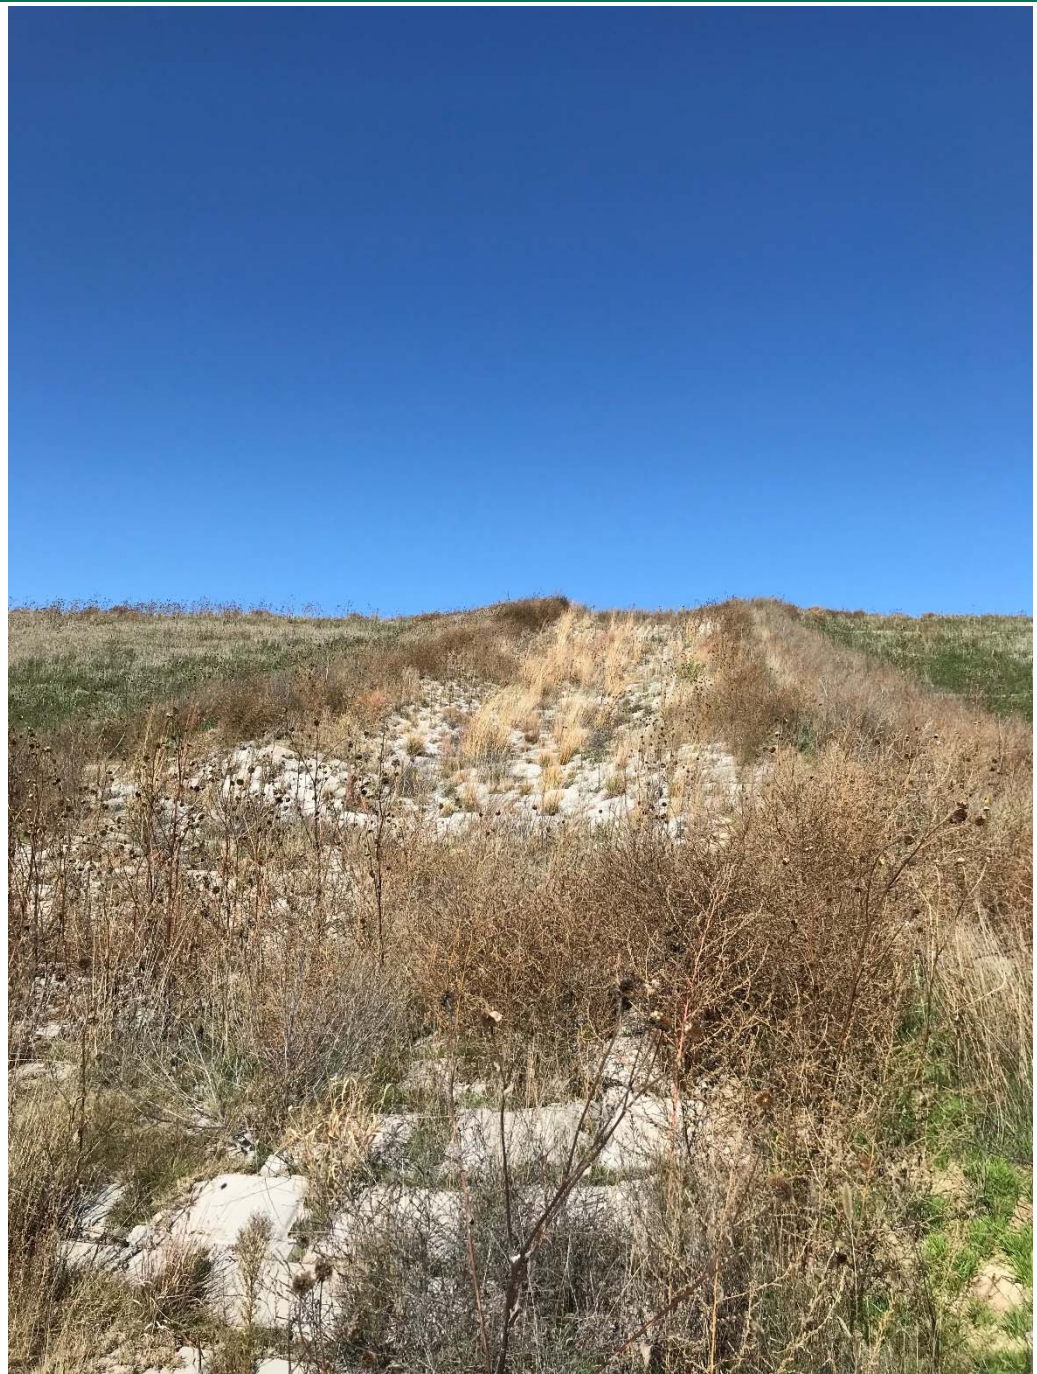
PHOTO 9

Vegetative growth of the final cover placed in 2015 has improved, resulting in reduced erosion of the cover soil. The terrace channels and downchute channel on the final cover appear to be functioning as designed.

Downchute
channel south
side of Ash
Landfill No. 4.

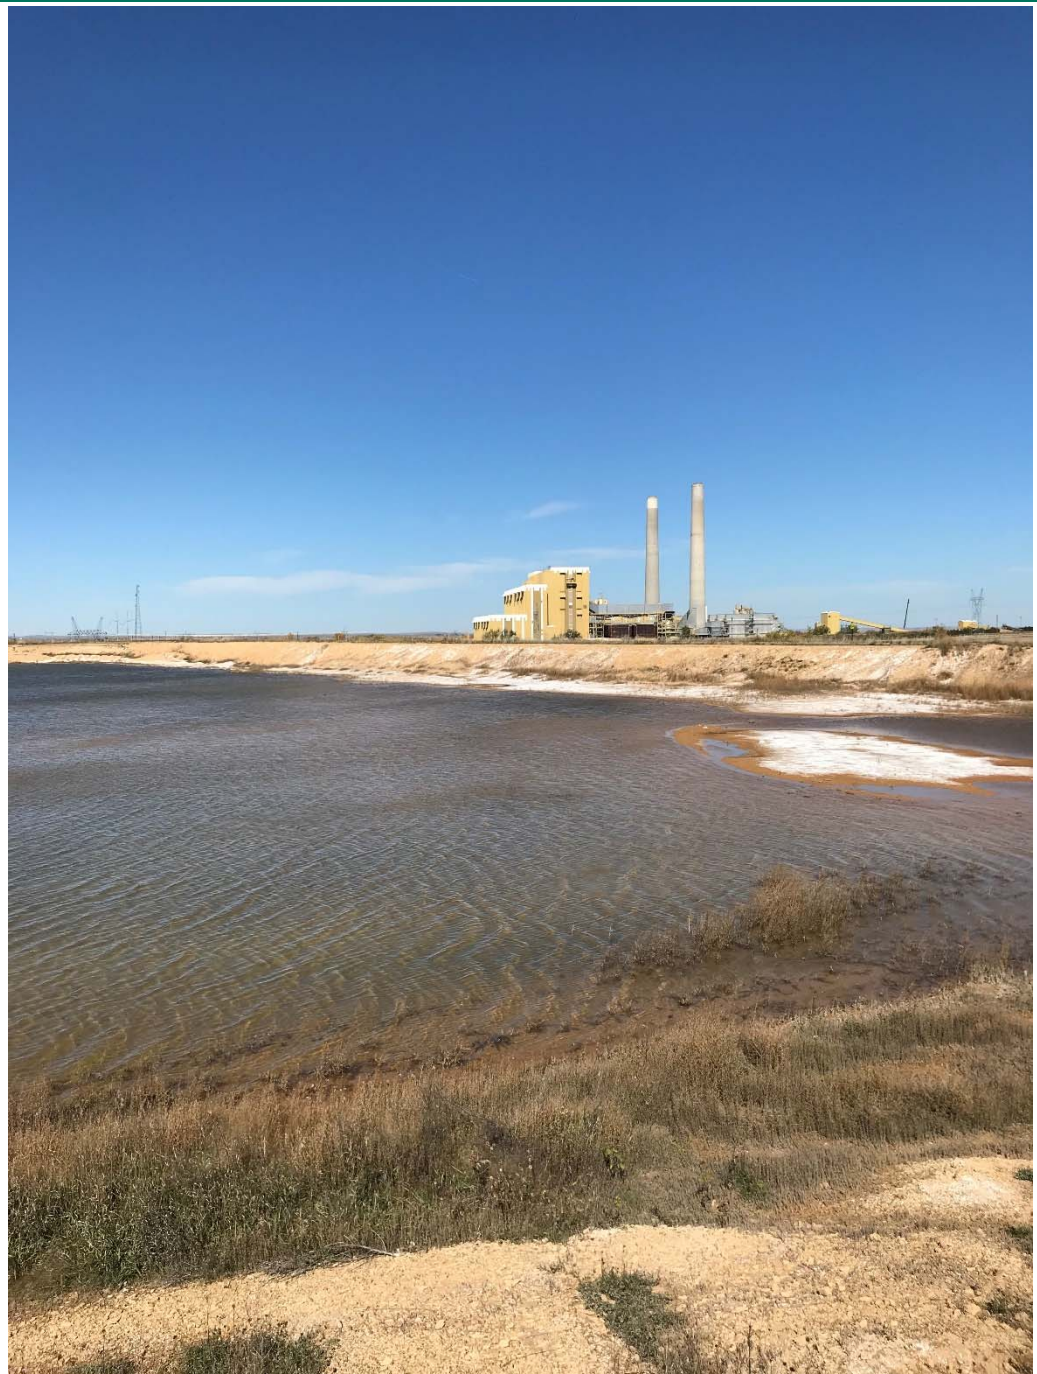
PHOTO 10

Contact water pond.

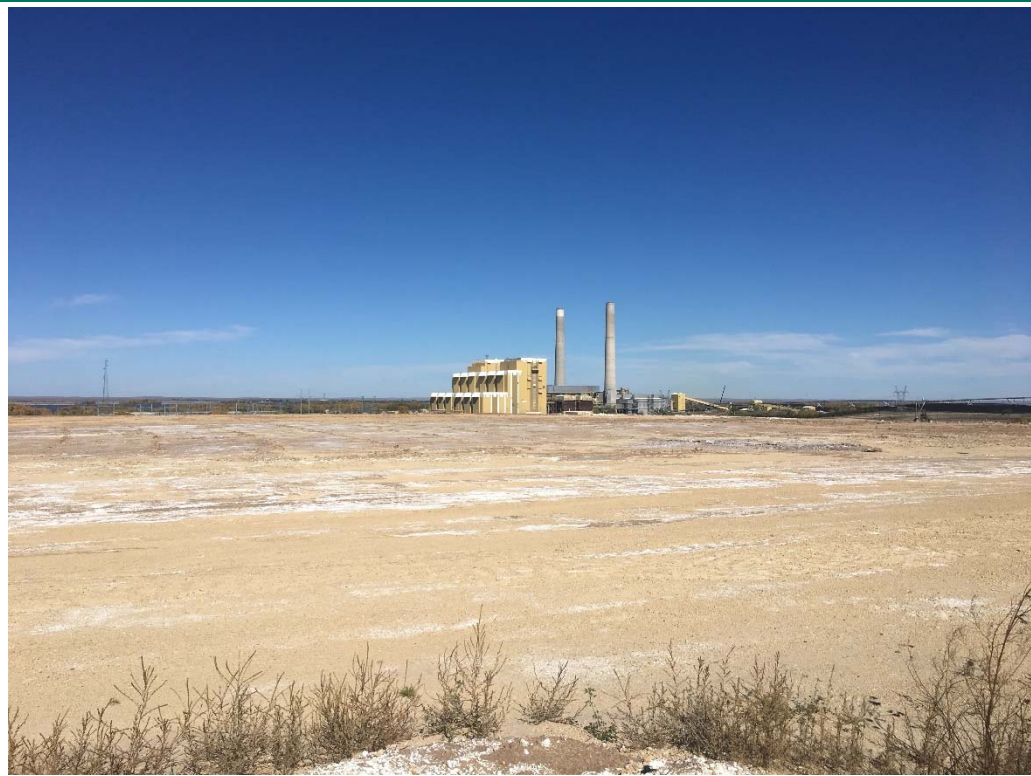
PHOTO 11

Active
deposition area
in Ash Landfill
No. 4.

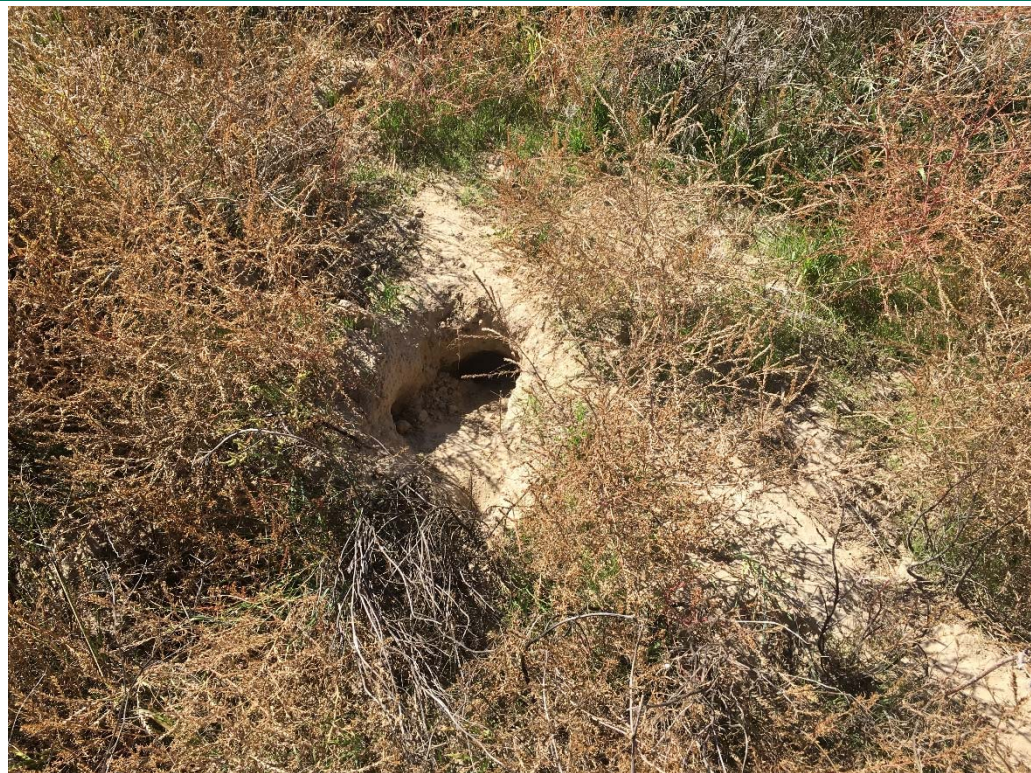
PHOTO 12

Animal burrow
on south side
of Ash Landfill
No. 4.

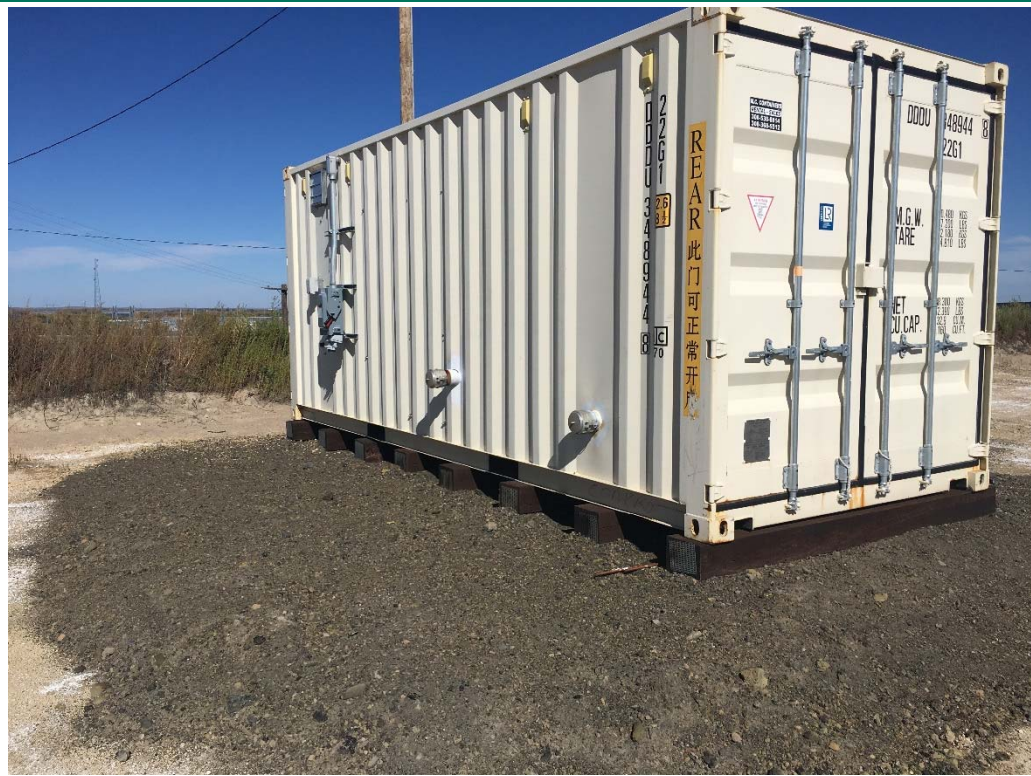
PHOTO 13

Center pivot
control
building.

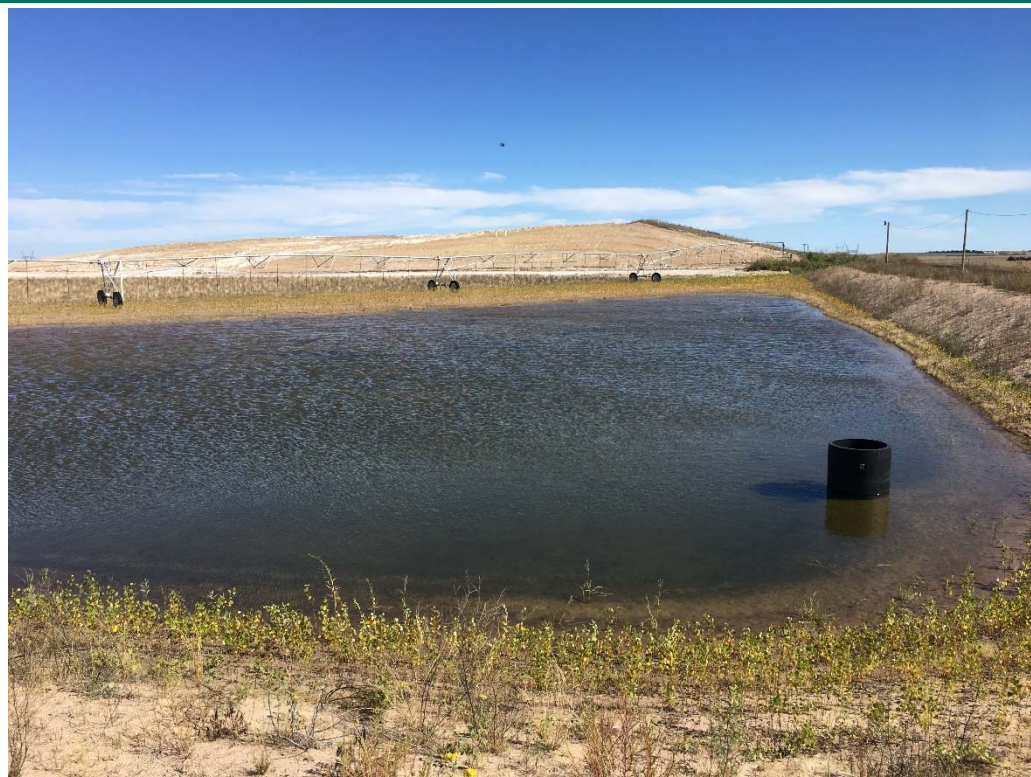
PHOTO 14

Sump area in
east cell of Ash
Landfill No. 3.
