2017 ANNUAL INSPECTION REPORT

ASH LANDFILL NO. 4

# 2017 ANNUAL INSPECTION REPORT SHELDON STATION ASH LANDFILL NO. 4

January 9, 2018

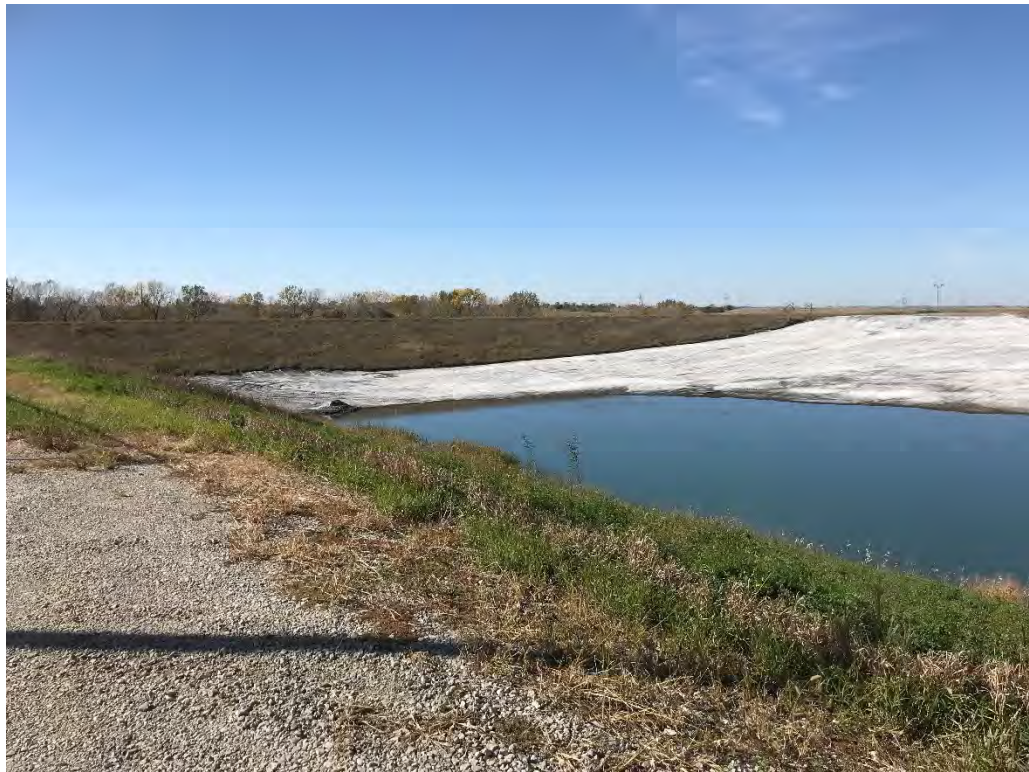
### PHOTO 1

Contact water contained within the lined facility.

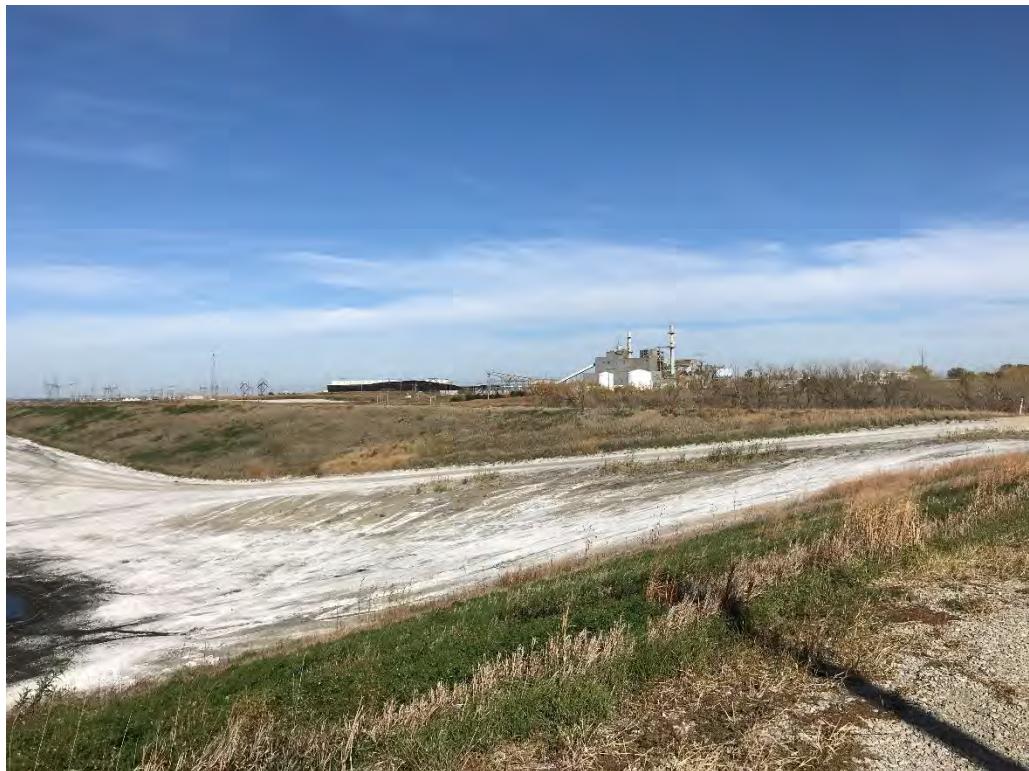
### PHOTO 2

Site access road.

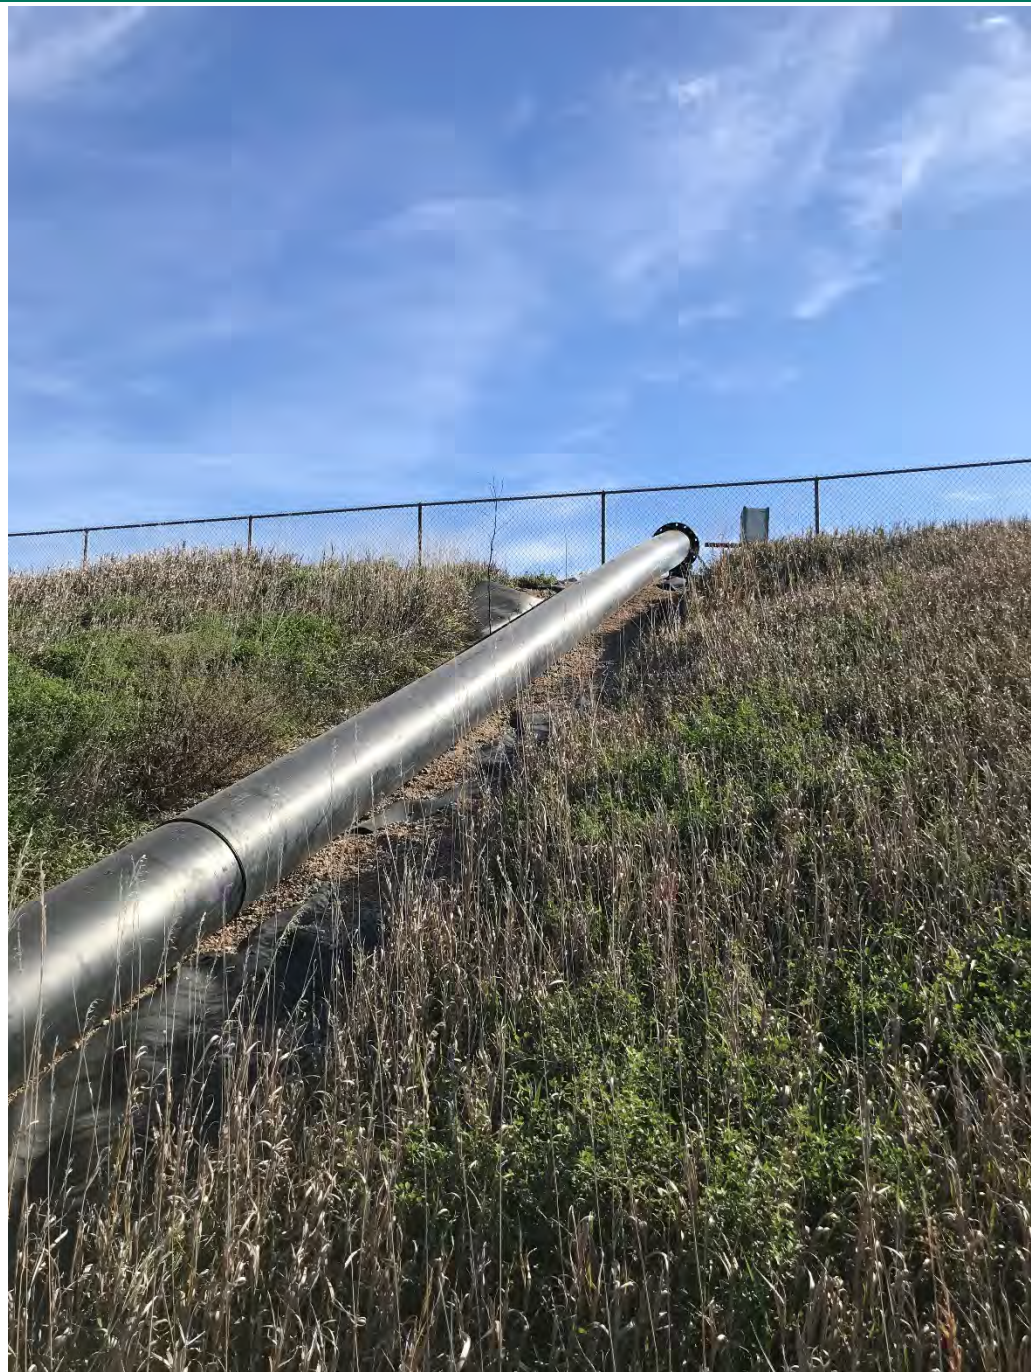
**PHOTO 3**  
LCS riser pipe.

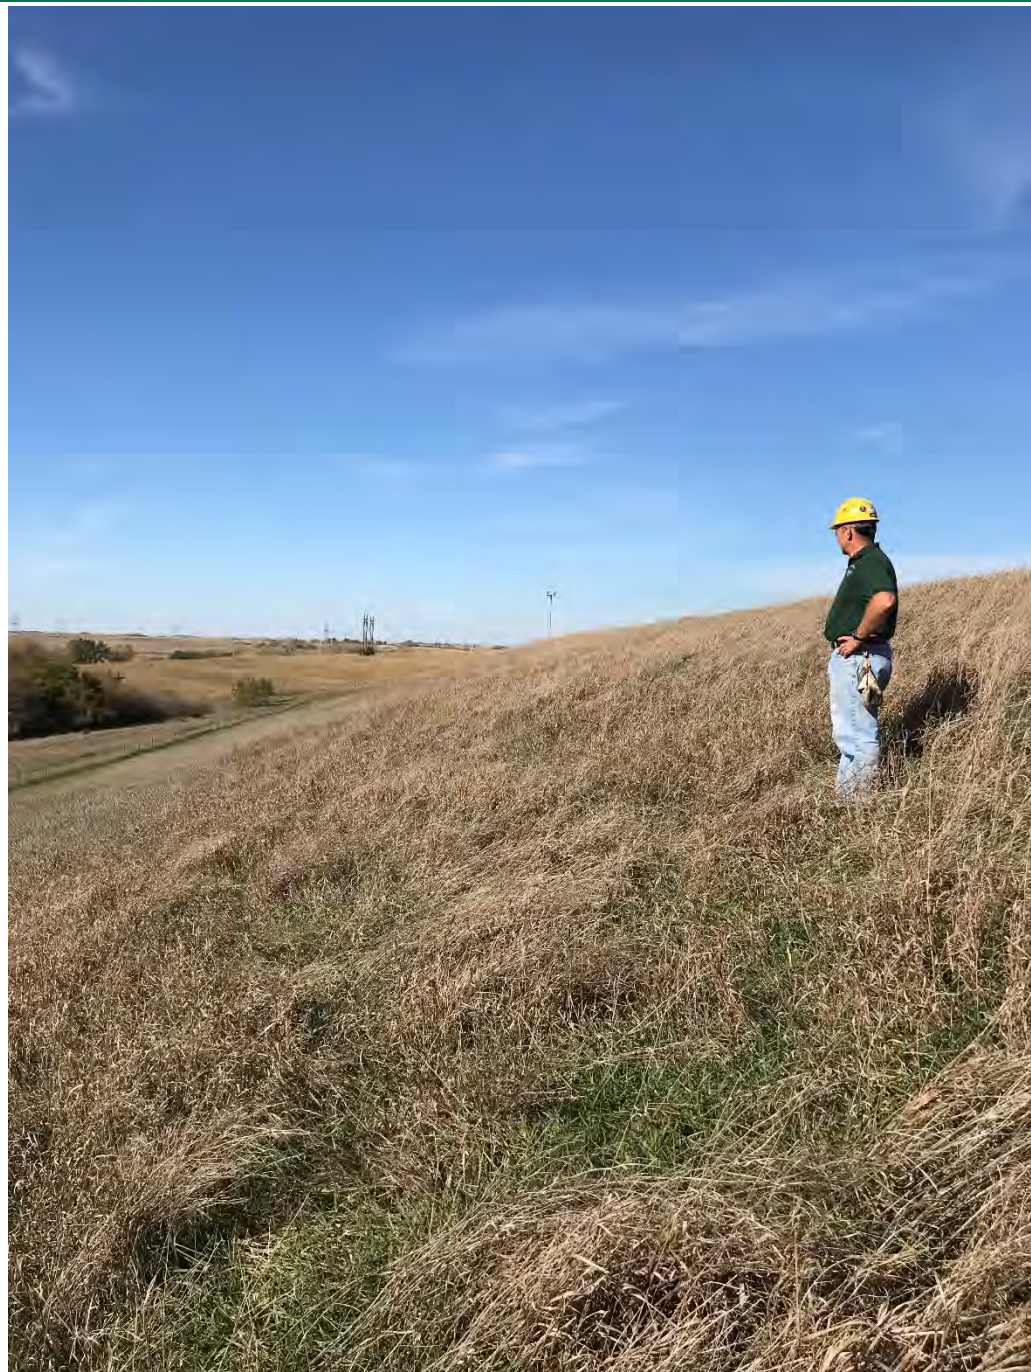
**PHOTO 4**

Vegetation on  
west slope of  
Ash Landfill  
No. 4.

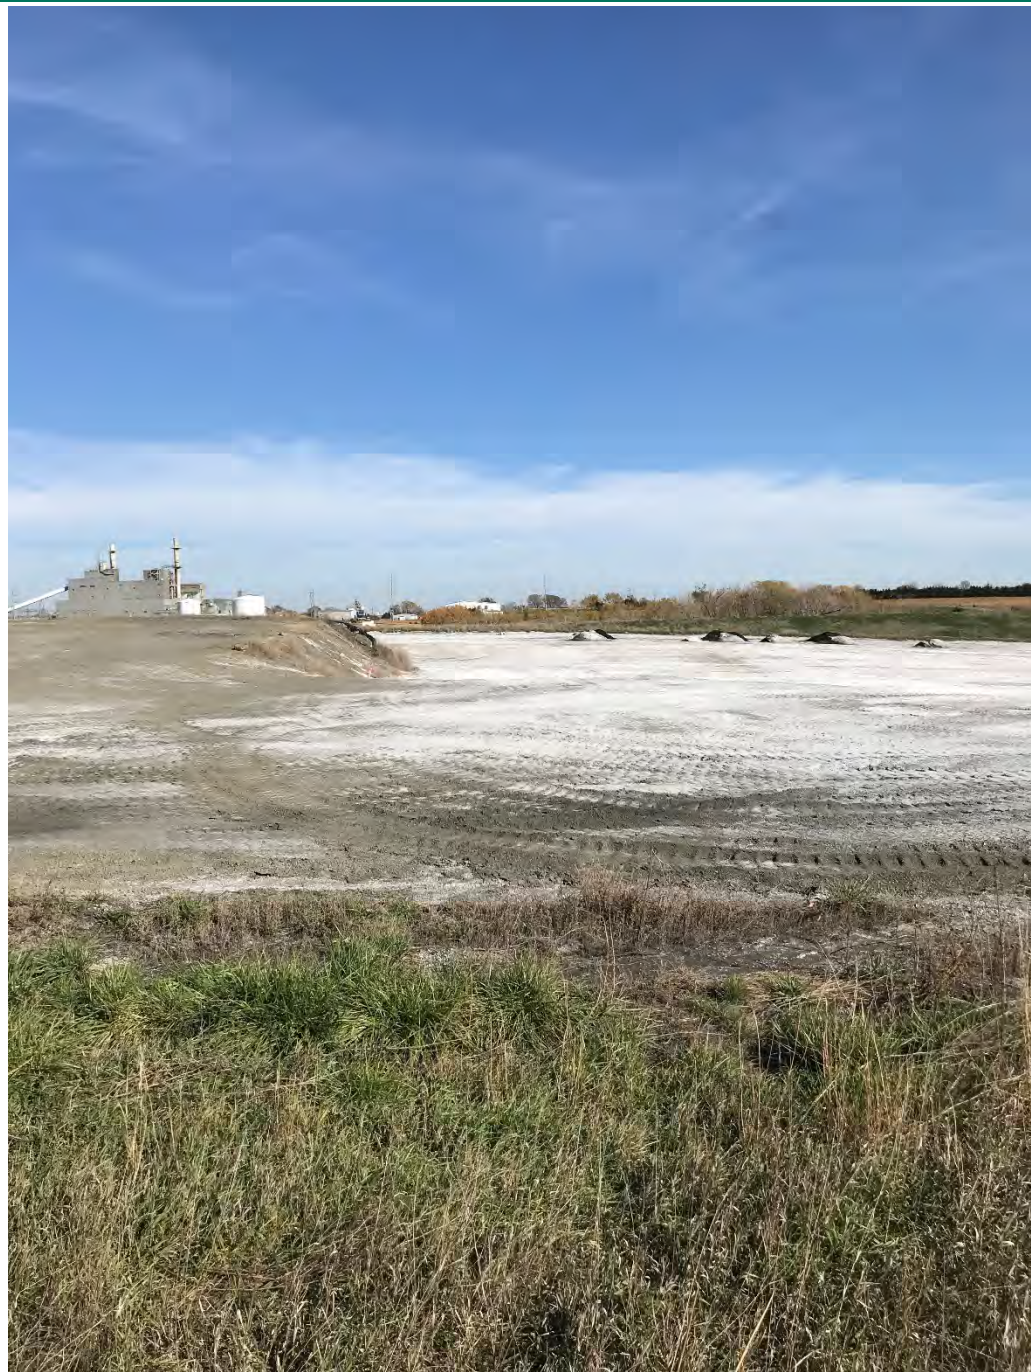
**PHOTO 5**

Active disposal  
area looking  
east.

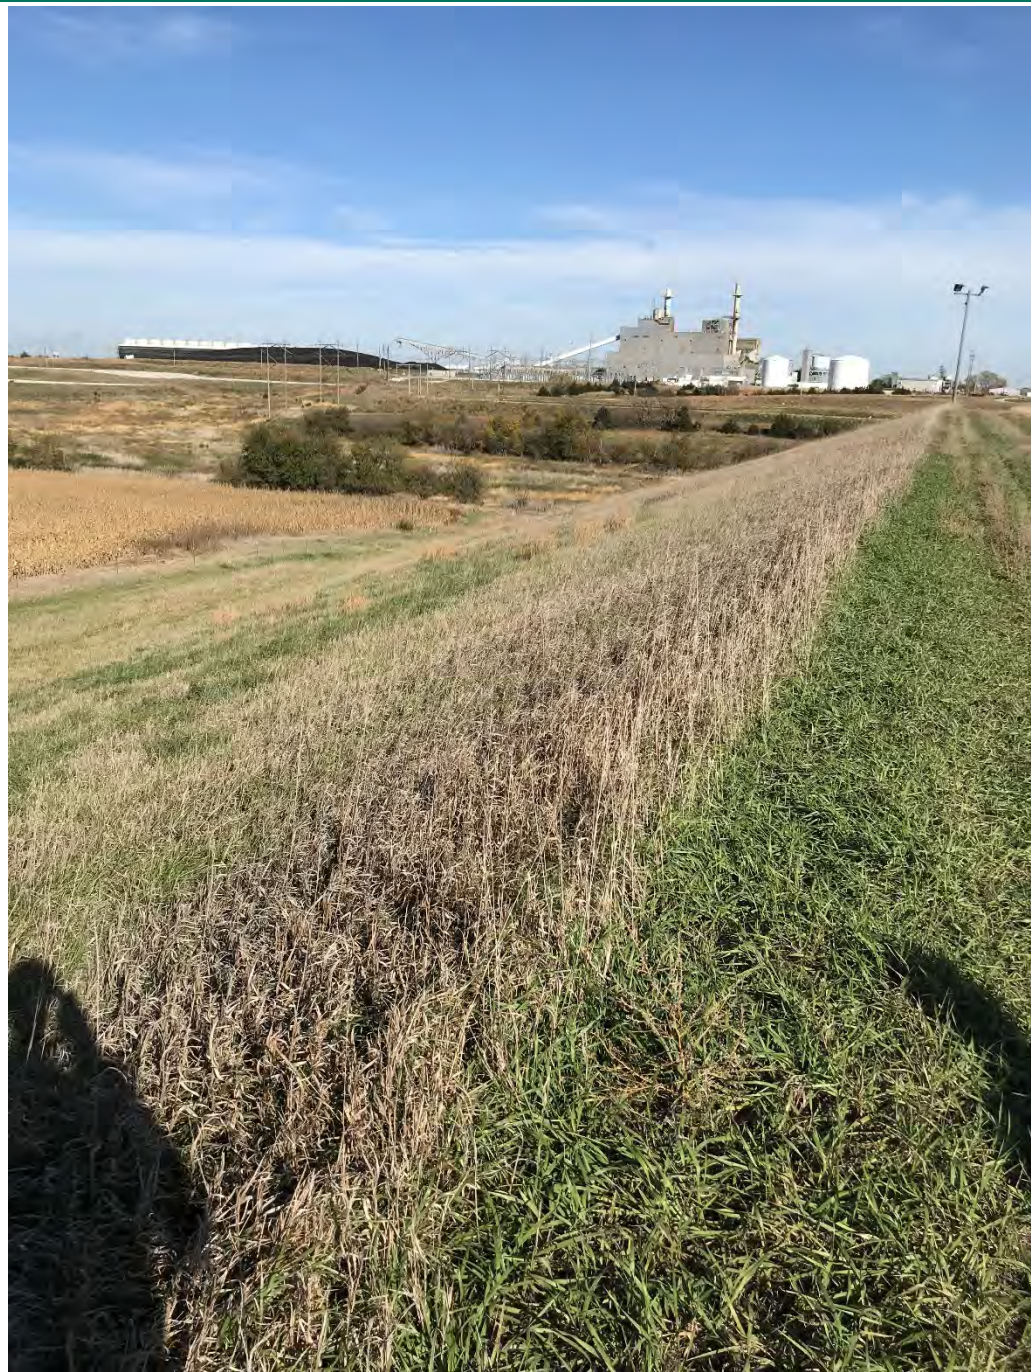
**PHOTO 6**

Exterior slope  
on east side of  
Ash Landfill  
No. 4.

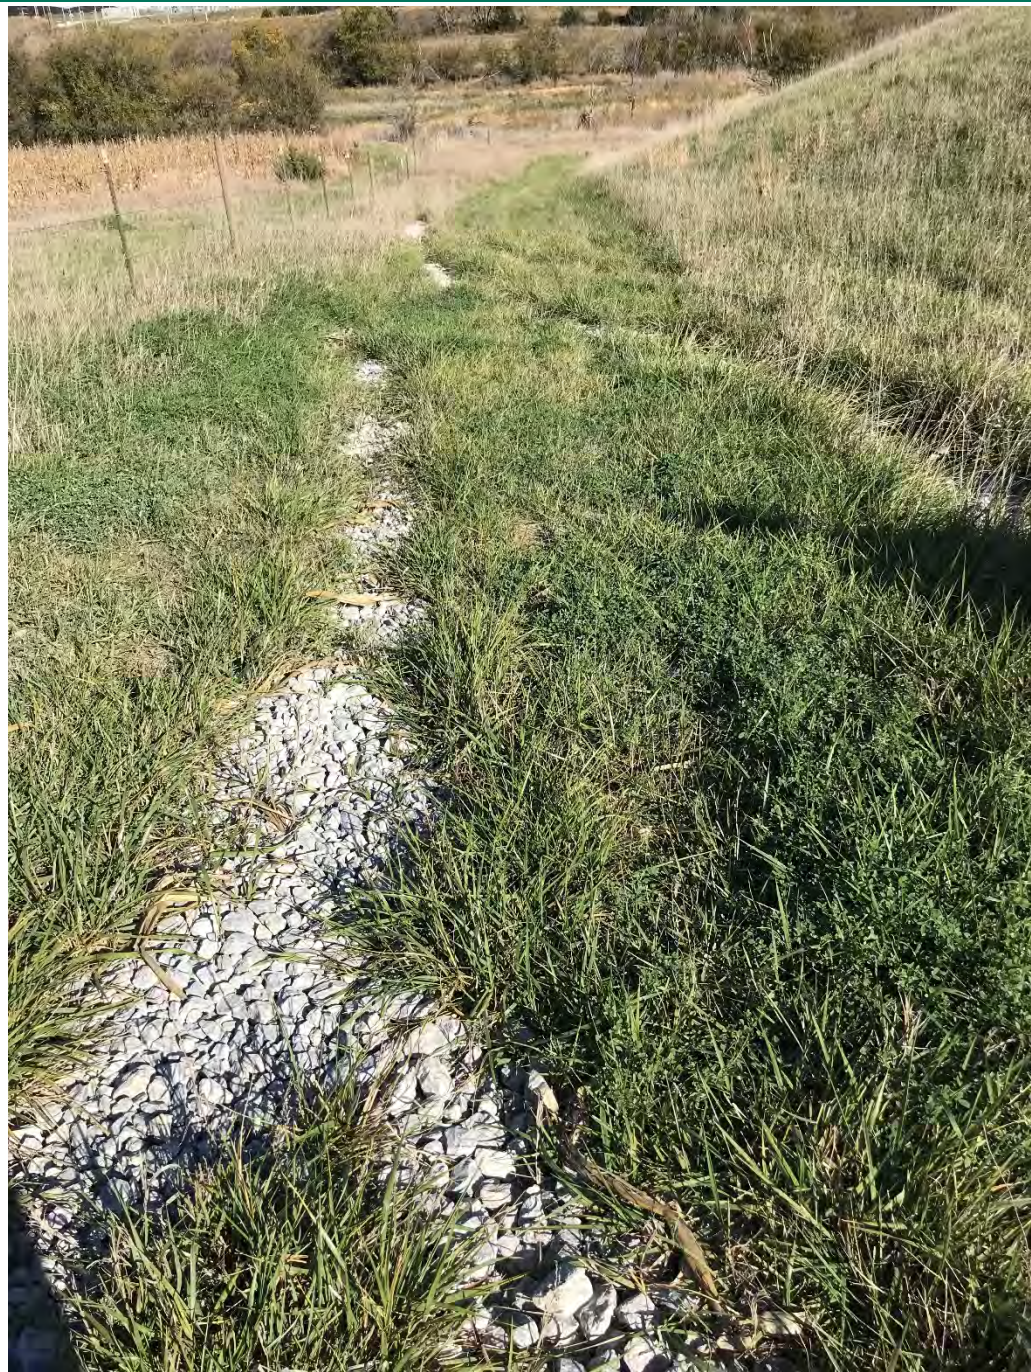
**PHOTO 7**

Minor erosional rills were observed near the toe of the north berm in during the 2015 annual inspection. NPPD has repaired these areas and backfilled the erosion rills with crushed rock. Vegetation has generally been established in the repaired areas, and significant erosion was not observed on the exterior slopes. NPPD should continue to monitor the exterior slopes of the disposal facility for erosion, both during weekly inspections and after large rain events.

Rock placed on north side of facility to prevent erosion and allow vehicle traffic.

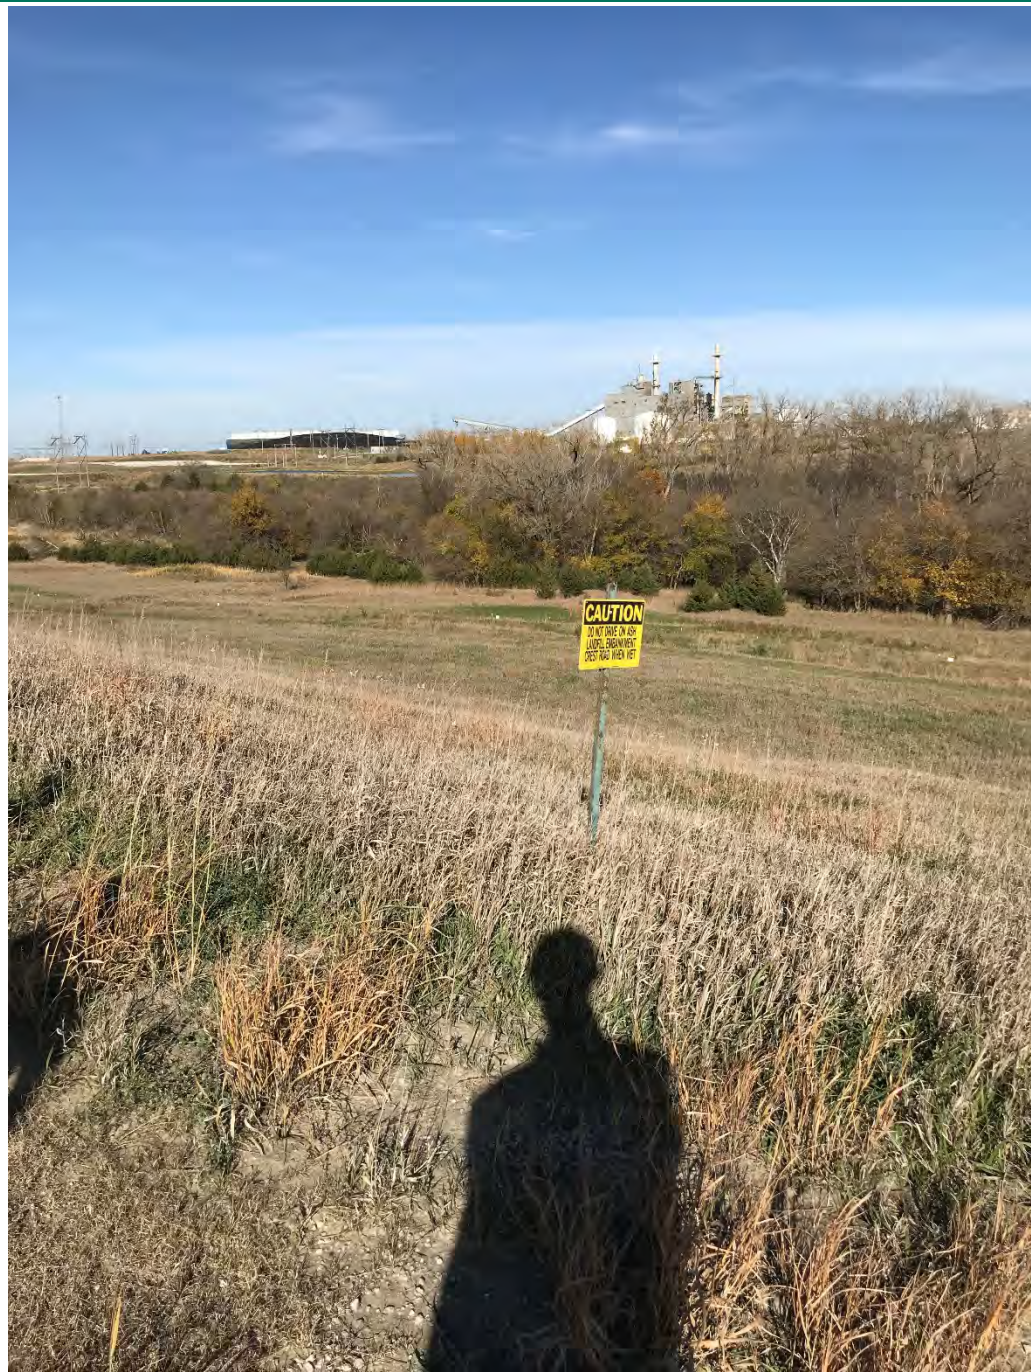
### PHOTO 8

Signage near  
facility  
entrance.

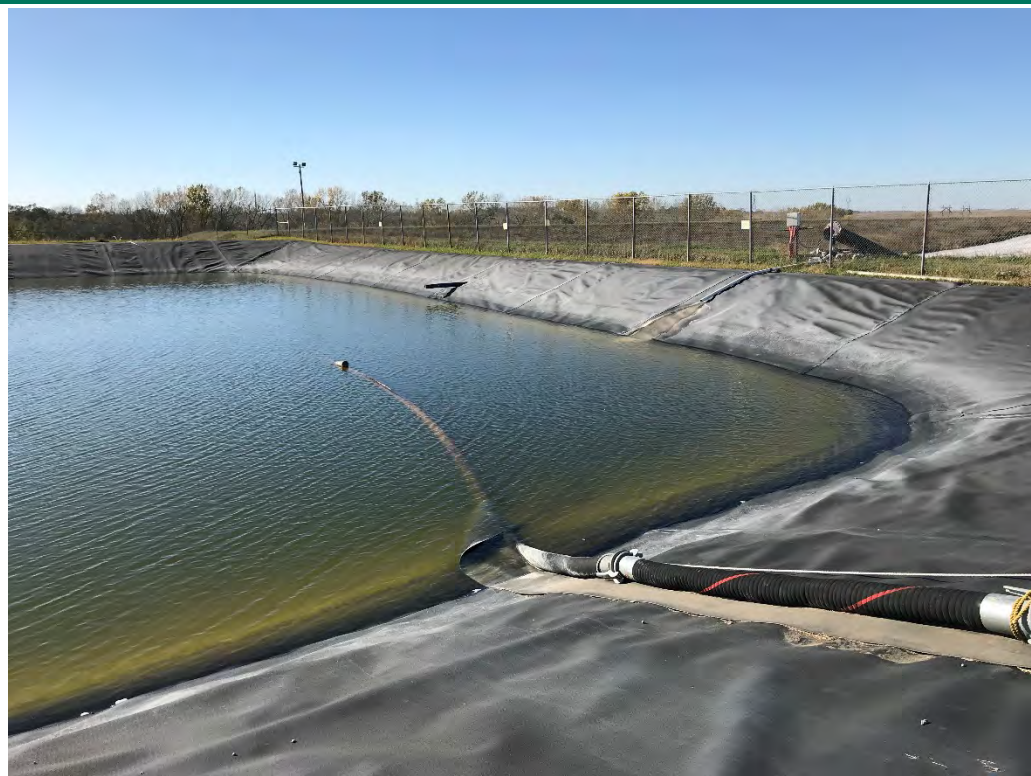
**PHOTO 9**

Contact water evaporation pond.

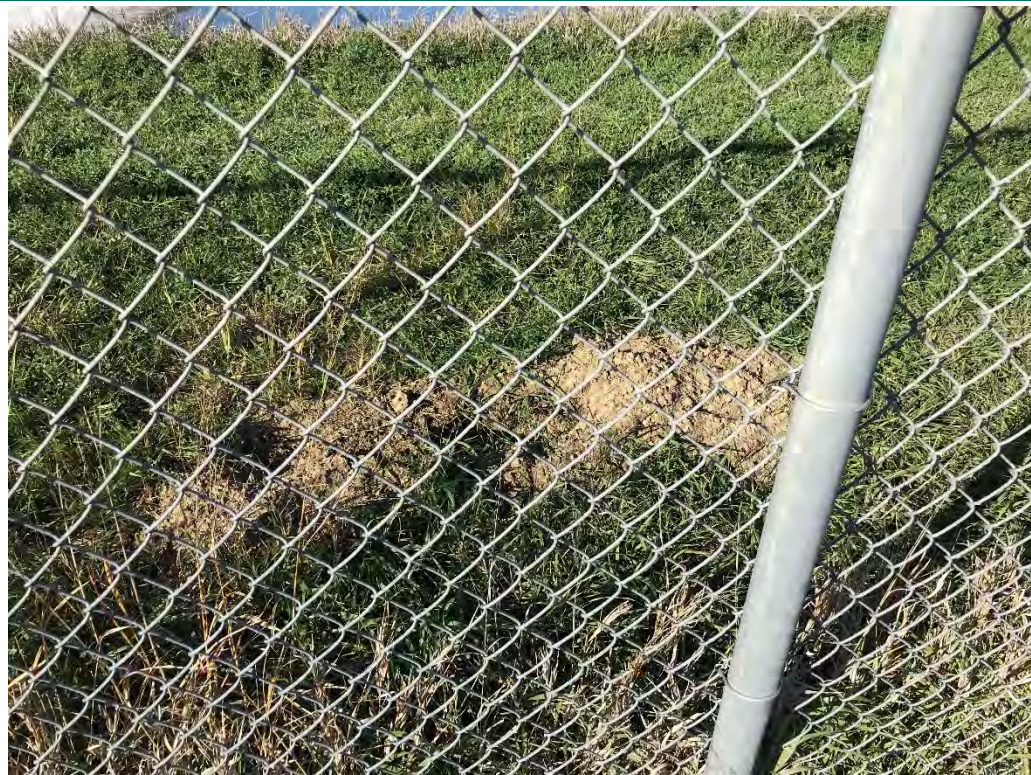
**PHOTO 10**

Isolated signs of historic (inactive) large animal burrowing were observed around the ash disposal facility. Efforts by NPPD and USDA to trap and relocate large burrowing animals appear to have been successful. Regardless, the embankments will continue to be inspected weekly, and signs of burrowing animals will be closely watched by plant personnel. Any increase in the level of small animal activity, or any sign of large animal burrowing will be remedied by trapping and removal to an off-site location.

Small animal burrow just outside of evaporation pond fence.

Any housekeeping concerns about the waste placement, coverage, and vegetation for visitors and neighbors?	<b>Minor animal burrows should be monitored. If additional animal activity is observed, NPPD should plan to trap animals and fill holes.</b>					
Is partial closure of the facility occurring?	Y	<u>N</u>	NI	NA	RA	
Has seed and mulch been applied on the closed areas of the site?	Y	N	NI	<u>NA</u>	RA	
Any visible or exposed soil or geomembrane liner?	Y	<u>N</u>	NI	NA	RA	<b>No exposed geomembrane within landfill. Evaporation pond liner is exposed by design.</b>
Were the concerns from the last annual observation addressed and corrected?	<u>Y</u>	N	NI	NA	RA	
<b>H. Comments</b>						
	<p><i>Describe <u>any</u> concerns identified above along with an overview of the current operations occurring at the facility. Include documentation of corrective action measures (photographs, plan view map, sketches, etc.) along with any work orders and anticipated dates of completion.</i></p> <p>Vegetation on exterior slopes is well established. Significant erosion was not observed on exterior or interior slopes.</p>
