2018 Annual Inspection Report

Gerald Gentleman Station Ash Disposal Facility

Golder Associates Inc.

December 20, 2018

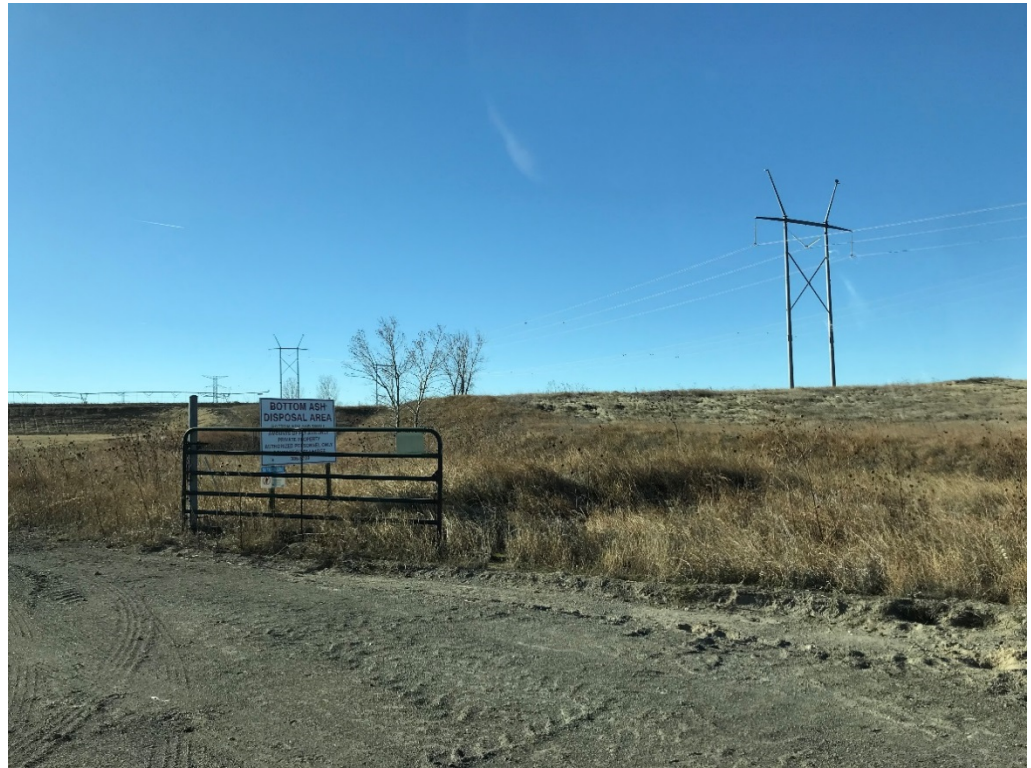
Ash Disposal Facility Annual Inspection, Gerald Gentleman Station**PHOTO 1**

Security gate & entrance to closed Bottom Ash Disposal Area.

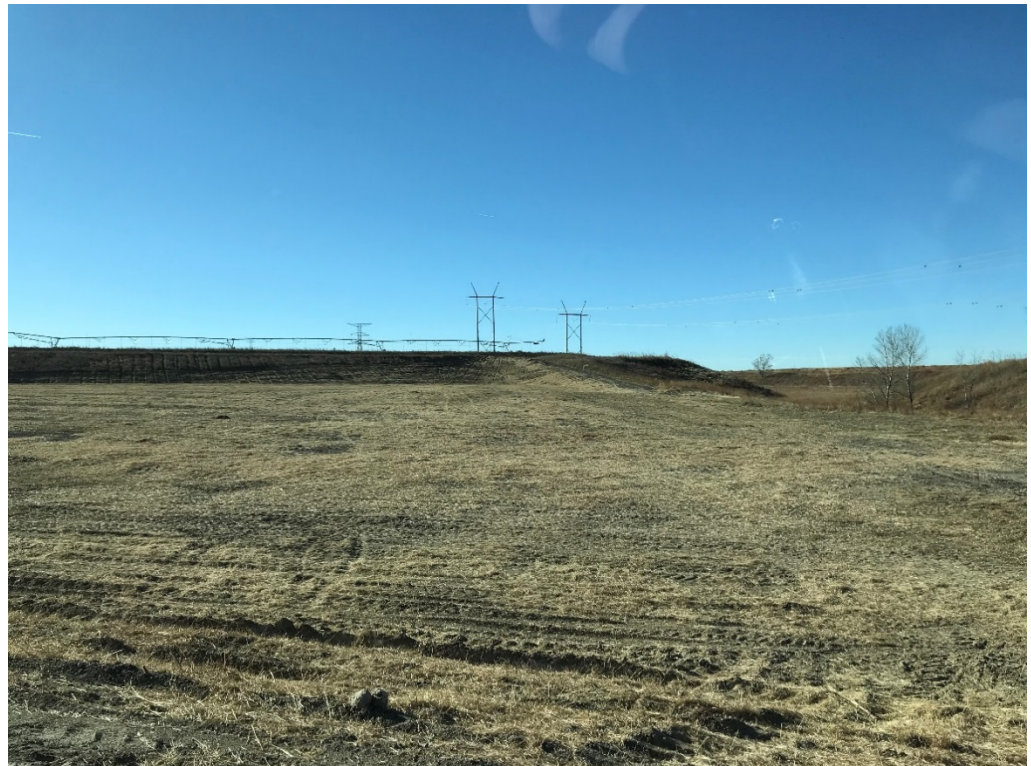
**PHOTO 2**

Mulching over the recently-closed Bottom Ash Disposal Area.

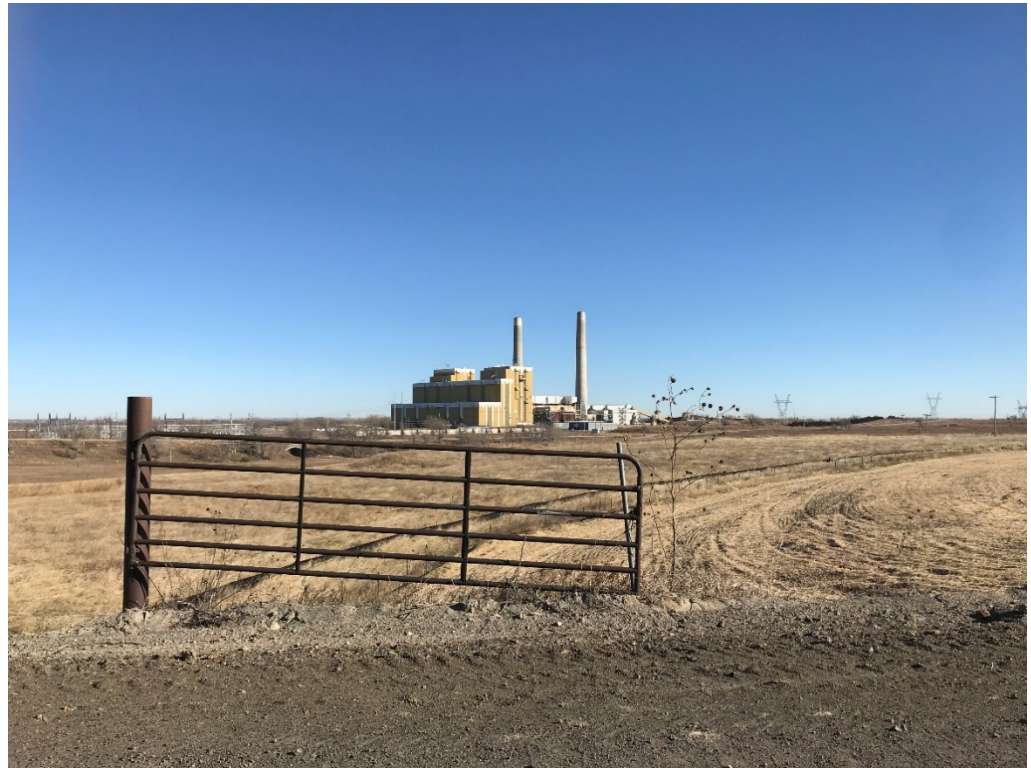
Ash Disposal Facility Annual Inspection, Gerald Gentleman Station**PHOTO 3**

Security gate at entrance to ash disposal area.

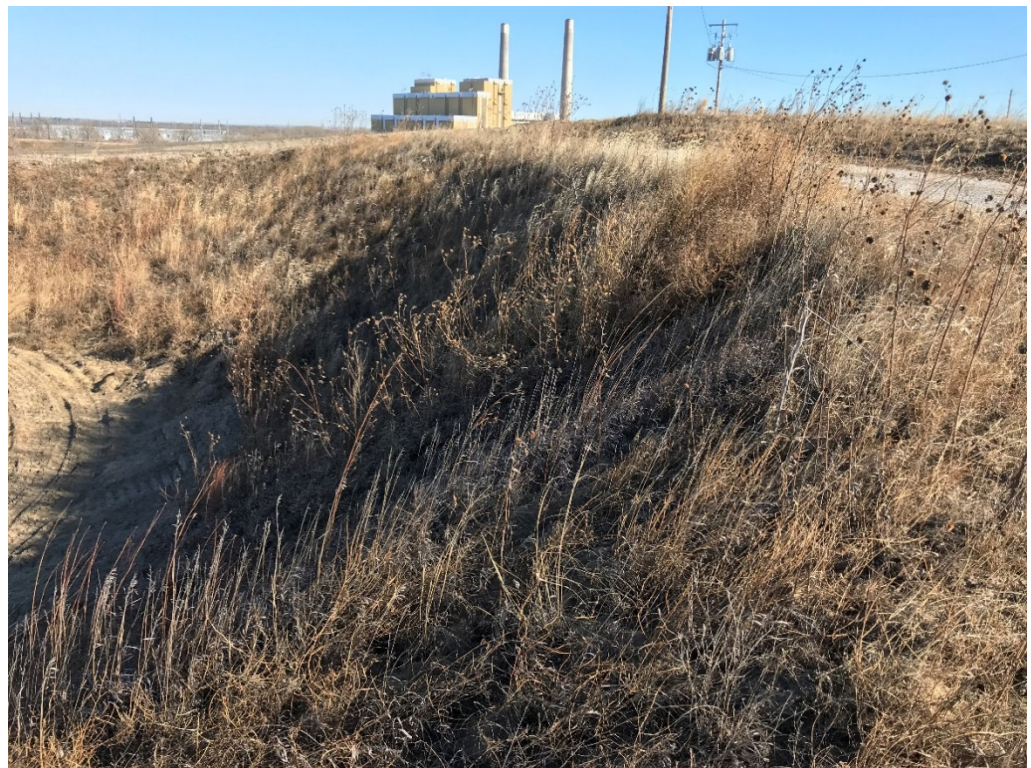
**PHOTO 4**

Some evidence of burrowing animals was observed both along the west outer slopes of Ash Landfill No. 3 (likely badger holes). The number of animal burrows observed was consistent with the previous inspection and has been reduced significantly from the 2015 inspection. NPPD inspects the embankments weekly, and signs of burrowing animals are documented. Animal burrows on the embankment slopes are addressed and repaired, as necessary. NPPD trapped three badgers on site in 2018.

Animal burrow and erosion on east side of Ash Pit No. 3.

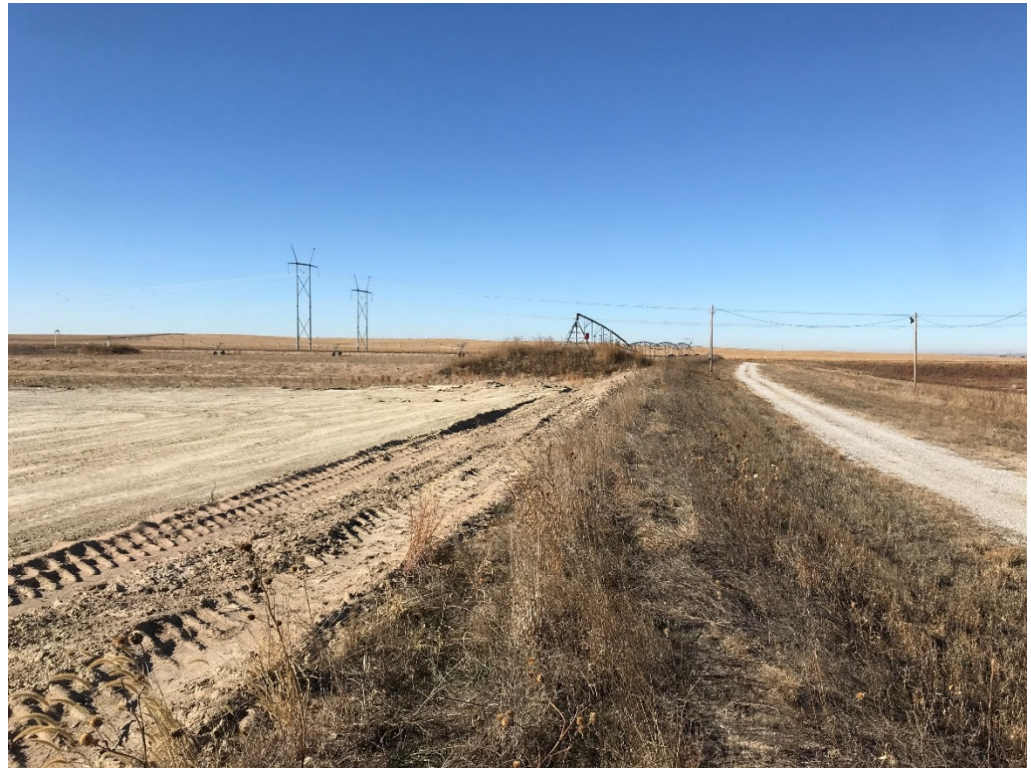
Ash Disposal Facility Annual Inspection, Gerald Gentleman Station**PHOTO 5**

Fly ash deposition in the north end of the east cell of Ash Landfill No. 3.

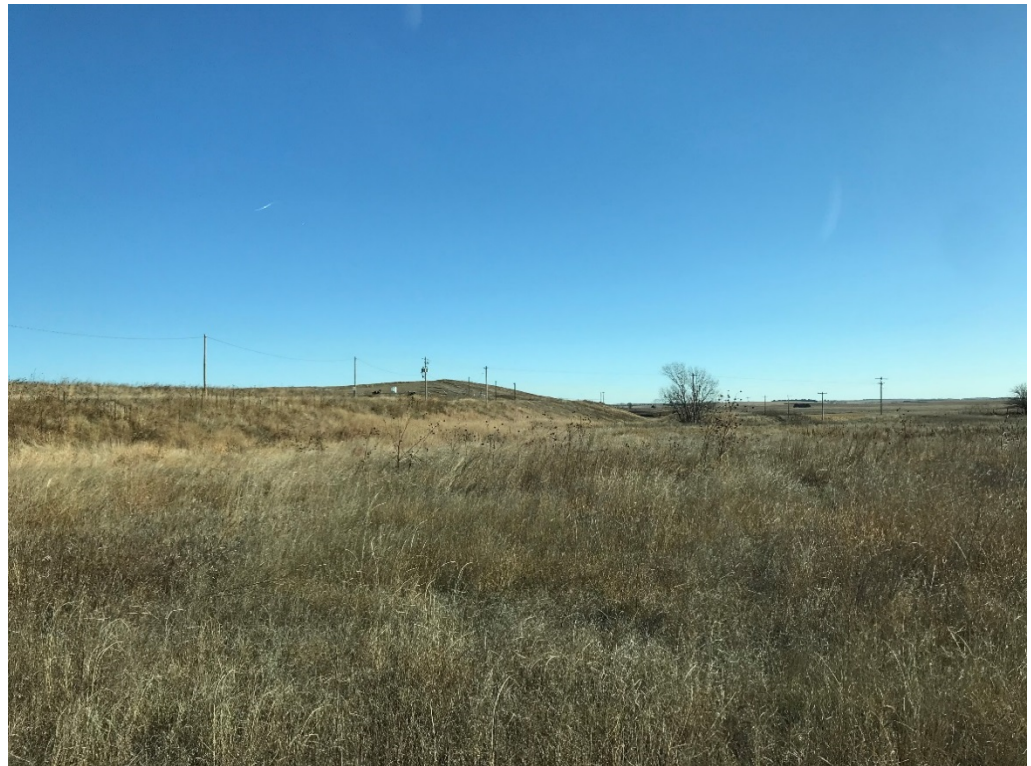
**PHOTO 6**

Minor erosion was observed on the outer embankment slopes on the west and south sides of Ash Landfill No. 3 and the south side of Ash Landfill No. 4. Erosion of the exterior slopes should be monitored and NPPD should continue to perform routine maintenance on the slopes. NPPD should address areas that are frequently eroded so that appropriate surface water controls can be developed.

South slope of Ash Landfill Nos. 3 and 4.

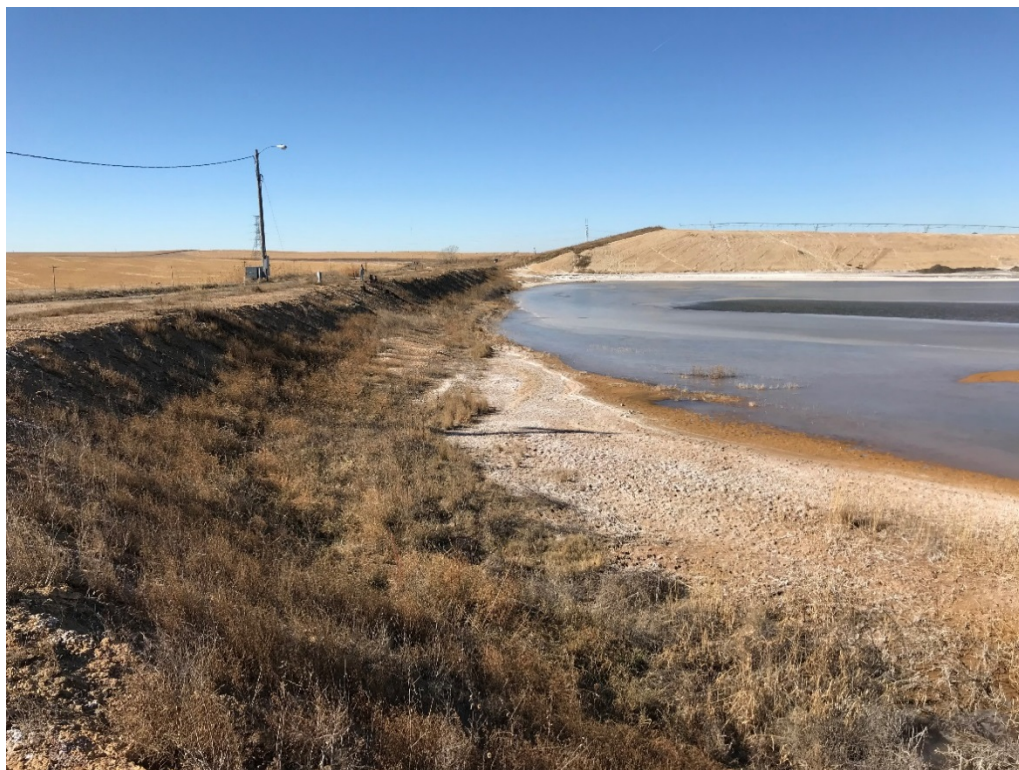
Ash Disposal Facility Annual Inspection, Gerald Gentleman Station**PHOTO 7**

Contact water contained in east end of Ash Landfill No. 4.

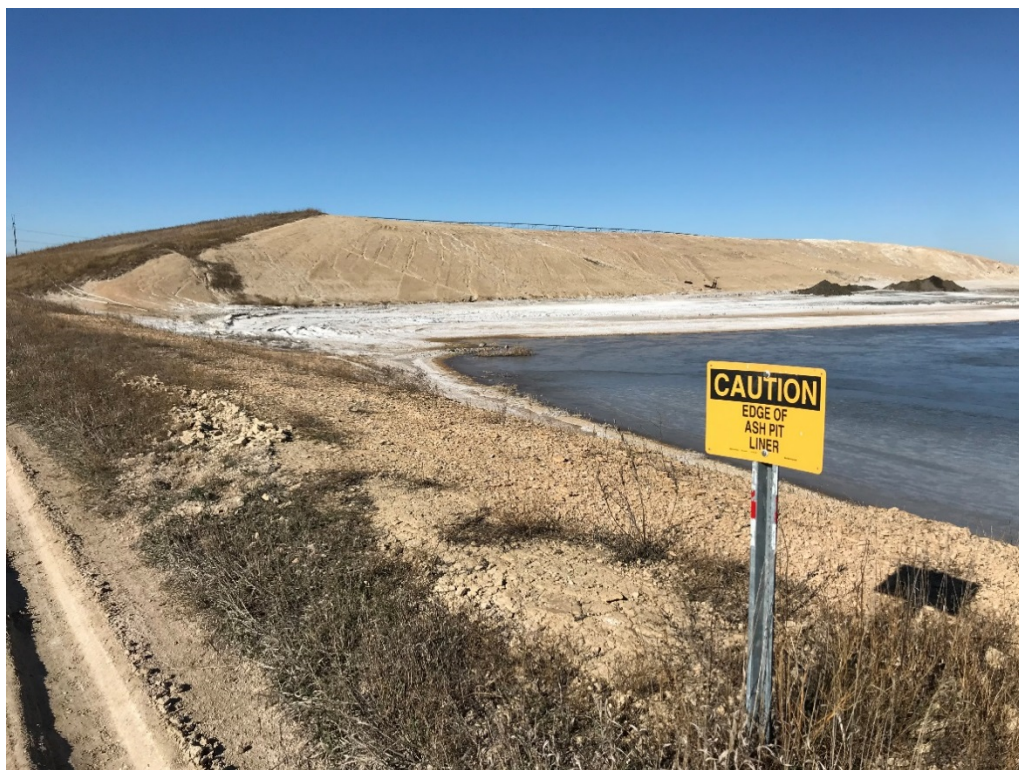
**PHOTO 8**

Edge of liner sign on south side of Ash Landfill No. 4.

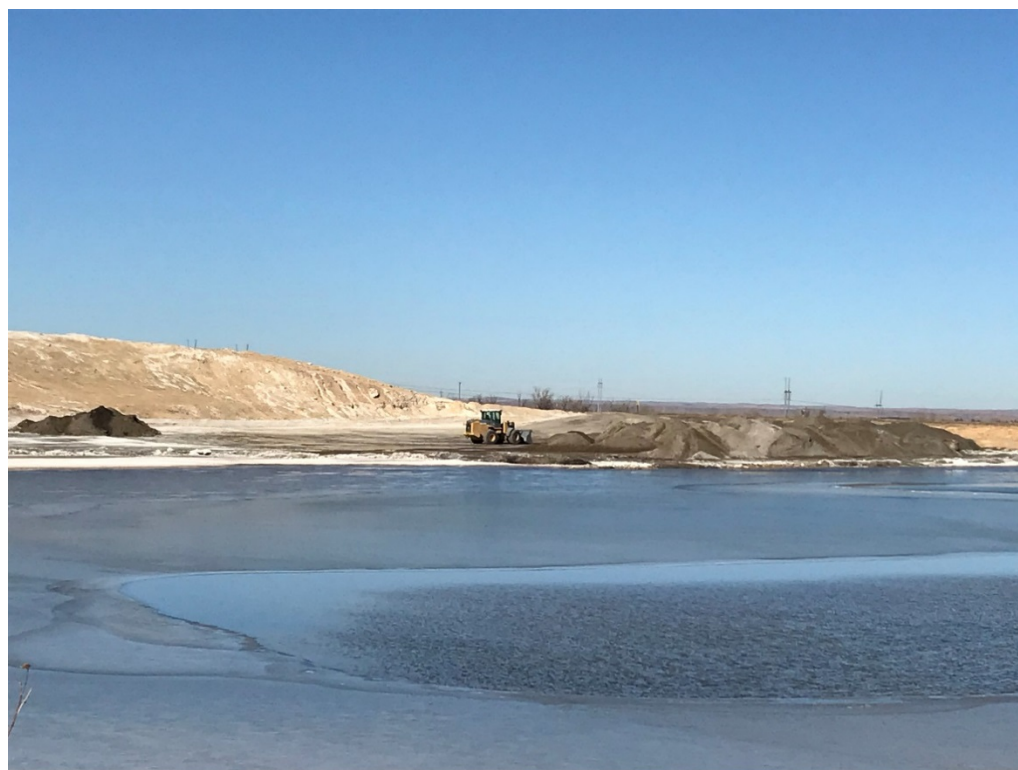
Ash Disposal Facility Annual Inspection, Gerald Gentleman Station**PHOTO 9**

New bottom ash stockpile and handling location in Ash Landfill No. 4.

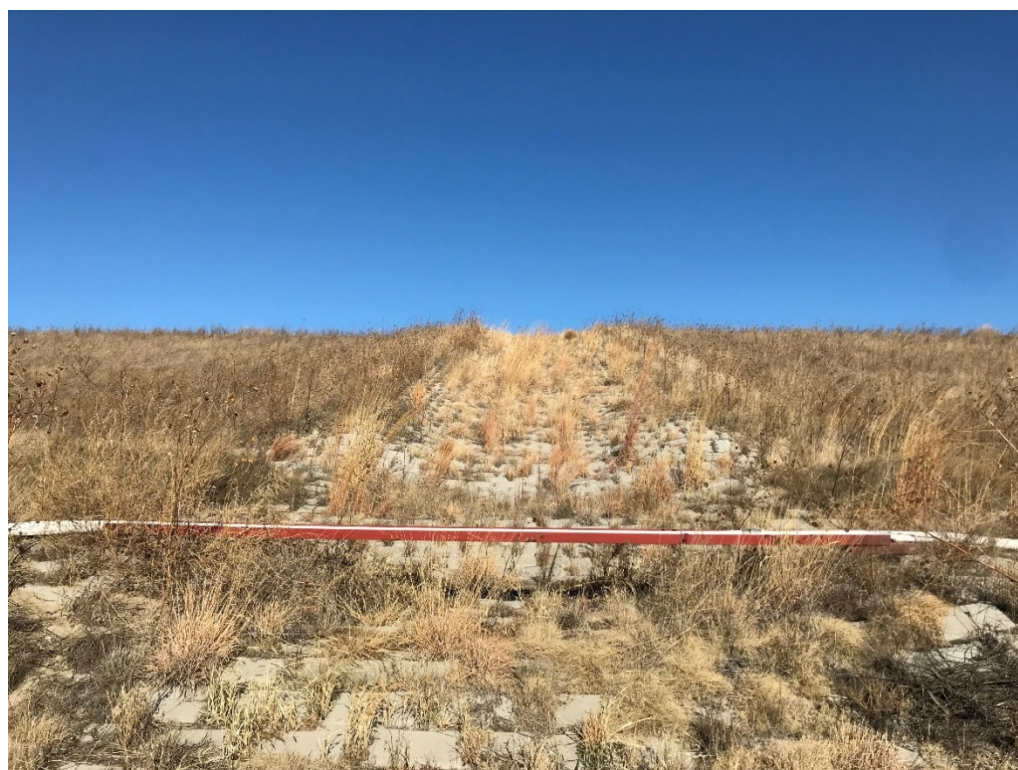
**PHOTO 10**

Vegetative growth of the final cover placed in 2015 has continued to improve, resulting in reduced erosion of the cover soil. The terrace channels and downchute channel on the final cover appear to be functioning as designed.

Downchute channel on south side of Ash Landfill No. 4.

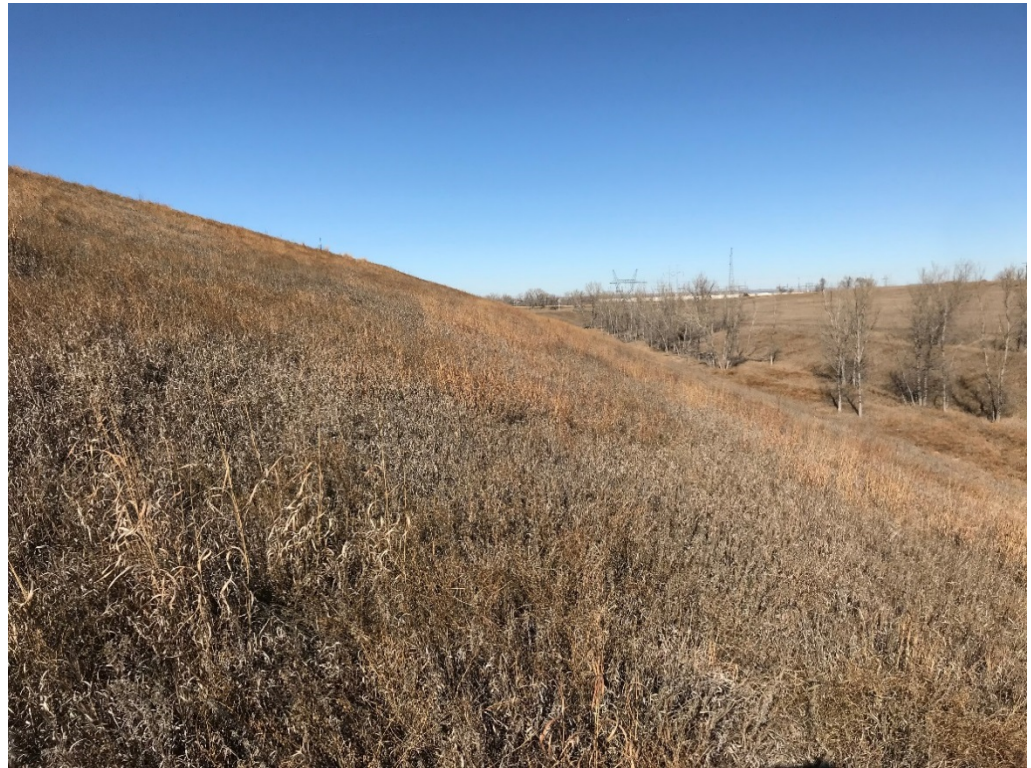
Ash Disposal Facility Annual Inspection, Gerald Gentleman Station**PHOTO 11**

Vegetation on east exterior slope of Ash Landfill No. 4.

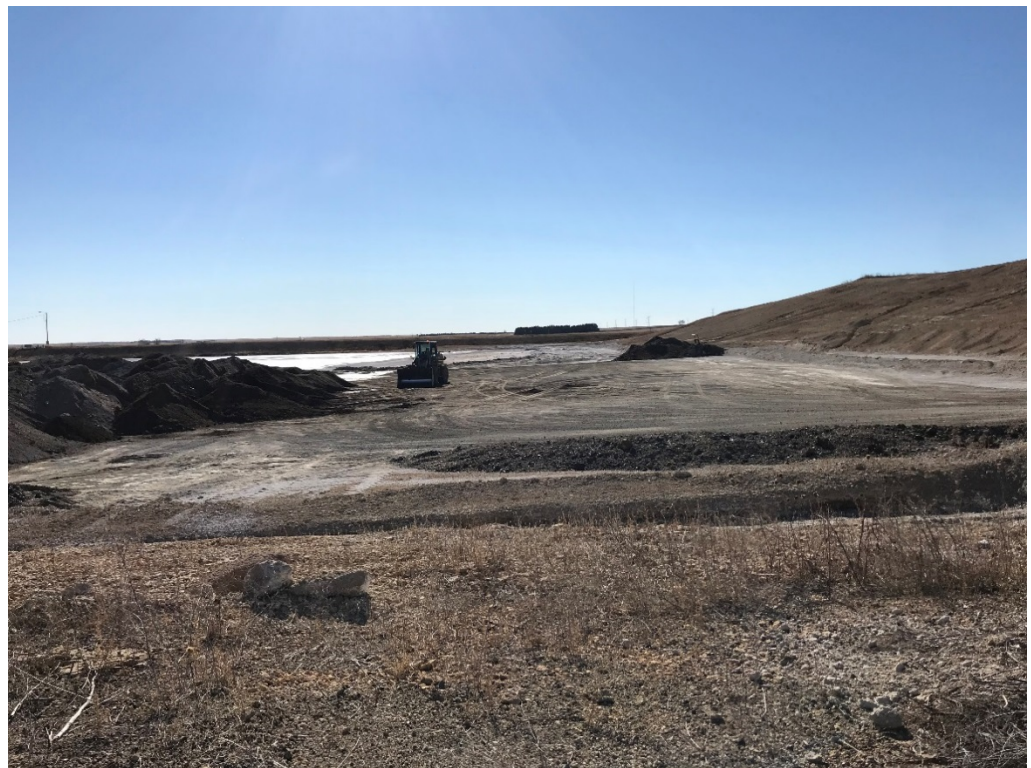
**PHOTO 12**

Bottom ash stockpile and handling area in Ash Landfill No. 4.

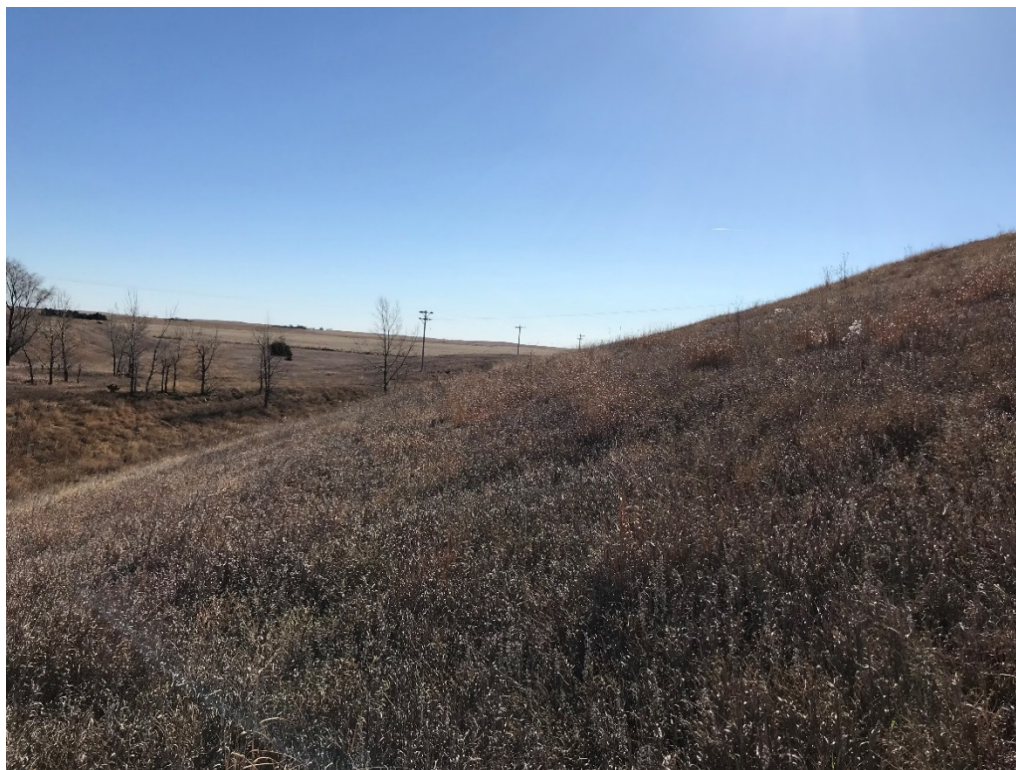
Ash Disposal Facility Annual Inspection, Gerald Gentleman Station**PHOTO 13**

Vegetation on
exterior slope of Ash
Landfill No. 4.

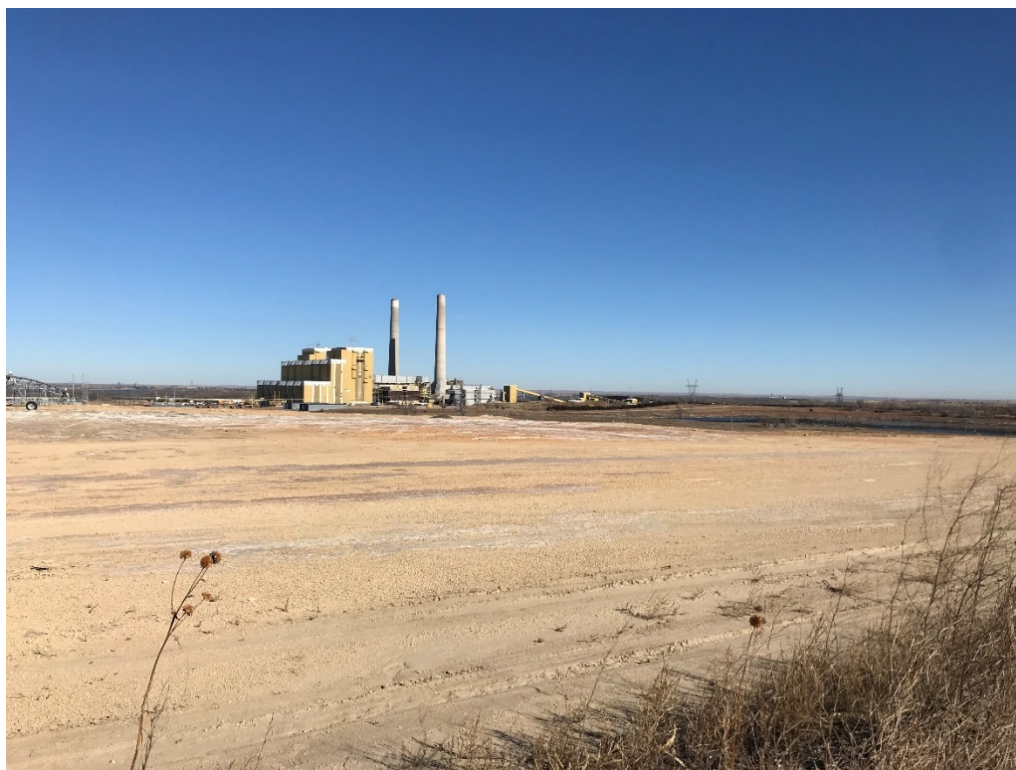
**PHOTO 14**

Fly ash deposition in
Ash Landfill No. 4.
