2018 Annual Inspection Report

Sheldon Station Ash Landfill No. 4

18101264-0001-1-R-0

December 19, 2018

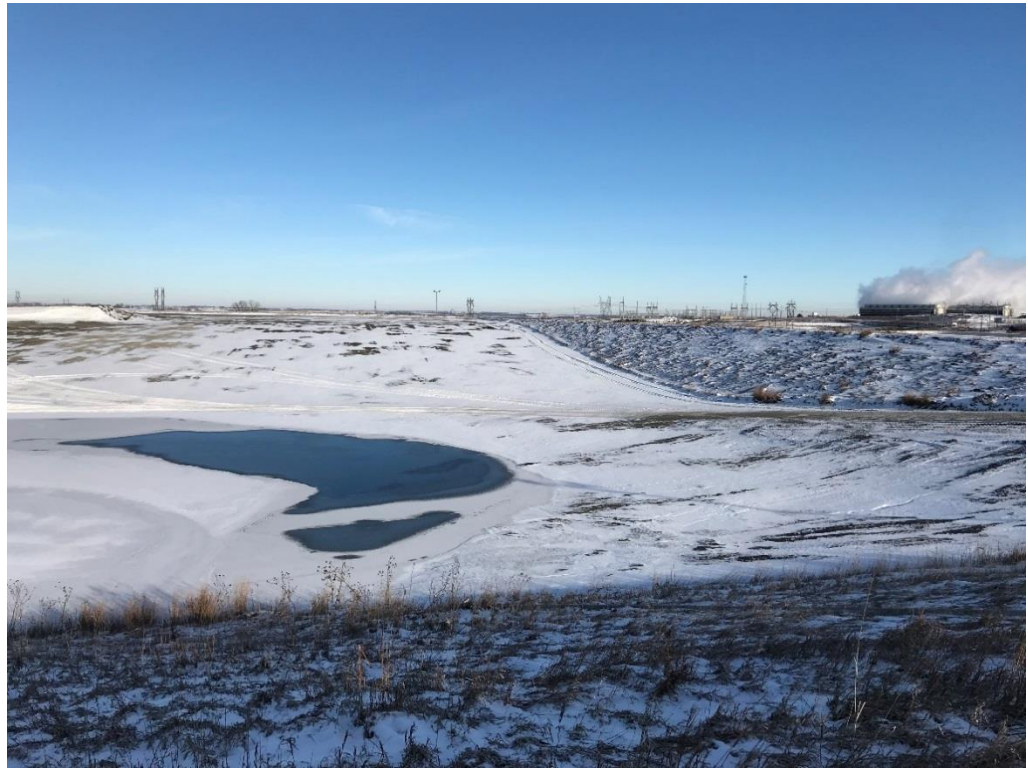
Ash Landfill No. 4 Annual Inspection, Sheldon Station**PHOTO 1**

Contact water
contained within the
lined facility.

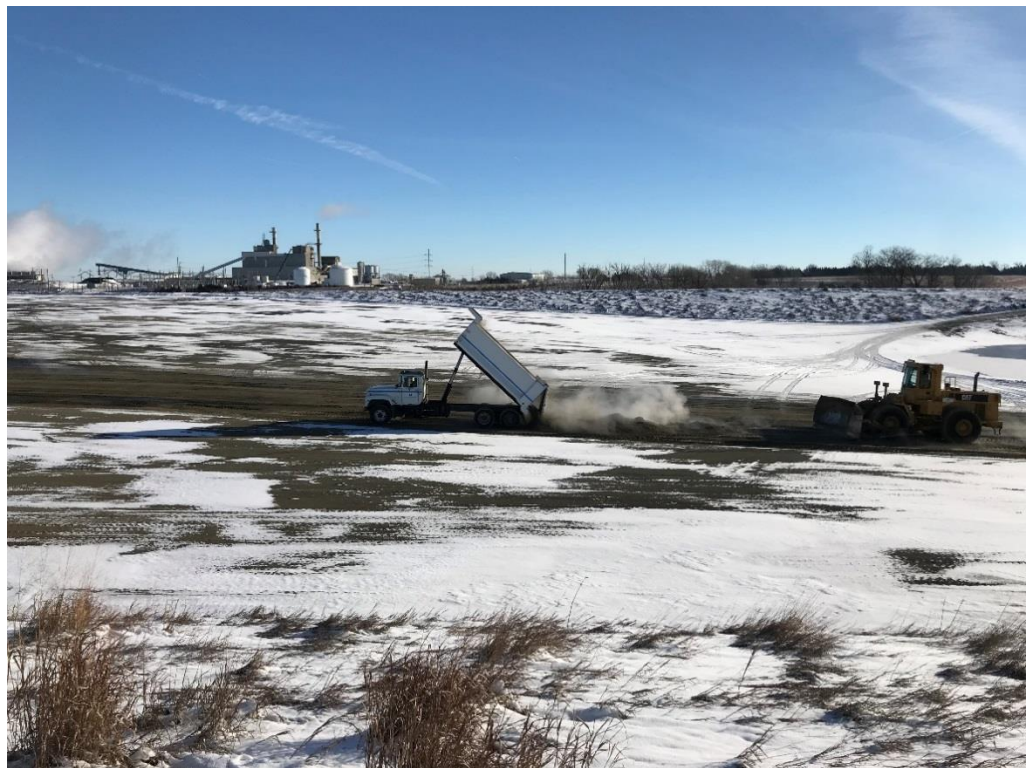
**PHOTO 2**

Fly ash deposition.

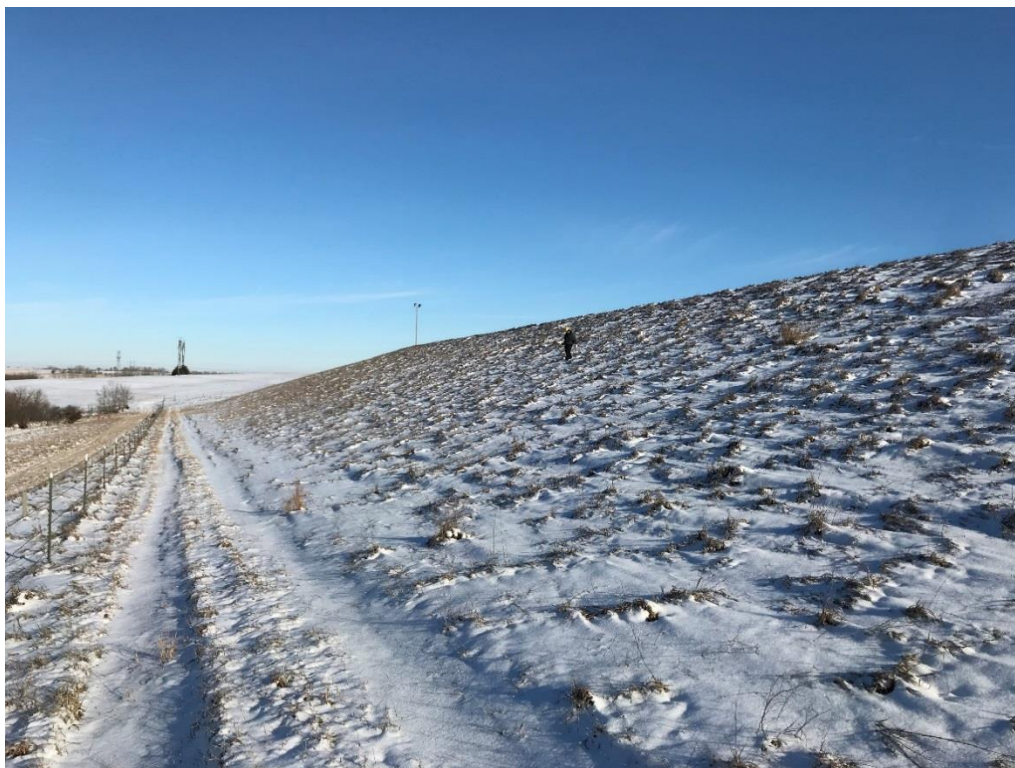
Ash Landfill No. 4 Annual Inspection, Sheldon Station**PHOTO 3**

Western exterior
slope of Ash Landfill
No. 4.

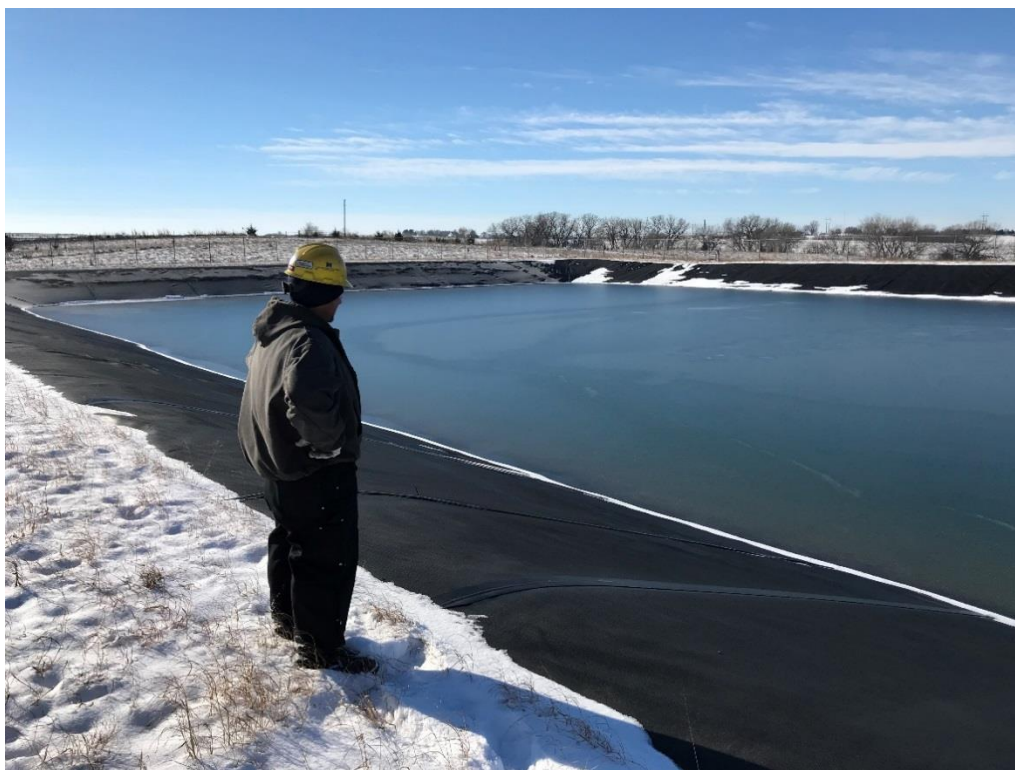
**PHOTO 4**

Contact water
evaporation pond.

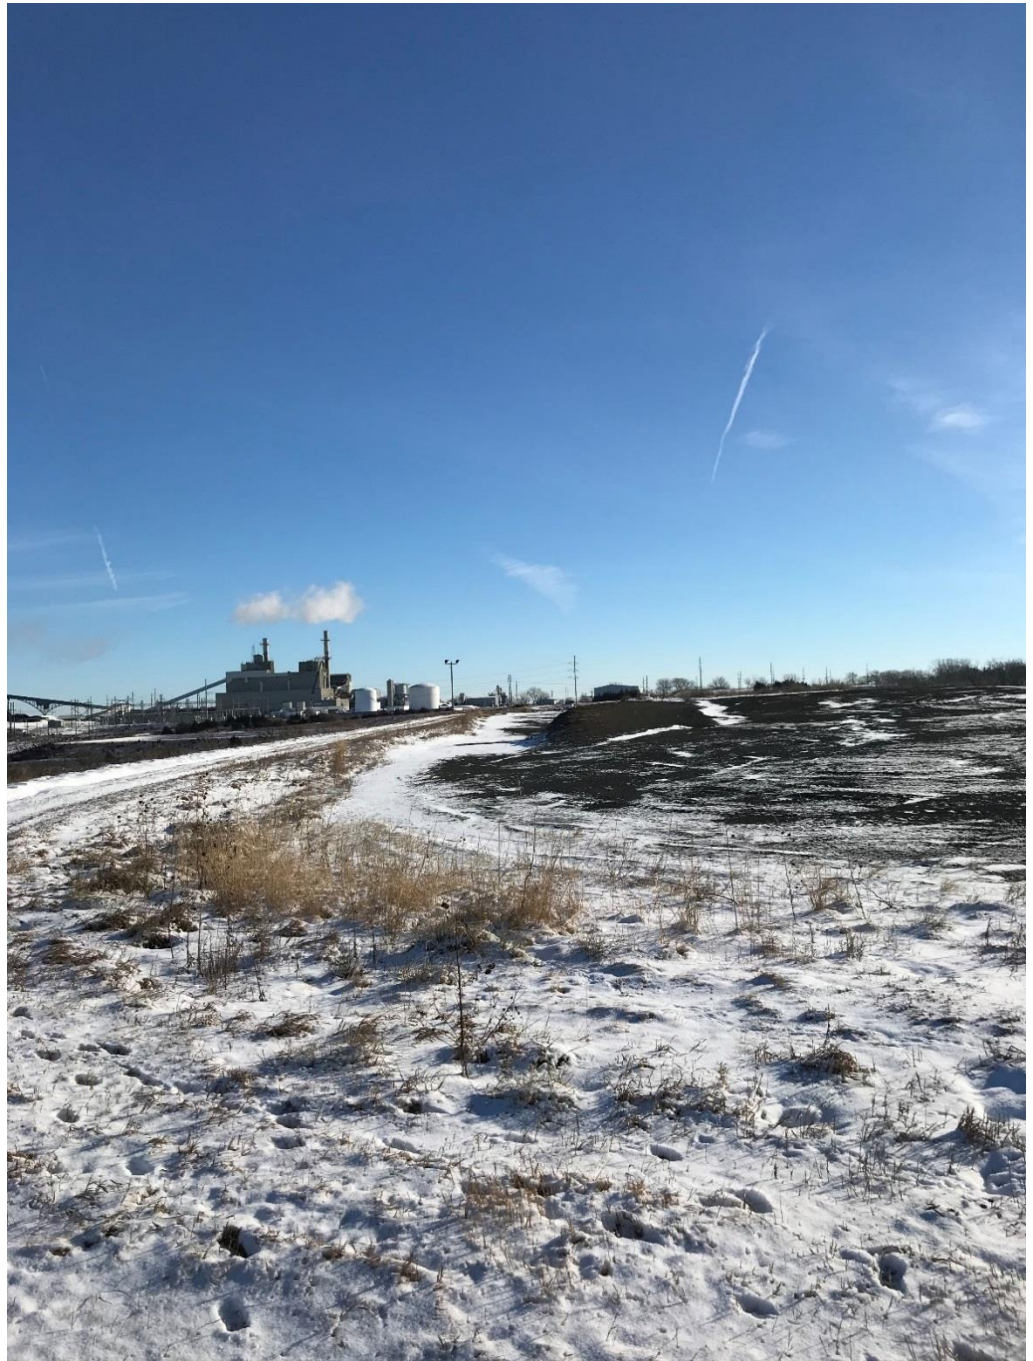
Ash Landfill No. 4 Annual Inspection, Sheldon Station**PHOTO 5**

Interior containment berms (north end of facility).

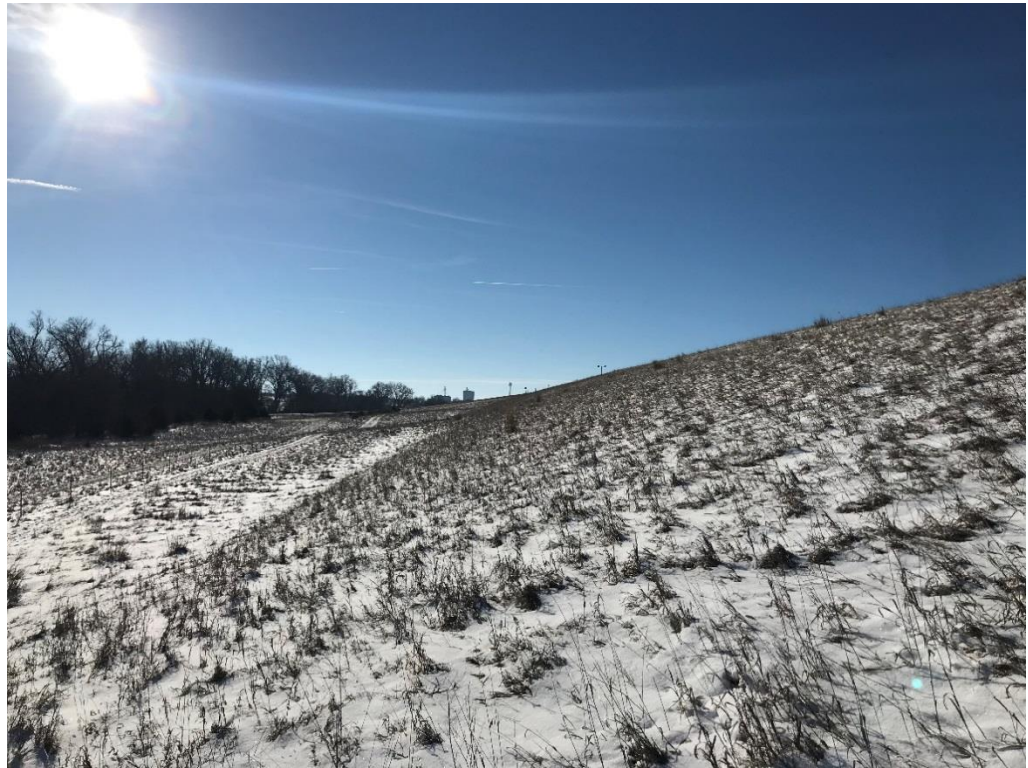
Ash Landfill No. 4 Annual Inspection, Sheldon Station**PHOTO 6**

Minor erosional rills have been observed near the toe of the exterior slopes in the northeast corner of the facility during previous inspections. NPPD has repaired these areas and backfilled the erosion rills with crushed rock. Vegetation has generally been established in the repaired areas, and significant erosion was not observed on the exterior slopes. However, erosion rills were observed across the perimeter road in this area. NPPD should continue to monitor the exterior slopes of the disposal facility for erosion, both during weekly inspections and after large rain events, making repairs, as necessary.

Exterior slope on
east side of Ash
Landfill No. 4.

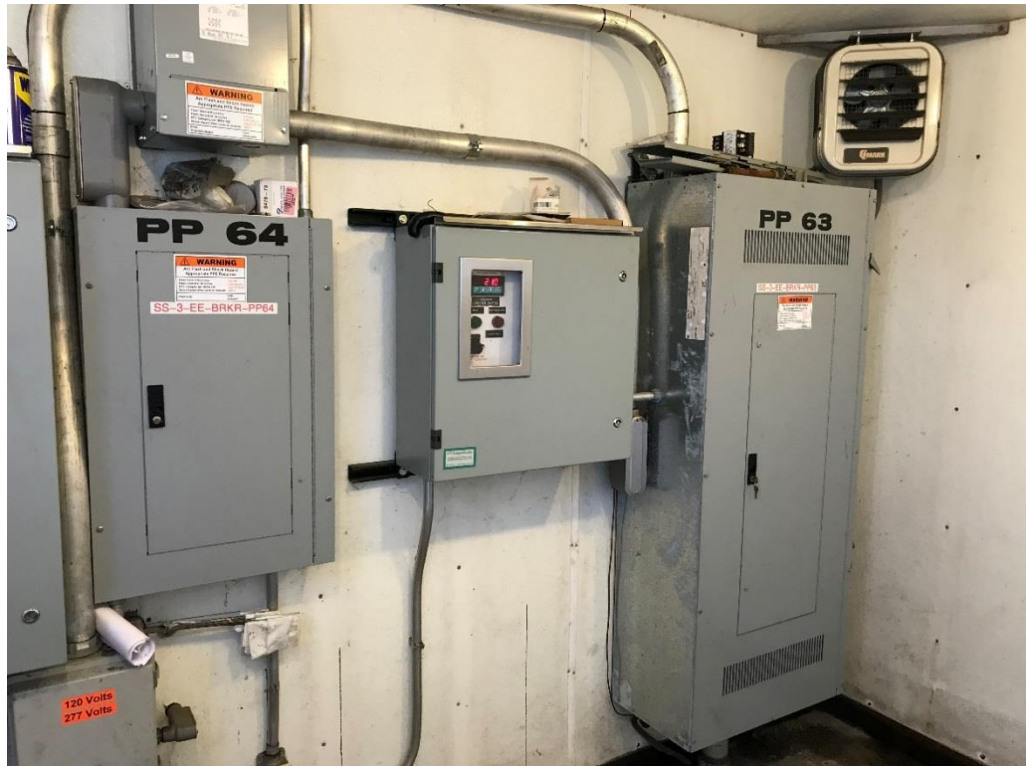
**PHOTO 7**

Contact water pond
pump controls and
instrumentation
