Laborer Struck by Skid-steer Loader While Exiting from a Tarp-enclosed Area on a Construction Site – Massachusetts

Massachusetts Case Report: 07-MA-019

Release Date: July 28, 2008

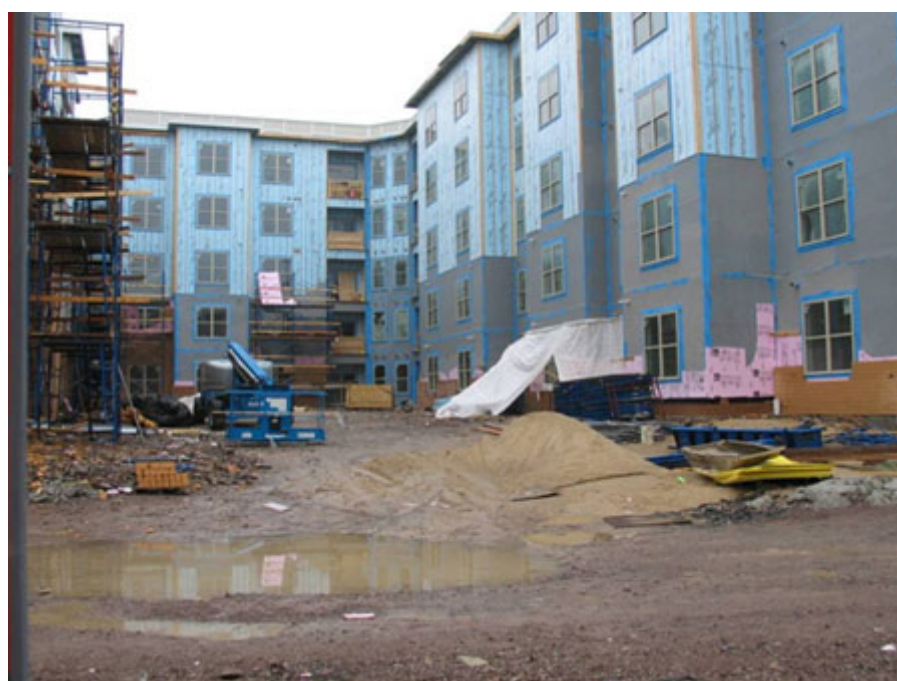
At the time of the incident, the company had approximately 14 people on-site and was performing brickwork on the exterior façade of a building ([Figure 1](#)). The victim's main job was to mix and supply mortar to the masons. These tasks involved the use of a large mechanical mixer to mix the mortar and the use of a wheelbarrow to transport the mortar to the masons' location.

The incident occurred a few minutes after 8:00 a.m. on a Monday morning. The weather conditions at the time of the incident consisted of temperatures around 40°F with an average wind speed of 16 miles per hour and no precipitation. The incident location was next to a building that was nearing completion. One section of tubular welded scaffolding was set up against the building and was enclosed by two blue tarps. The scaffold was being used as a supporting structure for the tarps that were set up to protect the work area and the workers from the environmental elements ([Figure 1](#)). There was no designated entrance or exit location to the tarp-enclosed area. Entering or exiting this area required the lifting of the bottom of the tarp and crouching down to get underneath the tarp.

Figure 1 – Similar location of the incident.
The tarp attached to the building without the scaffolding support.

Recommendation #1: Employers should ensure that tarp-enclosed areas have designated entrance/exit openings for workers.

Discussion: In this case, the victim and other co-workers would enter and exit the tarp-enclosed area multiple times during the day. This entailed the workers crouching down to lift up the bottom of the tarp and then crawling out. Inexpensive entrance/exit openings that still provide protection from the environment can easily be installed in tarps. One type of opening is the chamber type design. This typically consists of a vertical slit in the tarp with three foot wide strips of tarp material attached to the top of either side of the tarp covering the slit. Another option that could be used is a heavy duty tarp zipper. These zippers are self adhesive and can be installed vertically.

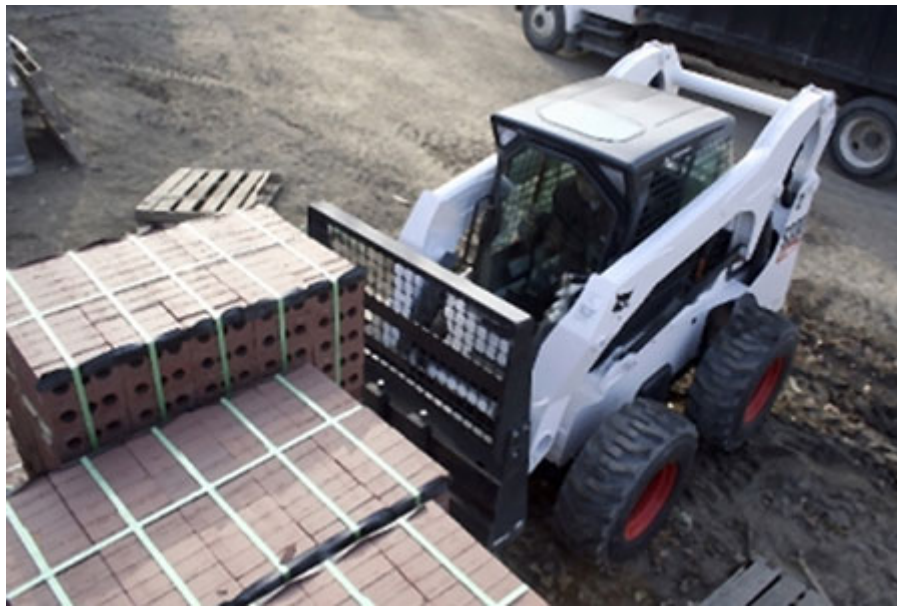
Prior to the incident, the victim was inside the tarp-enclosed area and a co-worker was operating the company's skid-steer loader in the forward direction. The co-worker was driving the skid-steer loader parallel to the tarp-enclosed area to load a pallet of bricks onto the skid-steer loader's forks. The pallet of bricks was located approximately 50 feet north of where the incident occurred. The skid-steer loader's forks were in a lowered position and did not have a load on them at the time of the incident.

At the time of the incident, the victim was exiting the tarp-enclosed area with the wheelbarrow to fill the wheelbarrow with mortar. The mortar mixing machine was located approximately 20 feet to the west of the tarp-enclosed area. The victim was crouched down close to the ground lifting up the bottom of the tarp while backing out from underneath the tarp-enclosed area and pulling the wheelbarrow with him at the same time. The victim, in the crouched position, was struck and run over by the skid-steer loader as it passed parallel to the tarp-enclosed area.

Figure 2 – Skid-steer loader similar to the one involved in the incident.
