Seventeen-Year-Old Laborer at Salvage Lumber Operation Crushed by Forklift That Tipped Over – New York

NIOSH In-house FACE Report 2000-22

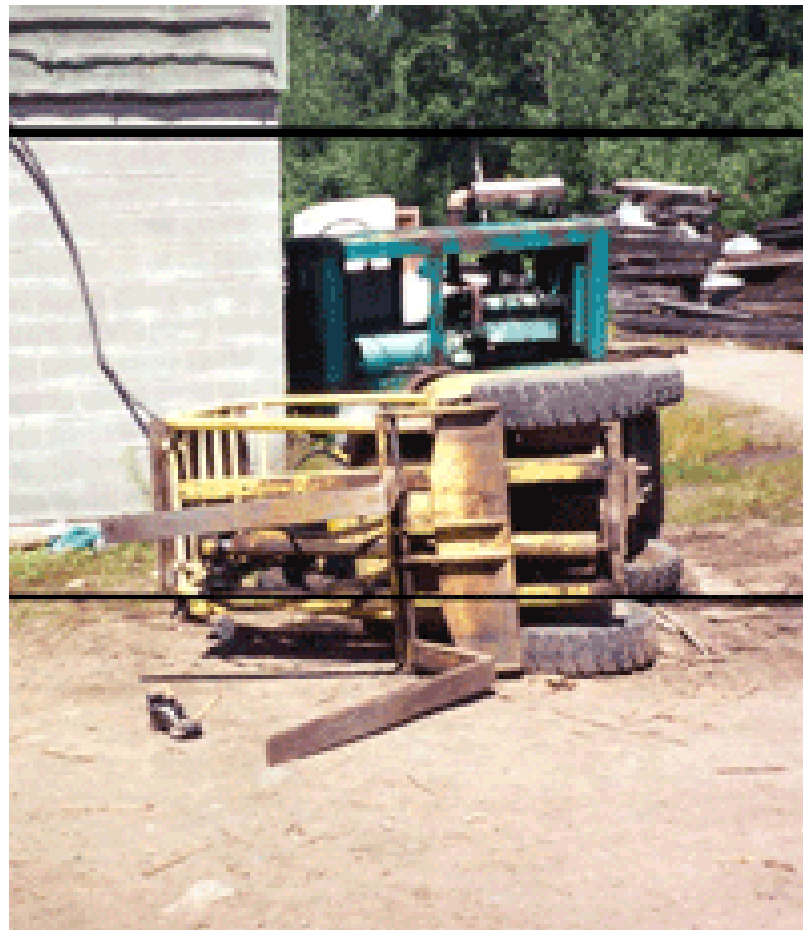
Photo 1. Overturned Forklift.

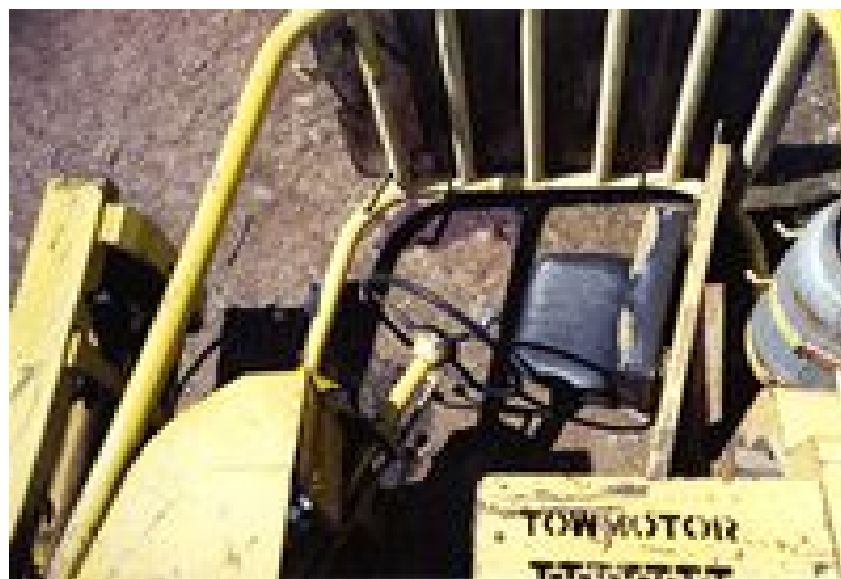
Discussion: The forklift involved in this incident, a 1964 Tow motor, was not equipped with an operator restraint system. The operator's seat was mounted on a heavy-gauge sheet-steel cover intended to be secured with bolts to the forklift's frame. However, the bolts for the steel cover were missing ([Photo 2](#)). According to the employer, this was the machine's condition when purchased at auction and he had assumed that it was acceptable for use. The machine was equipped with an overhead guard to protect an operator from being struck by falling material. During an overturn, the overhead guard is generally the part of the forklift that crushes the operator's head or torso after he or she falls or jumps outside of the operator's compartment. The risk of being crushed by the overhead guard or another rigid part of the forklift is greatly reduced if the operator remains restrained inside the operator's compartment. Since 1992, the American National Standards Institute has specified that forklift manufacturers equip new forklifts with operator restraint systems.³ Many forklift manufacturers offer restraint systems that can be retrofitted to older sit-down type machines. In the early 1970s the manufacturer of the forklift, Tow motor, ceased operations and was sold to Caterpillar Incorporated. During the investigation, it was learned that retrofit operator restraint systems are available for the forklift involved in the incident. Owners of Tow motor forklifts should contact their local Caterpillar Incorporated equipment distributor for assistance in obtaining retrofit operator restraint kits. Because many older forklifts are not equipped with a restraint system and operator compliance is less than 100% on forklifts equipped with a restraint system, operators of sit-down type forklifts should be instructed not to jump from the operator's compartment but to hold on, brace themselves, and lean in the opposite direction of the overturn. If the victim had been able to remain within the boundaries of the overhead guard, the severity of his injuries may have been reduced.

Photo 2. Overturned Forklift – Unsecured Operator's Seat

Recommendation #2: Employers should ensure that sit-down type forklifts are equipped with adequate operator restraint systems to protect the workers in the event of a tip over.
