# A Heavy Equipment Operator Died When the Dump Truck He Was Backing Slid Down an Embankment and Then Tumbled Over

California FACE Report #02CA001

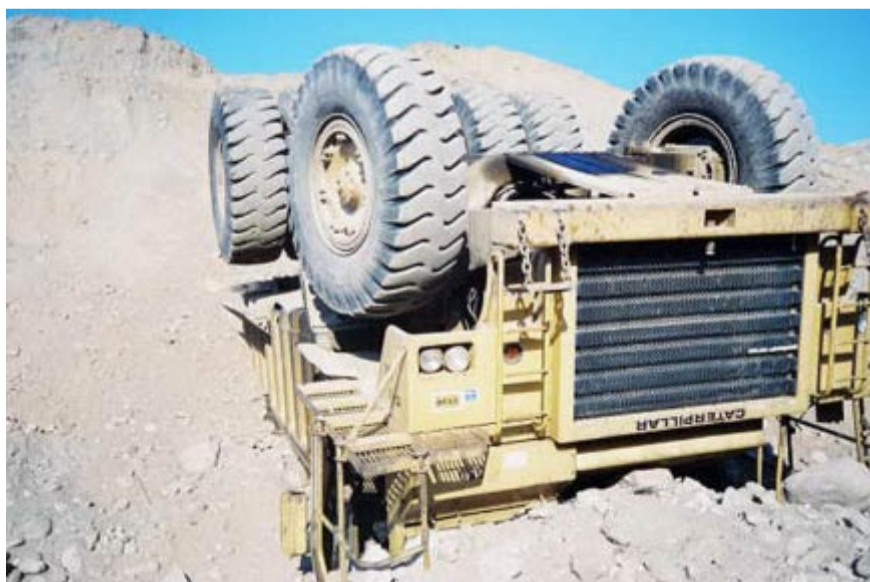
Exhibit #2

The ground beneath the rear tires gave way and the dump truck started to slide down the embankment. It continued down the embankment slowly for about 50 feet, then the rear of the bed of the truck wedged into the dirt causing the front of the truck to go vertical and then it rapidly turned over rear to front with the victim belted in the cab. The dump truck finally came to rest in an upside down position with the cab intact. Witnesses to the incident ran to the dump truck and removed the victim by cutting him out of the lap seat belt. The paramedics arrived and treated the victim. He was then airlifted to a hospital where he was pronounced dead.

View of the truck as it came to rest after tumbling over the embankment.

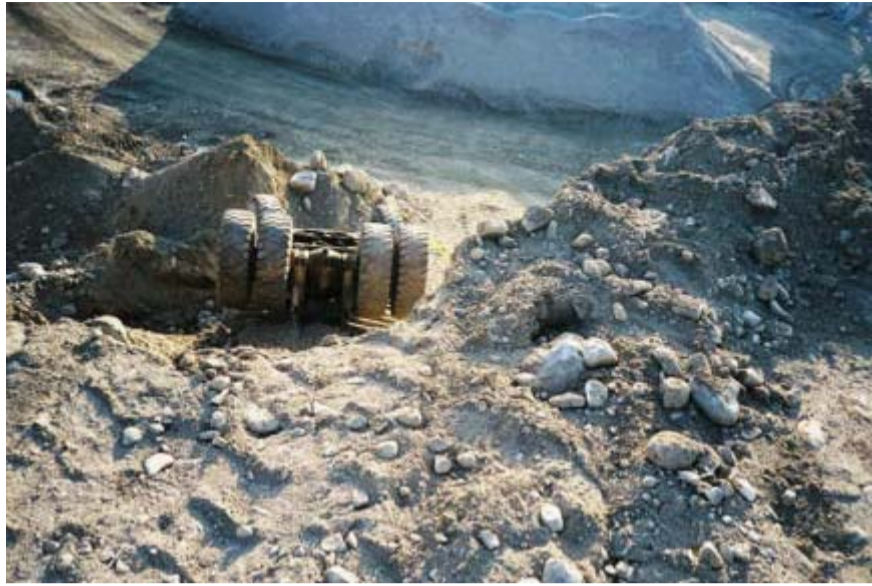
**Exhibit #3**

**View of the truck looking down from the top of the embankment.**

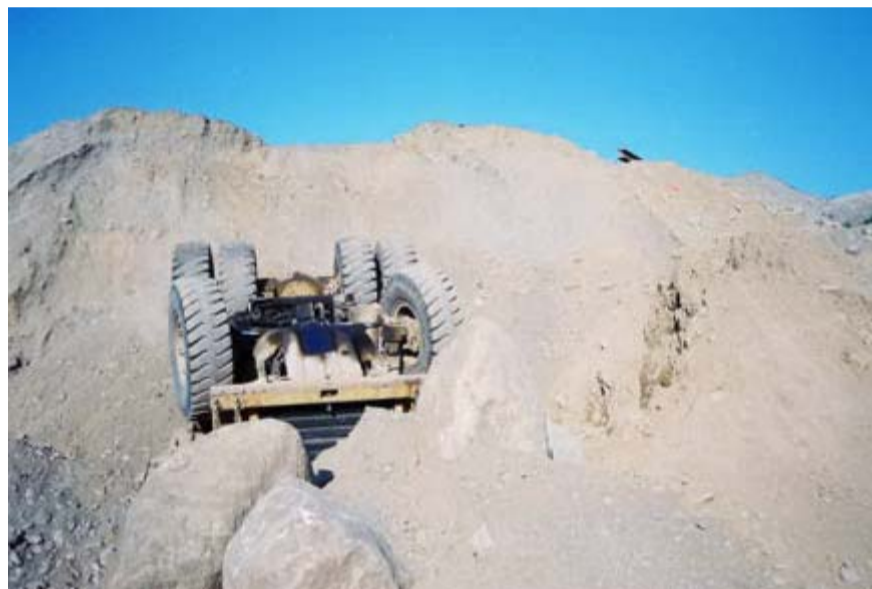
**Exhibit #4**

**View of the truck looking up from the bottom of the embankment.**

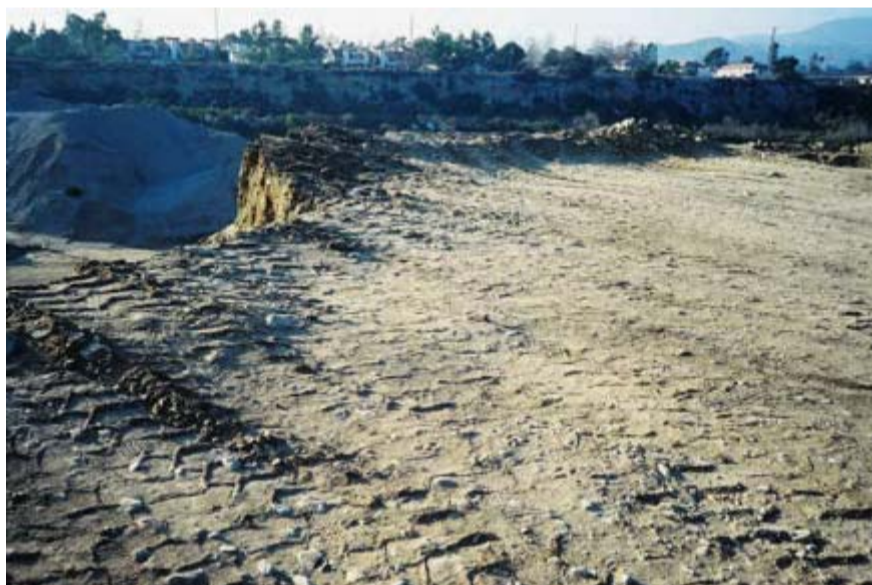
**Exhibit #5**

The site of the incident was a gravel pit that crushed rock and dirt. The rock and dirt were excavated in a separate area of the pit, then transported by truck to a designated area called the "dump pad" which was located on top of an embankment approximately 70 feet high (see Exhibits #5 & 6). Trucks would back up to the dump pad and dump their load as close to the edge of the embankment as possible. A bulldozer would then push the rock and dirt over the embankment and reestablish the berm. A berm is a mound of gravel and dirt at the edge of an embankment that is piled high enough to prevent trucks from over-traveling and over-turning. The truck involved in this incident was a 58 ton rock dump truck that was constructed for this purpose only and not subject to vehicle registration. The victim was not required to have a special license or certification to operate the truck.

Discussion: Berms, when properly installed, should prevent trucks from over-traveling and over-turning at dumping locations. In this particular case, the berm was inadequate in height and width to stop the truck. Had the berm been properly installed at this job site, this incident might have been prevented.

**View of the area looking north where the truck went over the embankment.**

**Recommendation #1: Ensure berms are adequately built to prevent trucks from over-traveling and over-turning at dumping locations.**

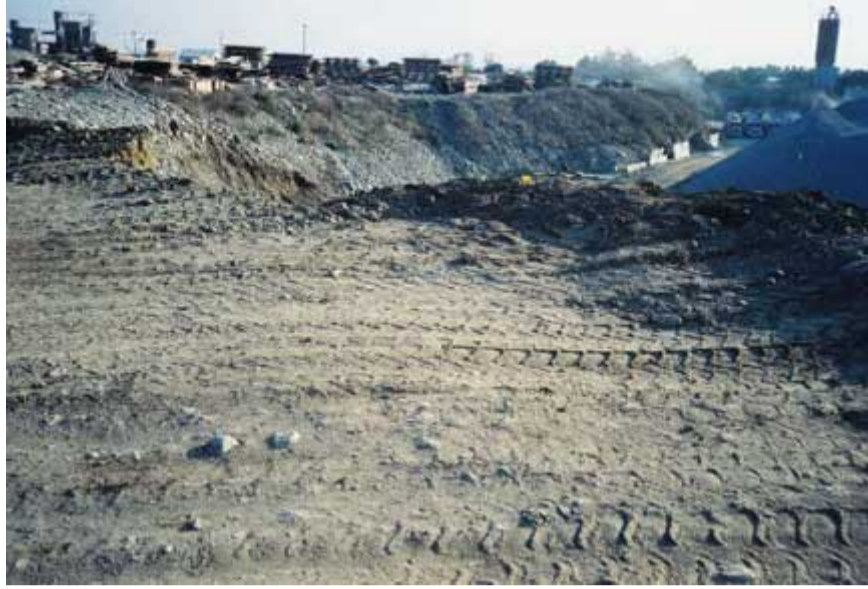
**Exhibit #6**

**View of the area looking south where the truck went over the embankment.**
