Hispanic Asbestos Remover Falls to Death from Ladder

Nebraska Case Report: 06NE002

Report Release Date: May 3, 2006

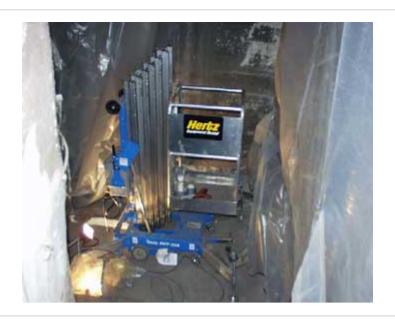
Attachment 2. Genie 30' Single Person Electric Platform Lift being used on site.

The site supervisor (worker #2) was attaching 6 mill plastic sheeting to 1"x 2"x 6' long wooden boards also on the lower level. Once attached, he climbed into the Genie 30 foot single-person electric platform lift. While holding onto the plastic sheeting, he raised the lift to the ceiling, approximately 29 foot overhead. While holding the board against the ceiling with one hand worker #2 used a Remington powder-actuated ram set gun with the other hand to shoot a nail through the board into the concrete ceiling. Realizing the sheeting was too heavy to hold with one hand, he lowered the lift far enough to have worker #3 hand him a piece of metal pipe that was lying nearby. The pipe was 5' 8" long, 3" in diameter and weighed between 12-15 pounds. He raised the lift back towards the ceiling, and then braced the pipe between the lift platform floor and the overhead board.

Discussion: Although not a regulatory requirement, every effort should be made to secure materials and/or equipment being utilized above other employees. The use of a simple lanyard equipped with snap hooks on both ends to attach to a tool and to the lift railing could prevent them from striking an employee below if dropped. If some form of "brace" is to be used again to support the overhead boards and sheeting, employers should consider drilling a hole through the pipe end and securing it to the basket, or using a tool that has less likelihood of rolling if loose. The toe board around the floor pan of the electric lift prevents materials that are placed there from falling off when not being used.

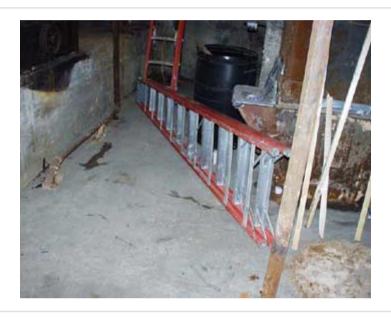
Attachment 3. 10' Step Ladder victim was standing on.

approximately 3 feet sideways, striking either the victim or the ladder he was standing on.

The victim fell 8 feet from the ladder to the concrete floor below. Worker #3 had his back to the victim. He stated he heard a noise, possibly from the pipe hitting the slanted roof. When he turned around he saw the victim lying on the concrete floor next to the ladder. He yelled at worker #2 in the lift, telling him the pipe had hit the victim and he was hurt. Worker #2 immediately lowered the lift and tried to render assistance to the victim. Worker #4 was not in direct line-of-sight of the accident and did not witness the fall.

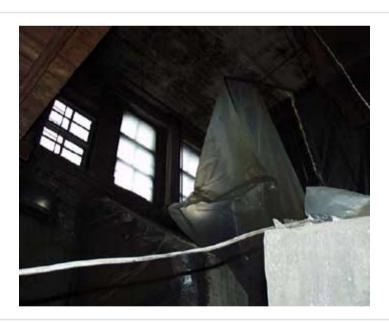
Attachment 4. Plastic sheeting that fell during accident.

As he did so, the pipe and board pulled away from the ceiling, causing them both to fall towards the ground. The board and sheeting remained attached to the ceiling by another board that was previously attached to the ceiling. The metal pipe fell out of the lift, falling approximately 14 feet, striking a 45 degree slanted roof that was directly underneath. The pipe then flew

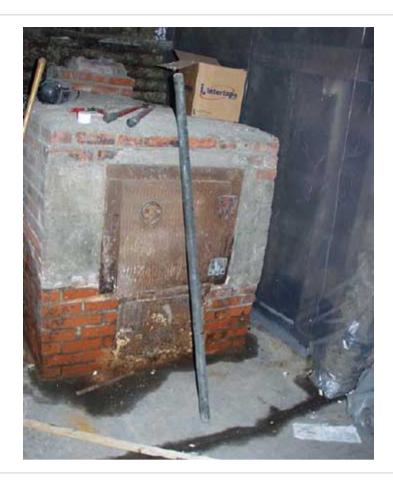
Attachment 5. Metal pipe being used to brace boards/sheeting.

While holding the pipe with his left hand, he used the ram set gun to shoot the second nail into the board. Although the nail remained sticking out of the board by ¼ inch, he thought the board was secure and removed his left hand from the pipe.

Recommendation #2: Ensure that tools being used above other workers are secured to prevent them from falling and striking other workers.
