Hotel Assistant Manager Dies Due to a Fall from a Ladder During Installation of Wood Trim

Michigan Case Report: 07MI136

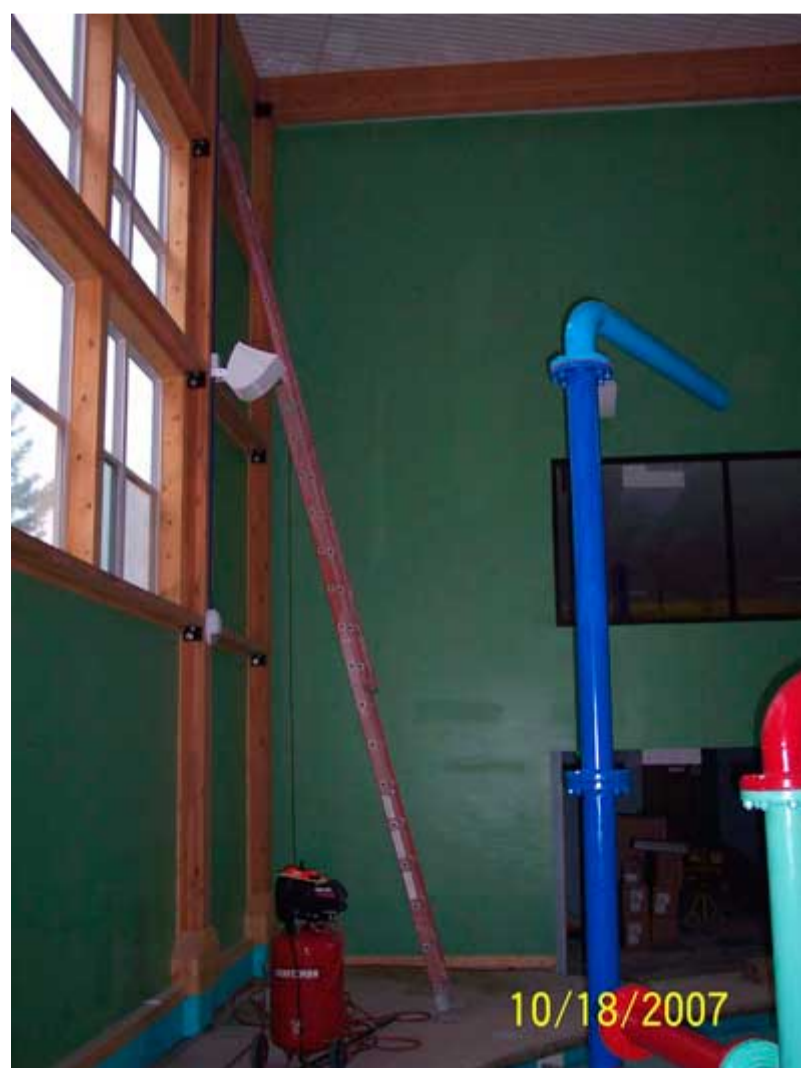
Figure 1. Police photo of incident scene one day after incident

The responding police department performed a re-enactment of the work the decedent was performing to show the nail gun's air hose and hose slack, location of ladder, and height of the decedent's fall (Figures 1 and 4).

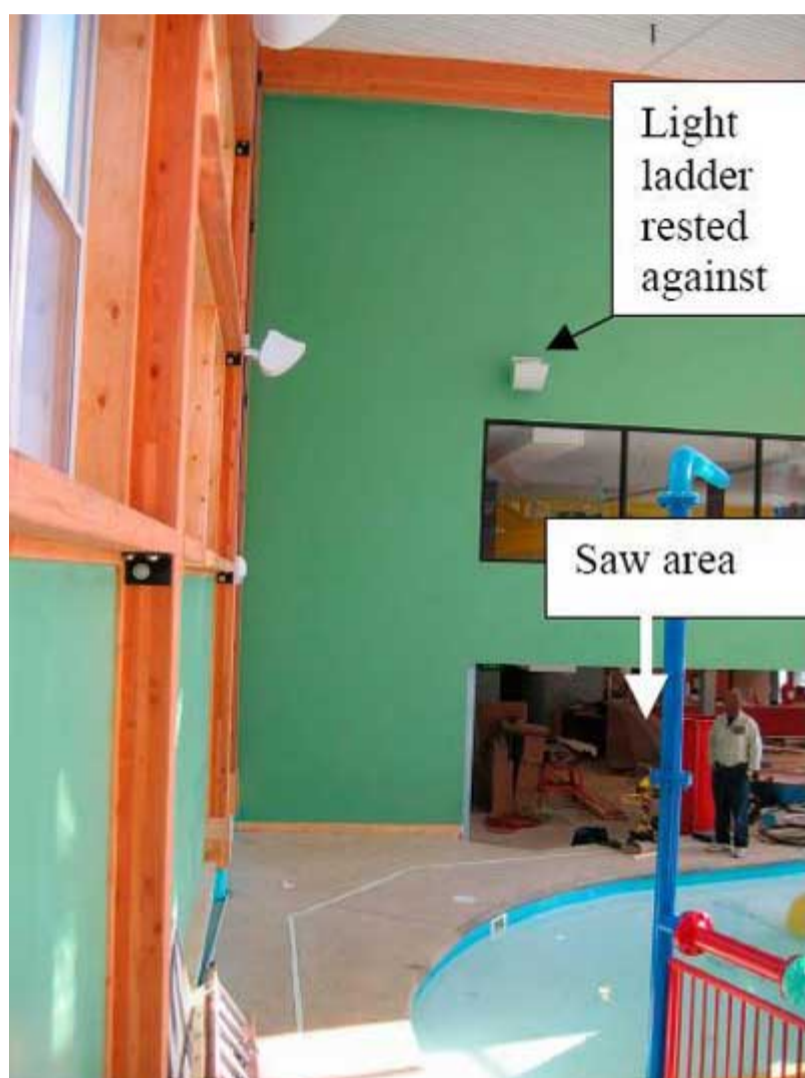
Figure 2. Work area of decedent

Co-owner #1 was called away from the saw area by Co-owner #2. While Co-owner #1 and Co-owner #2 were in another area of the jobsite, it appears the decedent placed the fiberglass ladder, extended to 24 feet 3 inches, against the west wall near the junction of the west wall and the north wall. He took two pieces of stained trim to the renovation area and left the remainder of the stained trim in the saw area (Figure 2).

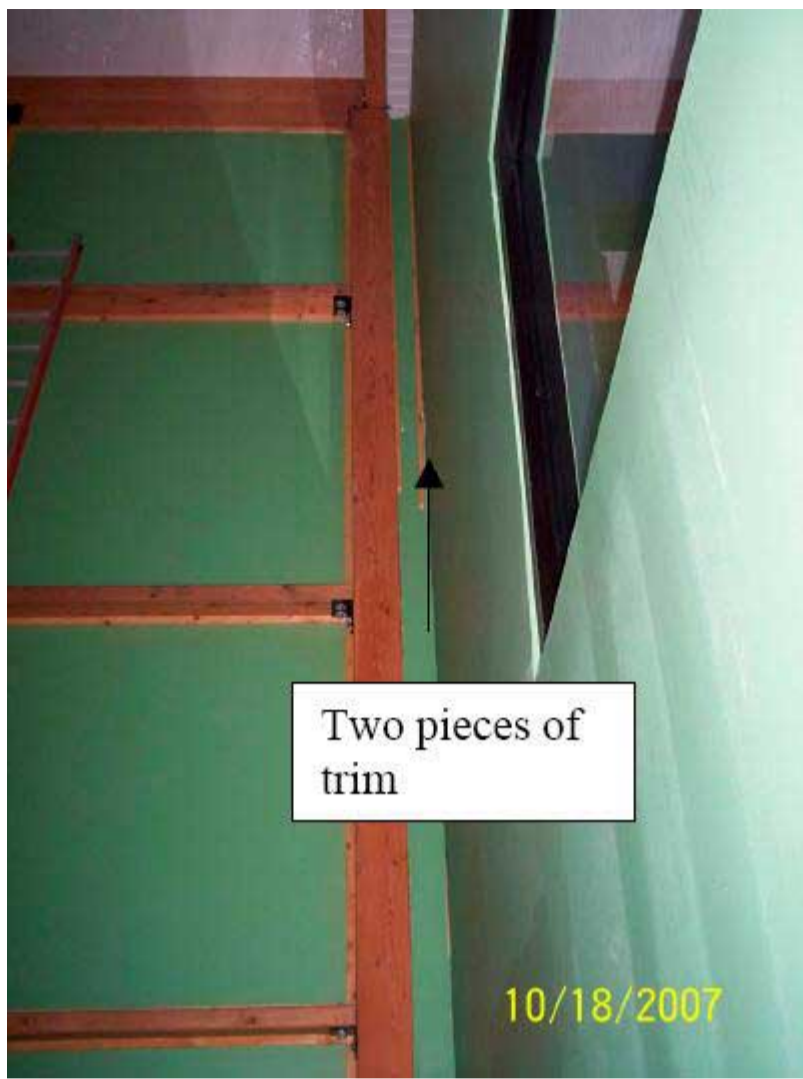
Figure 3. Placement of trim on west wall.

The sequence of events leading to the fall was unwitnessed. The decedent placed the base of the ladder approximately five to six feet away from the west wall. He ascended the ladder carrying the nail gun and trim to the wall/ceiling junction. Using the nail gun, he nailed two pieces of trim (Figure 3). The last nail on the trim was located 23 feet, 1 inch from the floor. Based upon the last nail position, it was estimated that the decedent fell approximately 20 feet to the concrete floor.

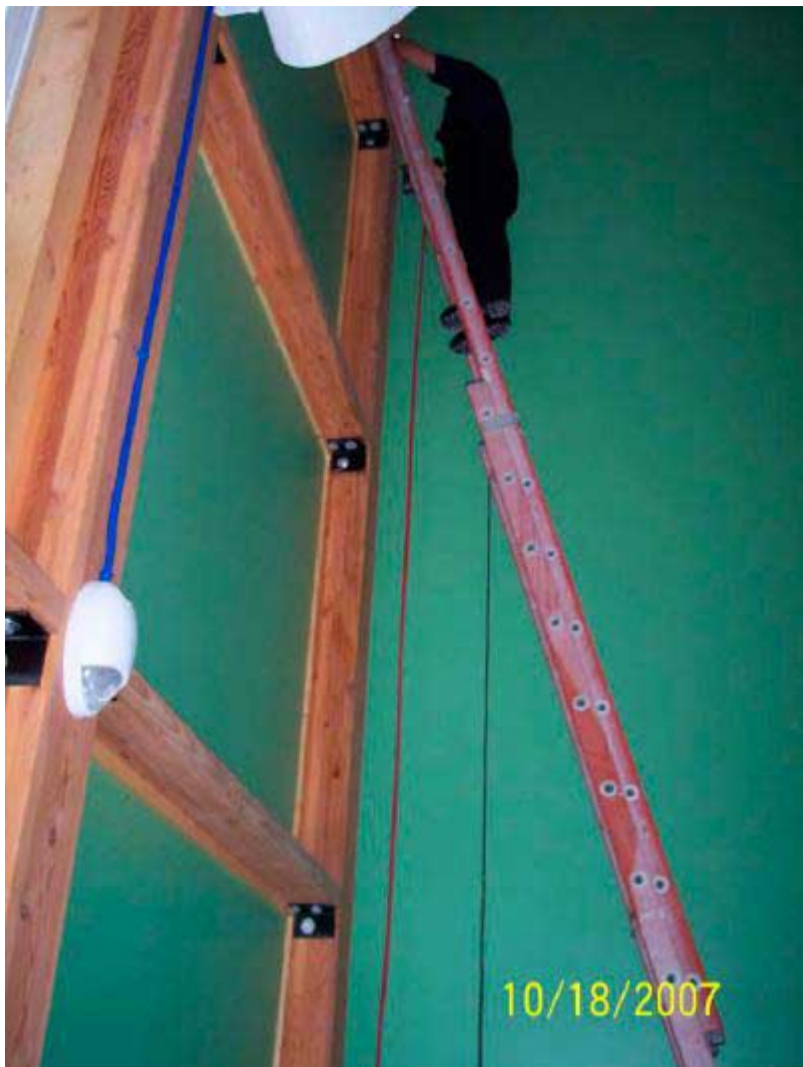
Figure 4. Police photo of postulated position of decedent on the ladder at the time of the fall
