Hispanic Carpenter Killed When Struck by Piece of Concrete That Fell From Rigging Device During Hoist in Highway Work Zone

Nebraska Case Report: 05NE028

Report Release Date: May 19, 2006

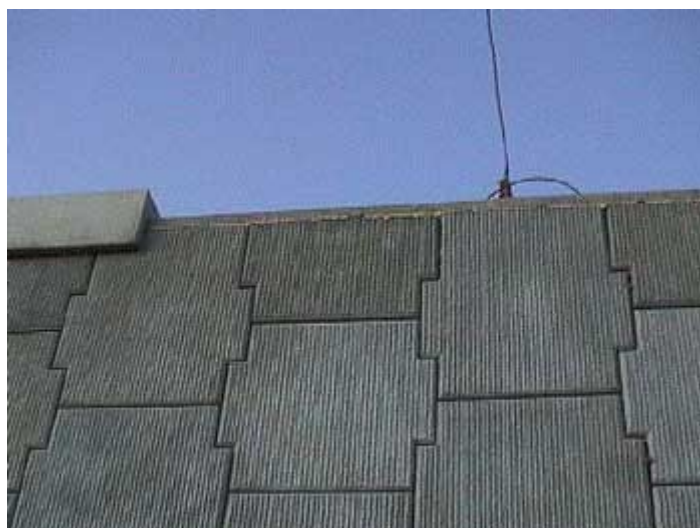
Attachment 2. Top of the concrete interlocking retaining wall where the piece of "cap" that fell was to be placed.

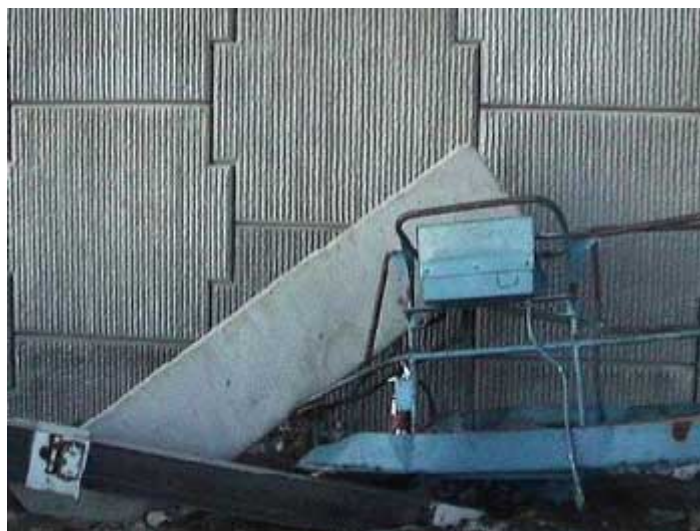
Attachment 3. Man lift personnel basket with concrete "cap" across railing.

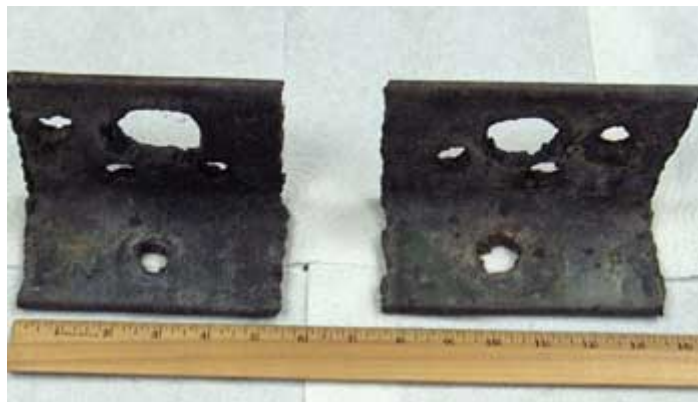
Work had to be delayed several days due to a severe snowstorm in the area. After the crew returned to the work site they could not locate the eye bolts. After discussion, the Job Superintendent (worker #7) decided they could take two pieces of 3"x3" angle iron approximately 6" long and use a cutting torch to make a hole in each side (one for the bolt, one for the sling), attach them to the "cap" with square-headed straight-bolts of the same diameter as the eye bolts and continue to lift "cap" into place. This procedure, using square-headed straight-bolts instead of the regular eye-bolts had never been used before. After fabricating the angle iron pieces, the new straight bolts were installed and used to move four pieces of "cap" without incident.

Attachment 4. Job-site manufactured lifting devices that were on top of concrete "cap" piece.

Recommendation #1: Ensure rigging and other equipment being used is suitable for the intended load.

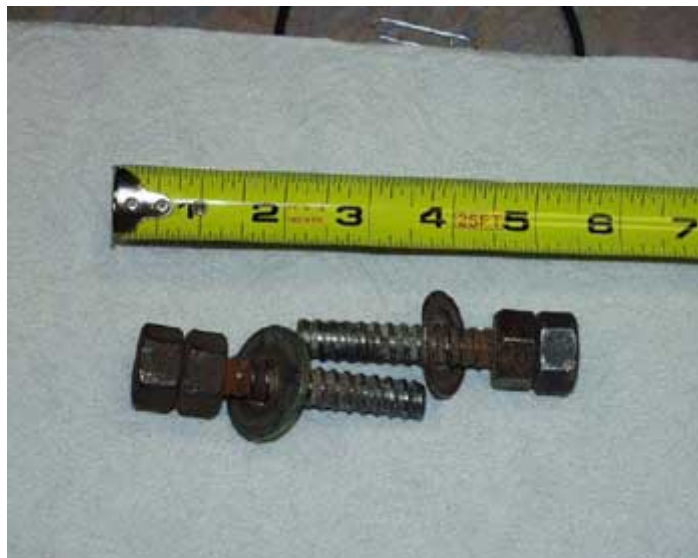
Discussion: The “tried & approved” method for lifting the “cap” could not be used due to the loss of the eye bolts. A decision was made by the Job Superintendent to use fabricated pieces of angle iron and substitute bolts to secure the “cap” to the crane’s sling. For unknown reasons, one of the straight bolts pulled out of the threaded insert. This allowed the pre-cast “cap” to swing away to the opposite side, placing all of the weight on the remaining bolt, causing it to also fail and pull out of the threaded insert. This allowed the “cap” to fall, striking the victim, leading to his death.

Attachment 5. Bolts that were screwed into threaded inserts on concrete "cap" that fell.

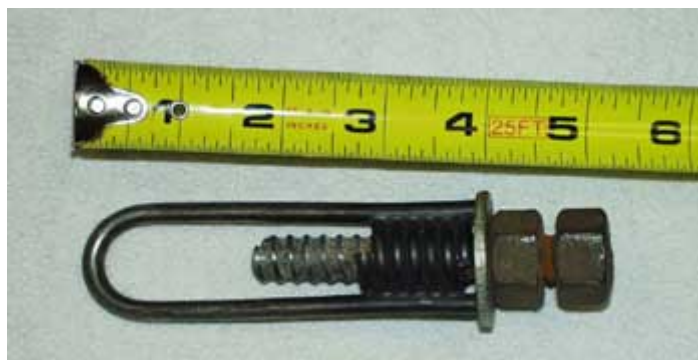
Attachment 6. New threaded insert with bolt involved in accident.

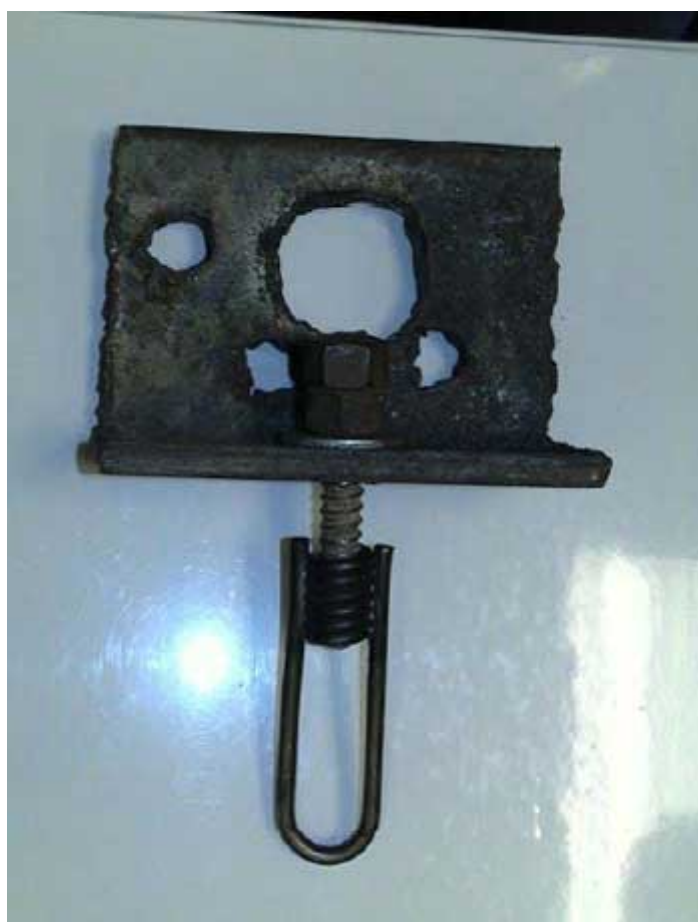
Attachment 7. New threaded insert with bolt attached to lifting device. Bolt & angle iron piece are from accident.
