Flagger Fatally Injured When Struck by a Car at a Highway Work Zone in Washington State

Washington Case Report 00WA011

Release Date: January 31, 2006

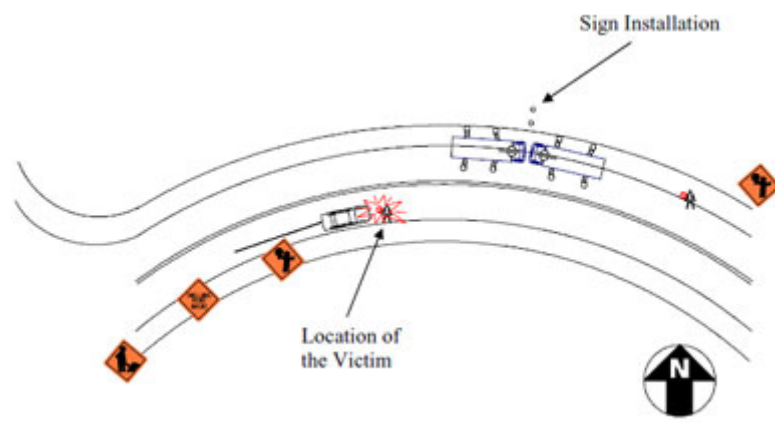
The flagging team established their flagging stations approximately 100 feet in advance of the work zone on both the eastbound and westbound lanes. As soon as the flagging team was in position, they informed the sign installation crew that they could move their trucks and equipment into position and begin setting up the work zone (figure 1 shows a schematic diagram of the work zone).

Figure 1. A schematic drawing of the incident scene (not to scale).

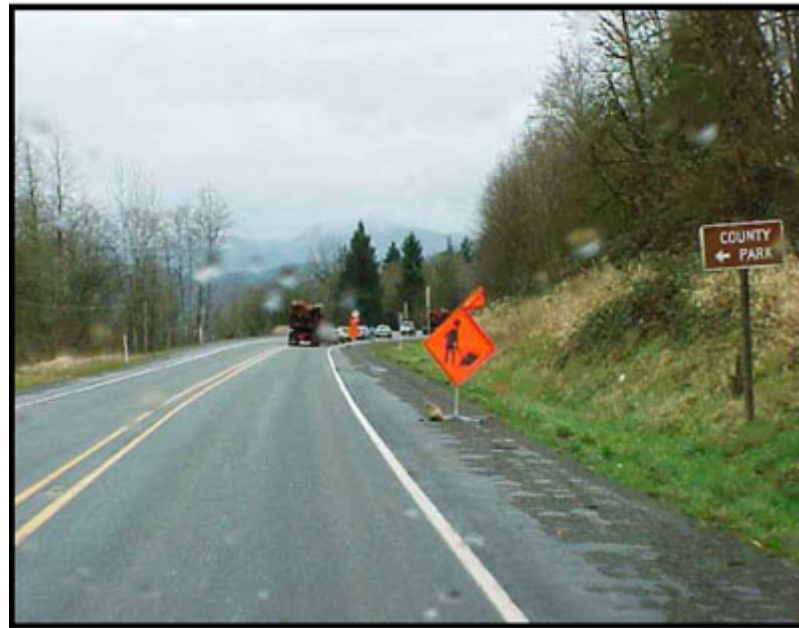
Photo 1. Shows work zone signs traveling eastbound heading toward the incident site which is just beyond the curve on the highway.

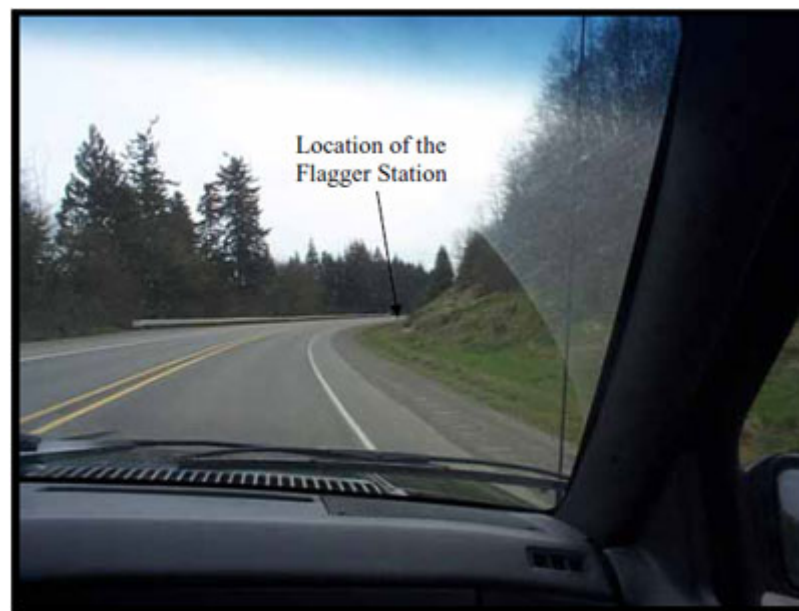
Photo 2. Shows the FACE Investigation vehicle traveling eastbound toward the flagger station and work zone during post incident FACE investigation.

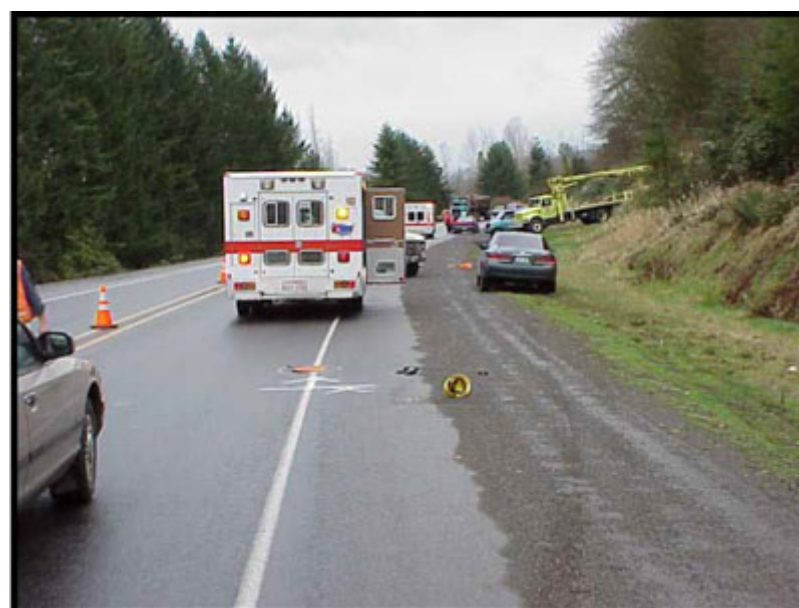
The highway had a paved shoulder that then gave way to a section of sloped packed soil and weeds. Witness statements and police reports indicate that the victim was perhaps standing in the eastbound traffic lane side of the highway fog line and was not facing oncoming (eastbound) traffic at the time of the incident.

Photo 3. Shows the incident site looking east on the eastbound traffic lane and the shoulder of the highway.

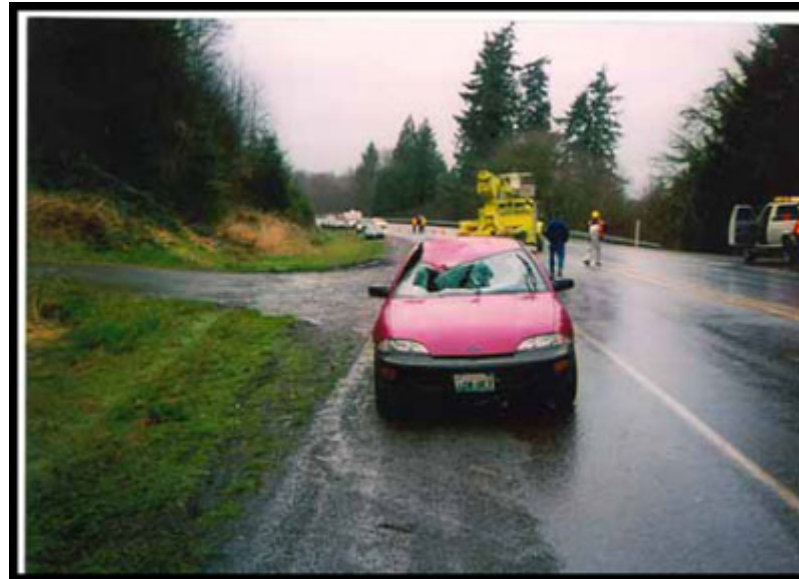
At that moment, an eastbound vehicle, a 1996 Chevrolet Cavalier was approaching the flagger station. It appears the victim did not see the approaching vehicle. The vehicle was traveling at an estimated 50–55 mph when it entered the work zone and it was observed that the vehicle showed no sign that it was slowing down. The lead flagger witnessed the vehicle strike the victim. He indicated that he did not hear the car breaking nor did he hear any skidding sounds from the vehicle before impact. He observed the victim hit the windshield and then go flying into the air for about 15 to 20 feet. He landed on his side and slid another 10 to 15 feet along the asphalt pavement before coming to a stop.

Photo 4. Shows the vehicle involved in the incident looking west along the shoulder of the eastbound lane.

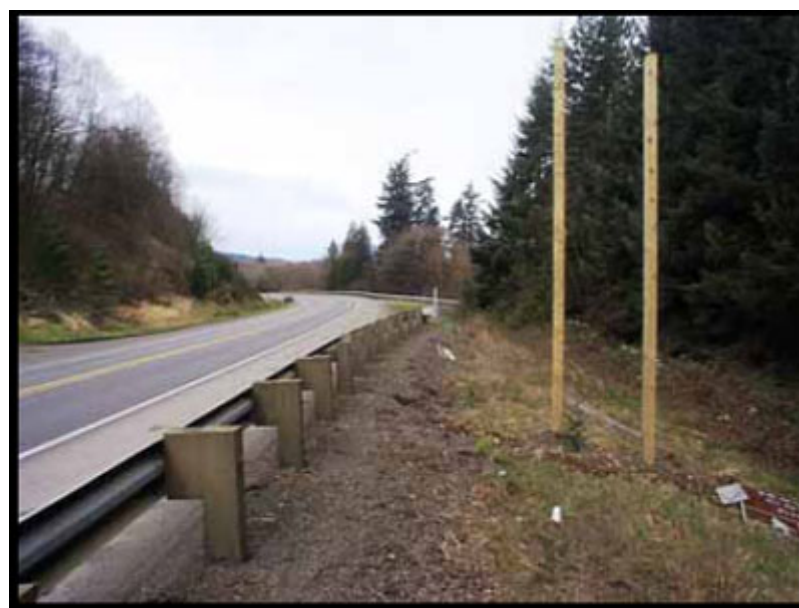
Photo 5. BEFORE – Shows the work zone site during 1st post-incident FACE investigation site visit, prior to fill, rock and gravel being brought in to augment the sign installation. Looking west along the eastbound lane of highway.

After this incident occurred, the organization decided to stop any further work on the county park sign installation until they had a chance to review all of the incident investigation facts and recommendations. After studying the incident and all the investigation reports and carefully assessing the work area, the company made the decision to bring in fill, rock and gravel so that they could safely park their work vehicles completely off the highway and behind the guardrails at that location (photos 5 and 6 show the site before and after filling the slope).

The organization, in essence, decided to follow some of the primary principles of the hierarchy of safety which were to eliminate/substitute and /or engineer out the hazard. They engineered out the hazard by redesigning the work zone and thus eliminating or reducing the hazard of the motoring public for the workers in the work zone. Rock and gravel fill was brought in to build up the berm along the inside of the guardrail so that work could be completed and any future maintenance would allow vehicles and workers to be protected by the guardrail and there would be no need to restrict traffic or establish any traffic control for the area. It was possible to complete the berm work off the roadway and behind the guardrail.

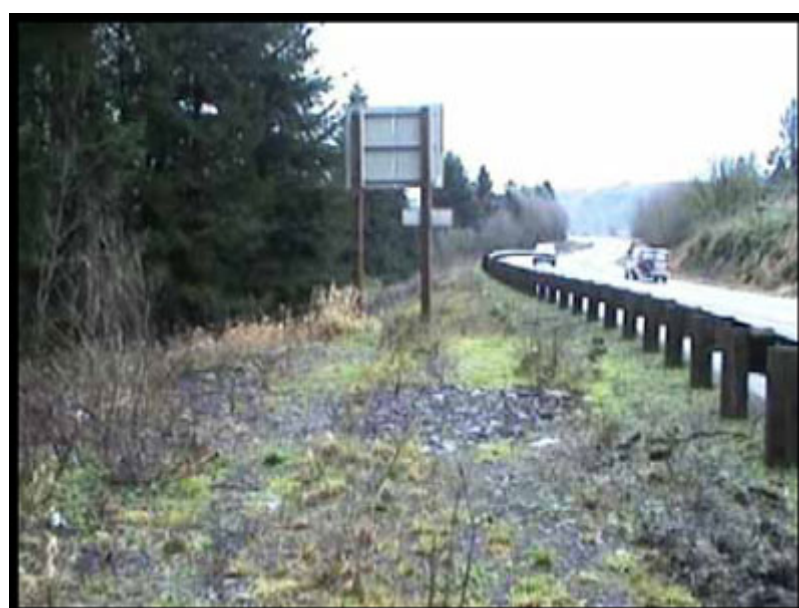
Photo 6. AFTER – Shows the work zone site during 2nd post-incident FACE investigation site visit, and after fill, rock & gravel had been brought in so sign installation could be completed off the roadway without impacting highway traffic. This view is looking east along the westbound lane of highway.
