# Heavy Equipment Operator Killed During Rollover of Front-end Loader

Alaska FACE 99AK027

Release Date: July 13, 2000

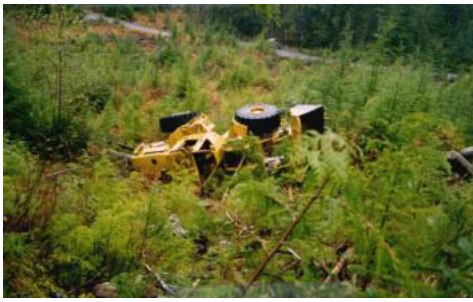
At approximately 10:45 A.M. on the day of the incident, a log truck driver saw the victim as he drove the loader from a staging area toward the main camp. At that time, the two vehicles were about ½ mile from the incident site. At approximately 12:00 noon, another log truck driver observed the loader lying on its side, halfway down a slope (Figure 2). He radioed the camp manager that the loader was off the road and had rolled down the slope. After completing his radio communication, the driver went down the slope to see if he could find the driver.

Figure 2. View of front-end loader from top of slope.

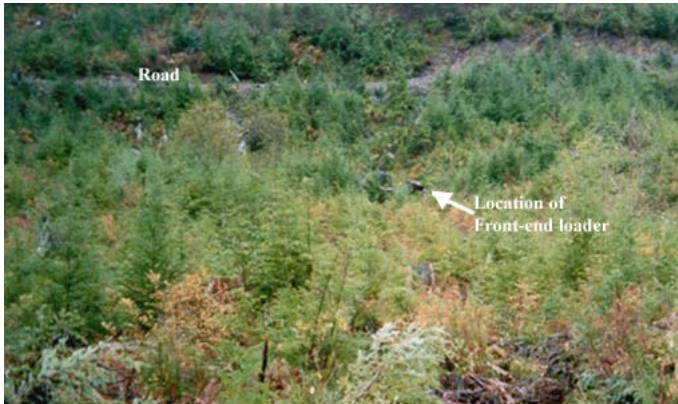
He found the victim between the road and the loader. He had been thrown from the operator's compartment and appeared crushed. A section of the operator compartment windshield and the driver's seat was 18 feet downslope of the victim (Figure 3). The loader came to rest 52 feet below the windshield and driver's seat (Figure 4). Alaska State Troopers were notified. The victim was pronounced dead at the scene.

Figure 3. View of slope and upper section of road.

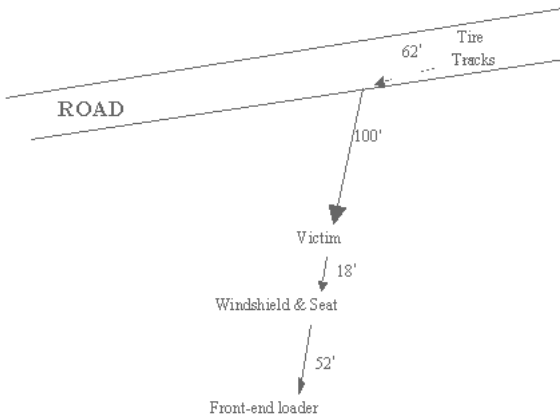
Figure 4. Diagram of incident site

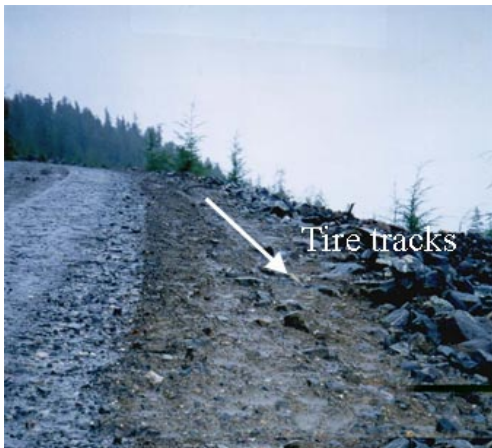
During the investigation, 62 feet of tire tracks, resembling those of the loader, were noted along the road. The tracks were along the edge of the road and ended at the point above the loader's location on the slope (Figure 5). Since the incident was not witnessed, it was surmised that the loader moved to the road edge before going off the road and rolling over.

Figure 5. View of tire track approaching road shoulder and departure point from road.

It could not be determined if the loader had stalled, causing a loss of steering or reduced maneuverability. Examination of the loader's brake system indicated that part of the front brake assembly was missing. The rear brake assembly was intact. Coworkers who responded to the scene reported seeing drag marks on the road. This could possibly indicate that braking (with only the rear brakes) was insufficient to slow and stop the loader; the operator may have lowered the loader's bucket to drag the ground to try to slow or stop the loader.
