Concrete Repairs, Ardrossan

Swart & Sons were contracted by Viterra in August 2018 to carry out structural concrete crack repairs to more than seventy concrete plinths at their Ardrossan property. Whilst undertaking repairs on site, we were requested to carry out additional repair works on concrete nib walls. All works were carried out in accordance with a specification provided by Viterra.

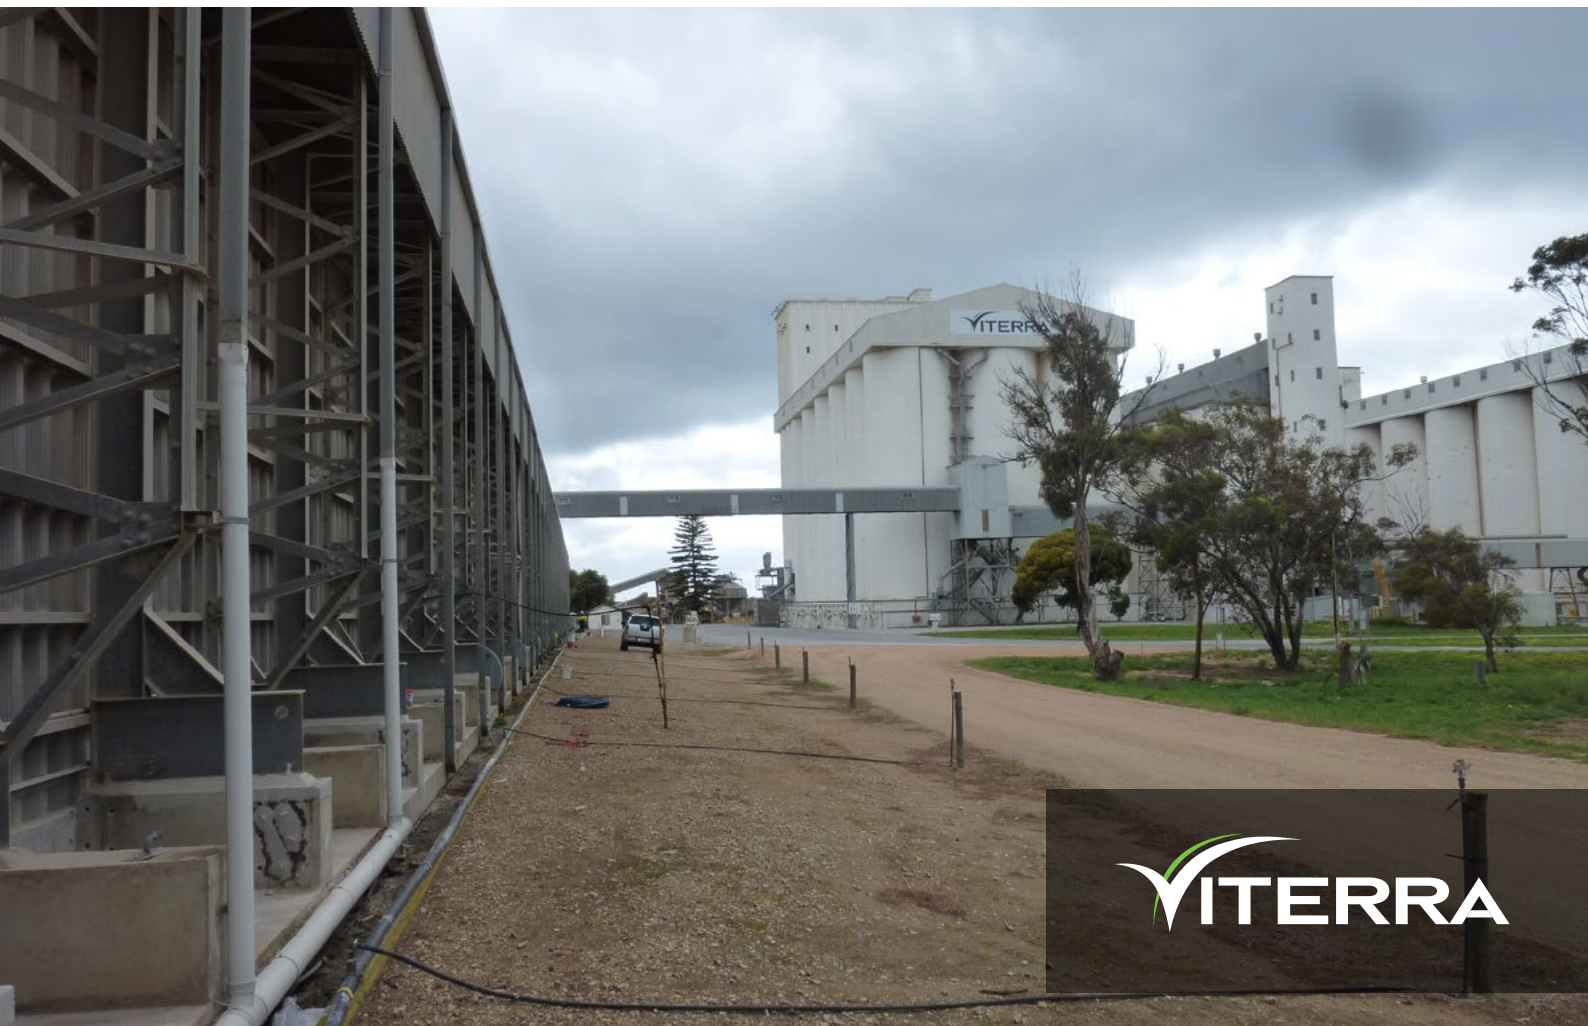
Viterra staff noticed major issues with the walling system including deformation of the walling system with associated rotation in steel girts. Cracking was also evident in concrete plinths.

Each plinth was individually assessed to determine the type of repair required. Once the level of deterioration was established, repairs were carried out to each plinth requiring remediation.

Cracking in the plinths and walls was rectified using the appropriate techniques and materials; from initial cutting around the cracks and grinding rust from steel, to placement of the appropriate primer and repair materials.
