## Adelaide Desalination Plant, Lonsdale

In July 2018 Swart & Sons were contracted by Adelaide Aqua Pty Ltd to carry out repair works on a concrete overflow tank. Works consisted of concrete repairs, abrasive blasting and application of protective coatings to the walls and floors of the tank. Due to the nature of the tank, work was considered to be 'high risk construction work', which incorporated working in confined spaces, risk of a person falling more than two metres plus working in an area with movement of powered mobile plant.

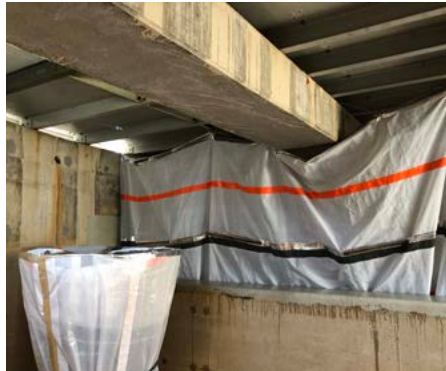
**Protecting areas before abrasive blasting to ensure debris does not escape the blasting area**

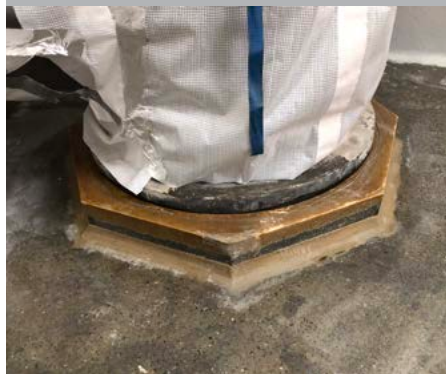
**Concrete repair at junction of water pipe and floor with epoxy binder/structural adhesive, subsequent to blasting and before application of protective coatings**

Concrete was remediated, where required, using a solvent free epoxy binder/structural adhesive.

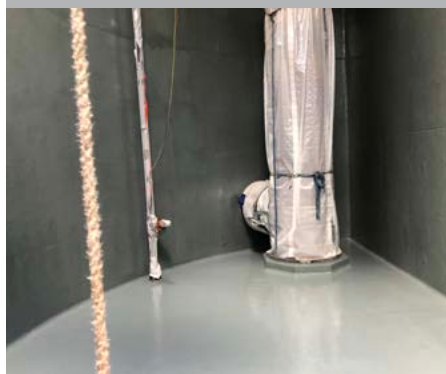
**Final coat of protective epoxy to floor and walls of overflow tank**

Subsequent to the concrete repair a specialist epoxy coating suitable for water handling structures and floors was applied to the internal walls and floor of the tank.
