BUILDING FIRE PROTECTION LAYERS:

HOW THEY FAILED IN THE 1973 SUMMERLAND FIRE

BY BENJAMIN KHOO and GUILLERMO REIN, PhD

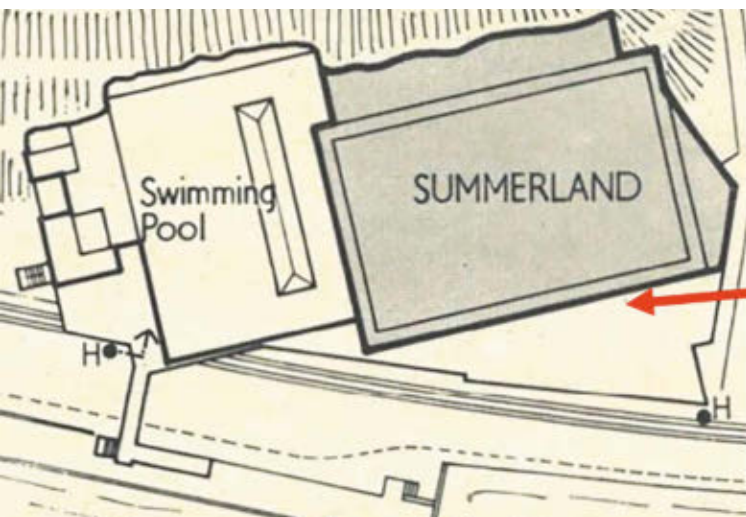
On August 2, 1973, at 7:40 PM, three Liverpool schoolboys were smoking near a dismantled kiosk. The boys discarded a lit match and caused a section of the kiosk to catch fire. The kiosk and its contents burned intensely within minutes, and flames began impinging onto the building's façade.^[10] Within about 20 minutes, an extensive fire was established on both the façade and within the building. At around 8:06 PM, the first fire appliances arrived to suppress the fire.^[11] Unfortunately, by this time, the fire was too well developed, and the fire brigade could only prevent further spread to other parts of the building. The fire was eventually extinguished around 9:00 PM.

Figure 2a. The red arrow represents the area where the fire was believed to have started. (Source: RIBA Journal)

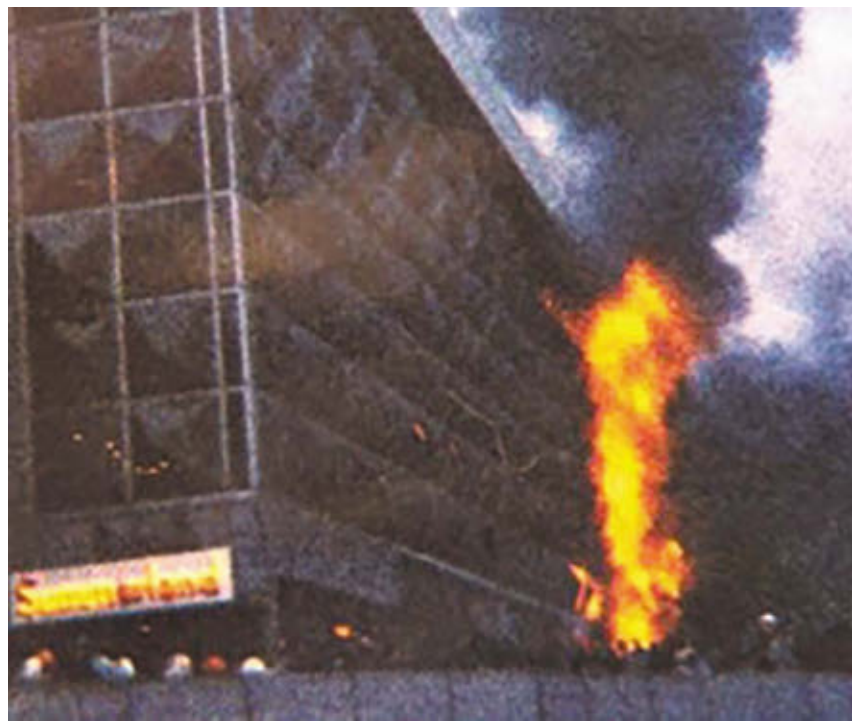
Figure 2b. The façade showed extensive fire within about 20 minutes.

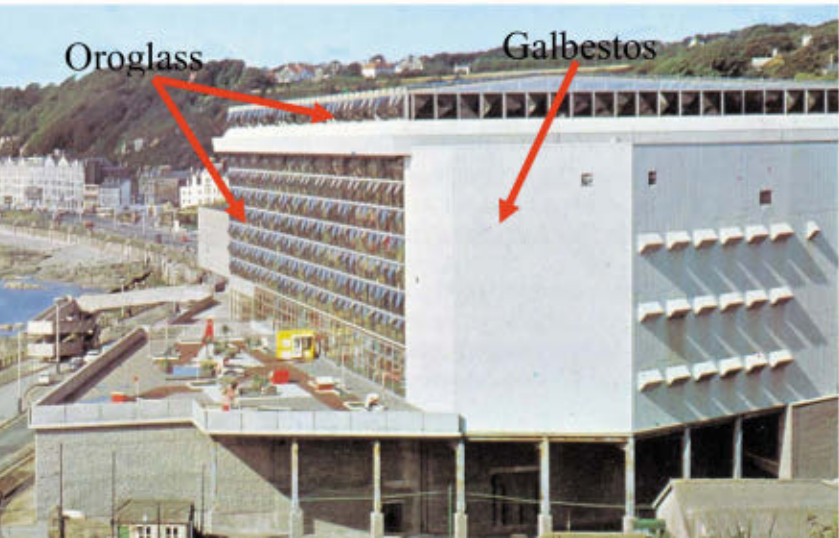
All three materials are extremely flammable and cover the building extensively, as shown in Figure 4.

Figure 4. Oroglas and Galbestos were used extensively across Summerland’s façade. (Source: Fortes Promotional Booklet)

The use of Oroglas, a relatively new material at that time, was granted after relaxation of the regulations. The relaxation was given on the basis that Oroglas was believed to be noncombustible although not fire resistant after passing the BS 467 Part 5 test (since withdrawn).

Galbestos was initially not included in the building plan and was introduced later as a substitute for reinforced concrete due to financial reasons.^[11] The designer was aware that Galbestos would not comply with the regulation as it is both combustible and not fire resistant. However, he believed that the material would still be adequate to prevent fast fire spread. The proposal to replace the reinforced concrete with Galbestos was then submitted without making clear that Galbestos required further relaxation of regulations. The authority thought the application was to reconfirm the waiver for Oroglas and approved the submission without seeking further advice. The approved submission made no mention that the waiver was only for Oroglas, leading to a misunderstanding that both materials were approved.

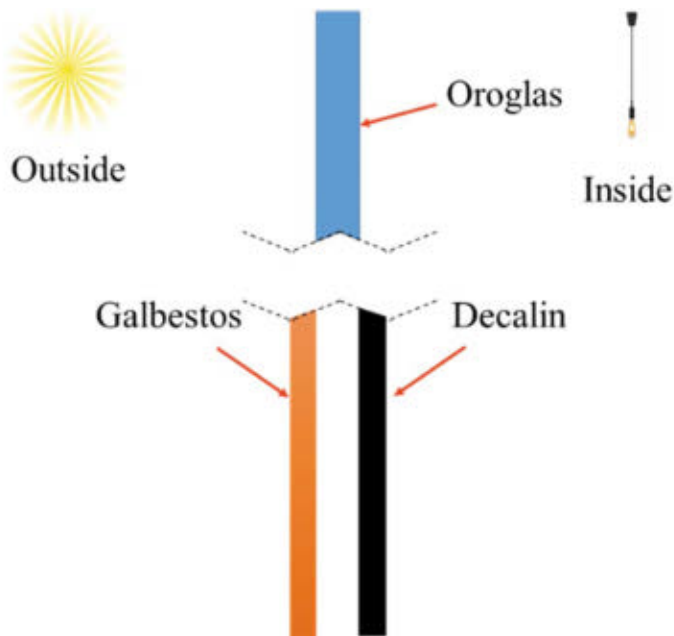
Figure 5a. Two Façade Types on the Summerland Building: Oroglas and Galbestos/Decalin (Decalin Not Always Present)^[13]

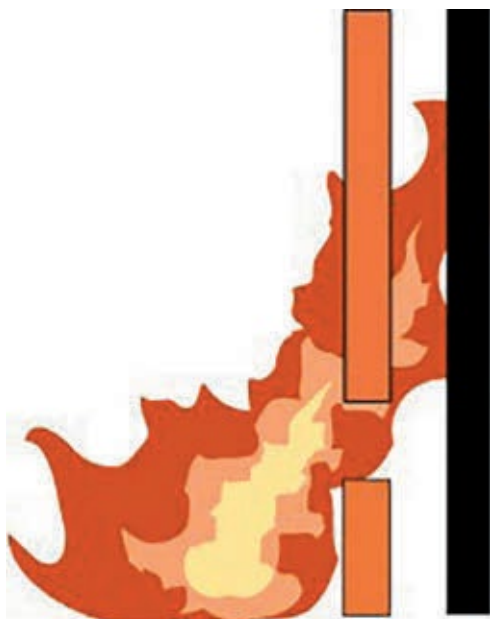
Lastly, the gap formed between the Galbestos and Decalin allowed the fire to develop with great intensity from within, as shown in Figure 5.^[11] This gap was technically not considered a cavity under Bye Law 47. However, from a fire engineering standpoint, it behaves similarly to a cavity and would still need to be

fire-stopped as a matter of good practice. The severity of the fire in the cavity was made worse with the use of Decalin. The decision to replace plasterboard with Decalin was made hastily after the designer was introduced to it.^[11] Under time pressure to find a sound-insulating board, the designer found Decalin fit the requirements and replaced the less-combustible plasterboard without further investigation of Decalin's fire properties.

Figure 5b. Note that the cavity formed between Galbestos and Decalin encouraged fire spread.^[13]

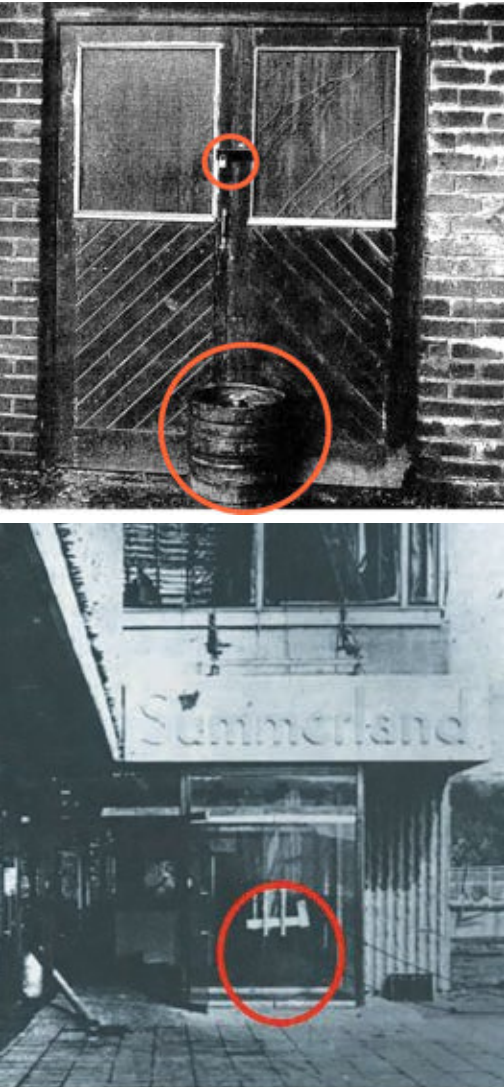
staff assuming that responsibility to organize fire drills fell on other staff, and no emergency procedures were in place. Consequently, during the emergency, staff were not aware of their responsibility to guide occupants out of the building nor unlock emergency exits, as shown in Figure 6. Some staff also committed a mistake by cutting off the electrical supply, believing it was the correct procedure to ensure public safety. This reduced visibility within the building due to the lights being turned off, which worsened the evacuation process.

Figure 6a and b. Photos taken after the fire show some exits are still locked and obstructed. (Source: Police Photographs, Isle of Man Public Record Office)

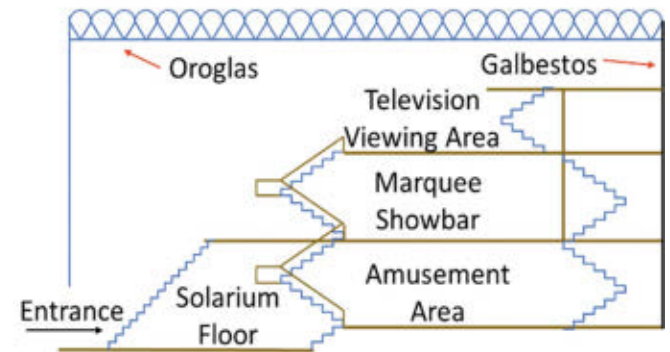
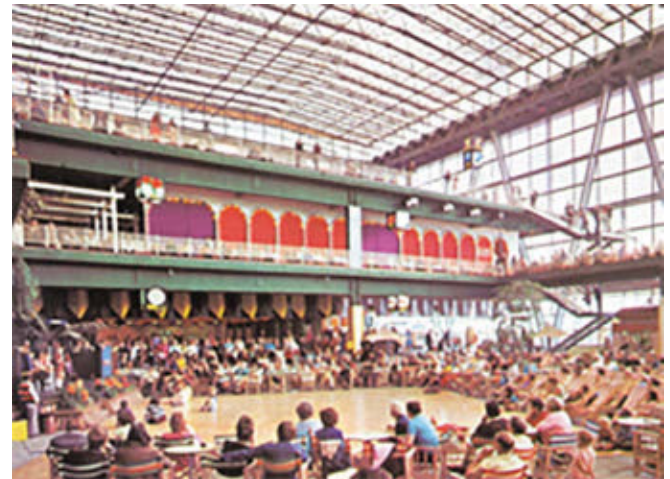
The compartmentation layer of a building ensures that fire does not spread quickly throughout the building. This allows more time for emergency service and occupants to react to the fire. The nature of the Summerland building to have a single, large compartment meant that it could not be compartmentalized completely, as seen in Figure 7. Additionally, the lack of fire-stop between each level and the external wall meant that fire could spread upward quickly via the chimney effect.^[8] Furthermore, as the fire spread to the roof, Oroglas at the ceiling melted to not only vent the fire below, but also to spread fire across the building via burning droplets.

Figure 7a and b. Summerland was designed to have a single, large space with limited compartmentation. (Source: Fortes' Promotional Booklet)

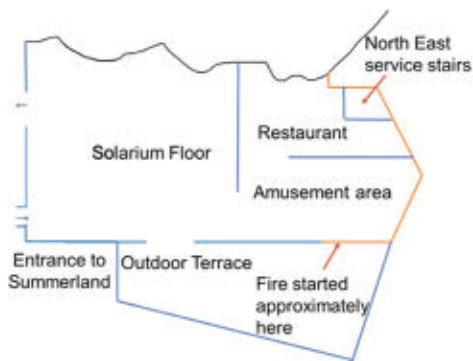
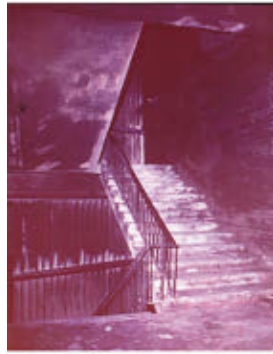
Lastly, to ensure safe evacuation of the building users, stairways are normally compartmentalized. When the Summerland building was first designed, some stairways were compartmentalized to facilitate an emergency evacuation. Unfortunately, when the reinforced concrete was replaced with Galbestos, the northeast service stair, as shown in Figure 8, was surrounded by combustible walls. A further breach of this compartmentalized stairway was made by an unauthorized doorway to allow easier movement of goods into and out of a bar. The unauthorized doorway was responsible for a huge amount of smoke entering the stairway, which may have resulted in 12 people dead just 3 meters from the exit.^[11]

Figure 8a and b. The northeast service stairs, one of the supposedly compartmentalized stairways, was surrounded by Galbestos (orange line), which is flammable (Source: Report of the Summerland Fire Commission)

In addition, the compartmentation of the building failed due to poor material choices at key areas and unauthorized modifications to the building. The use of a flammable material as the wall in the emergency stairway failed to provide a safe pathway to exit the building.

Furthermore, an unauthorized doorway near the compartmentalized stairway for easier movement of goods allowed smoke to enter the stairway resulting in multiple deaths.
