Cardiac and Vascular Group (CVG)

November 20, 2020

Product Id	Product Description	Serial No/Lot No	Event Date	Reference Nos (mPXR)
BB841	Affinity Fusion™ Oxygenator and Cardiotomy/Venous Reservoir (CVR) with Balance™ Biosurface	LN: 13326113 (Not Returned)	October 9, 2020	704004478 (765459)
		LN: 13326113 (Not Returned)	October 9, 2020	704056602 (774562)
		SN: 8401046107 LN: 13326113	October 14, 2020	704013984 (767165)

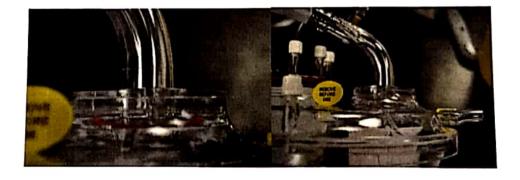
Visual inspection showed the venous inlet tube was installed when received (see photos below). The customer provided video showing the venous inlet port was easily removed and installed; however, it was not evident from the video that the venous inlet port was loose/separated from the device prior to the demonstration.

The venous inlet tube was removed from the lid. The outer diameter (OD) of the venous inlet tube that secures into the lid was measured against the specification. The following measurements of 1.816 inches in one direction and 1.820 inches in the other direction were recorded, (specification is 1.818 +/- 0.005 inches).

The diameter of the shoulder that snaps into the lid measured 0.870 inches (specification is 0.872 +/- 0.005 inches).

Medtronic Quality Engineers confirmed the venous down tube dislodged from the lid based on the customer provided pictures. Returned product analysis found the associated dimensions for venous tube and lid retention features to be within specification. The retention feature of the venous inlet tube is designed to withstand a foreseeable force encountered during transportation or during use, such as when the tubing is knocked or pulled.

Based on the Venous Inlet dislodgement occurrences, a potential cause was identified during production and corrective actions were taken. The potential cause for the Venous Inlet dislodgement was determined to be the manual method at which the lubricant is applied to the Venous Inlet O-ring, leading to inconsistences in the amount. To mitigate the inconsistences in the amount of lubricant applied, production implemented an automated method to apply lubricant to the Venous O-ring. These devices were manufactured prior to corrective actions. We will continue to monitor this product for similar events.
