## Supplementary File 1

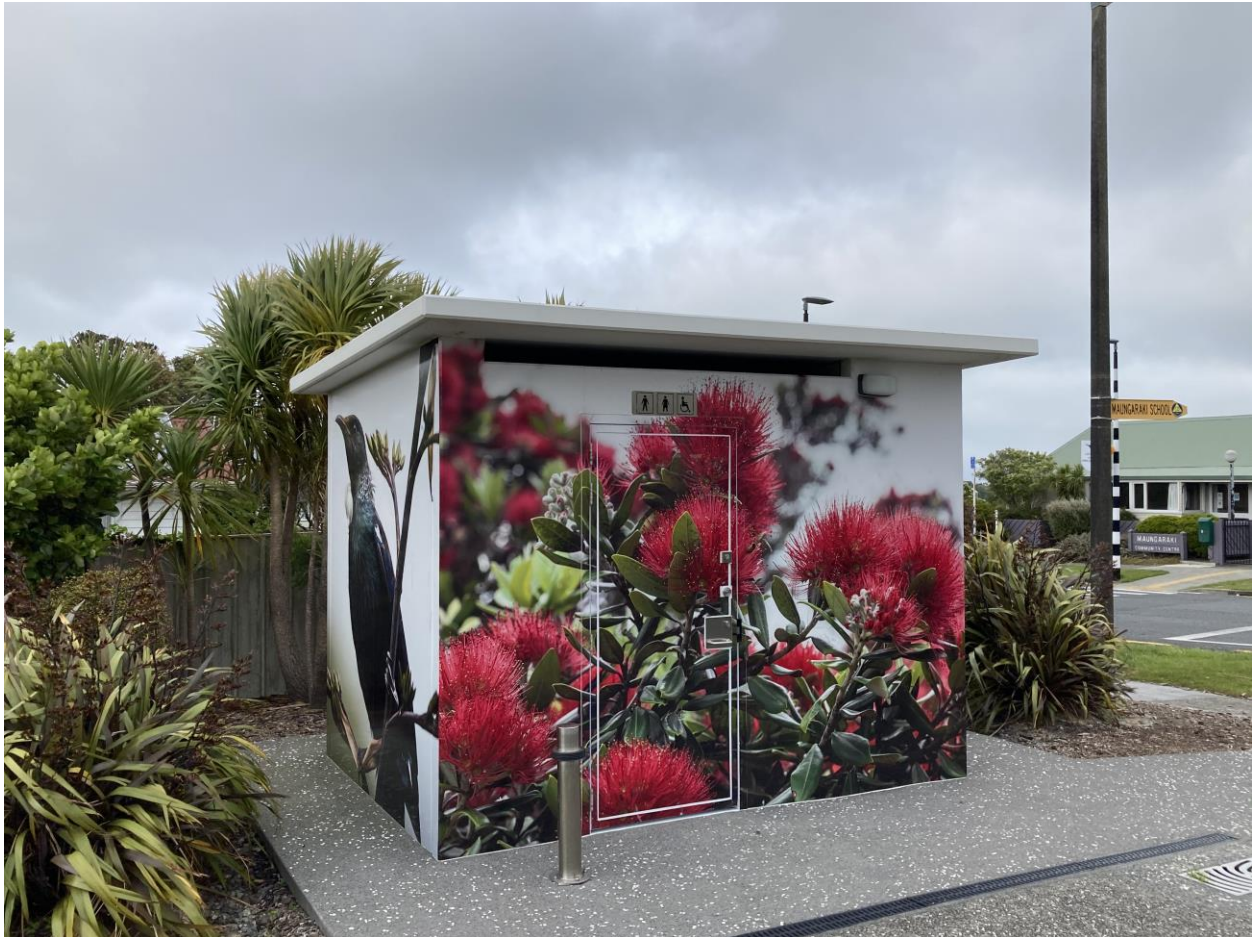
Figure S1-1: Exterior art work on a public toilet which may reduce the risk of graffiti attacks and vandalism (toilet in the suburb of Maungaraki, Lower Hutt) (photograph by first author, 2020)

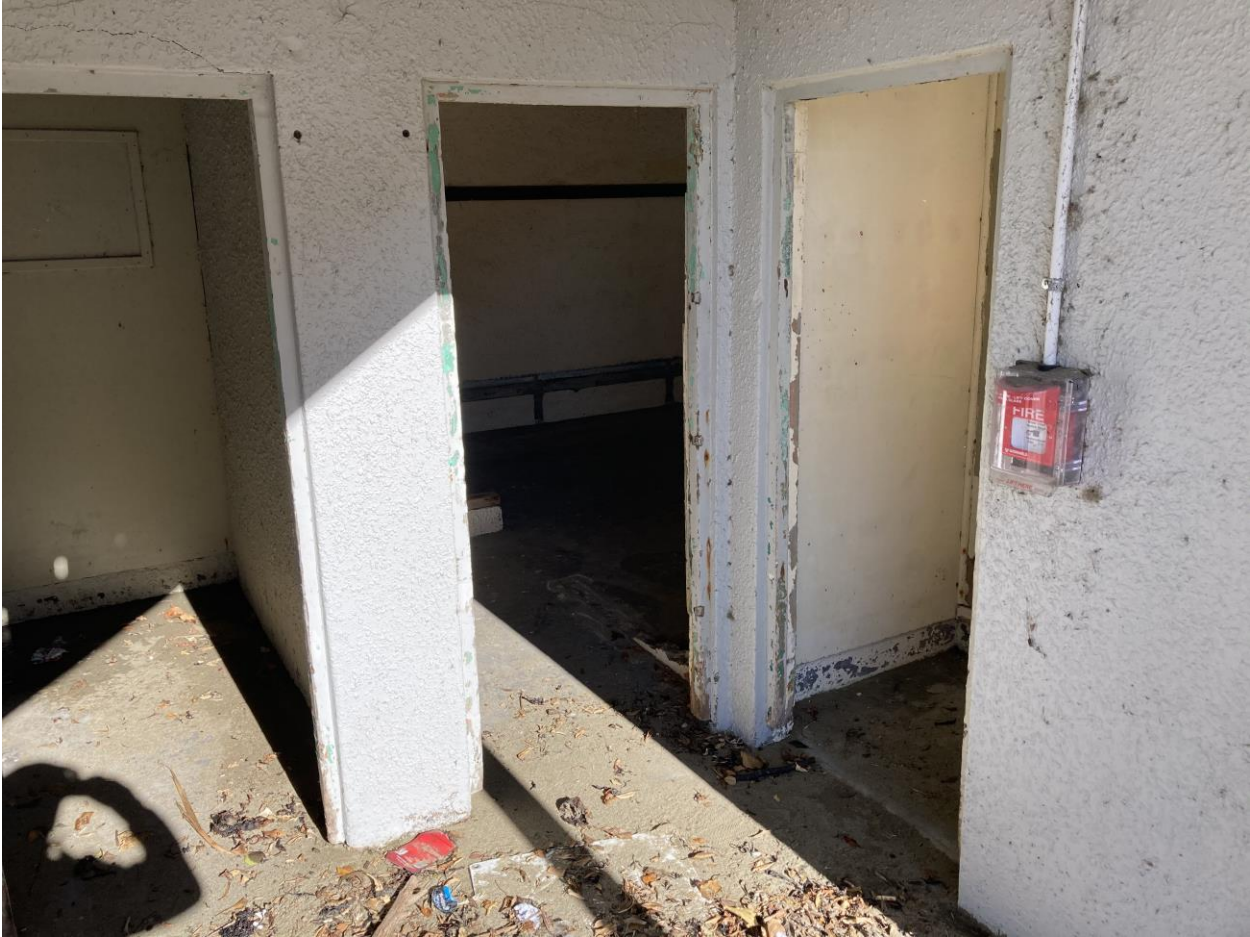
Figure S1-2: Dilapidated entrance to a public toilet with no signage as to it being men's or women's on Island Bay Beach Wellington (photograph by first author, 2020)

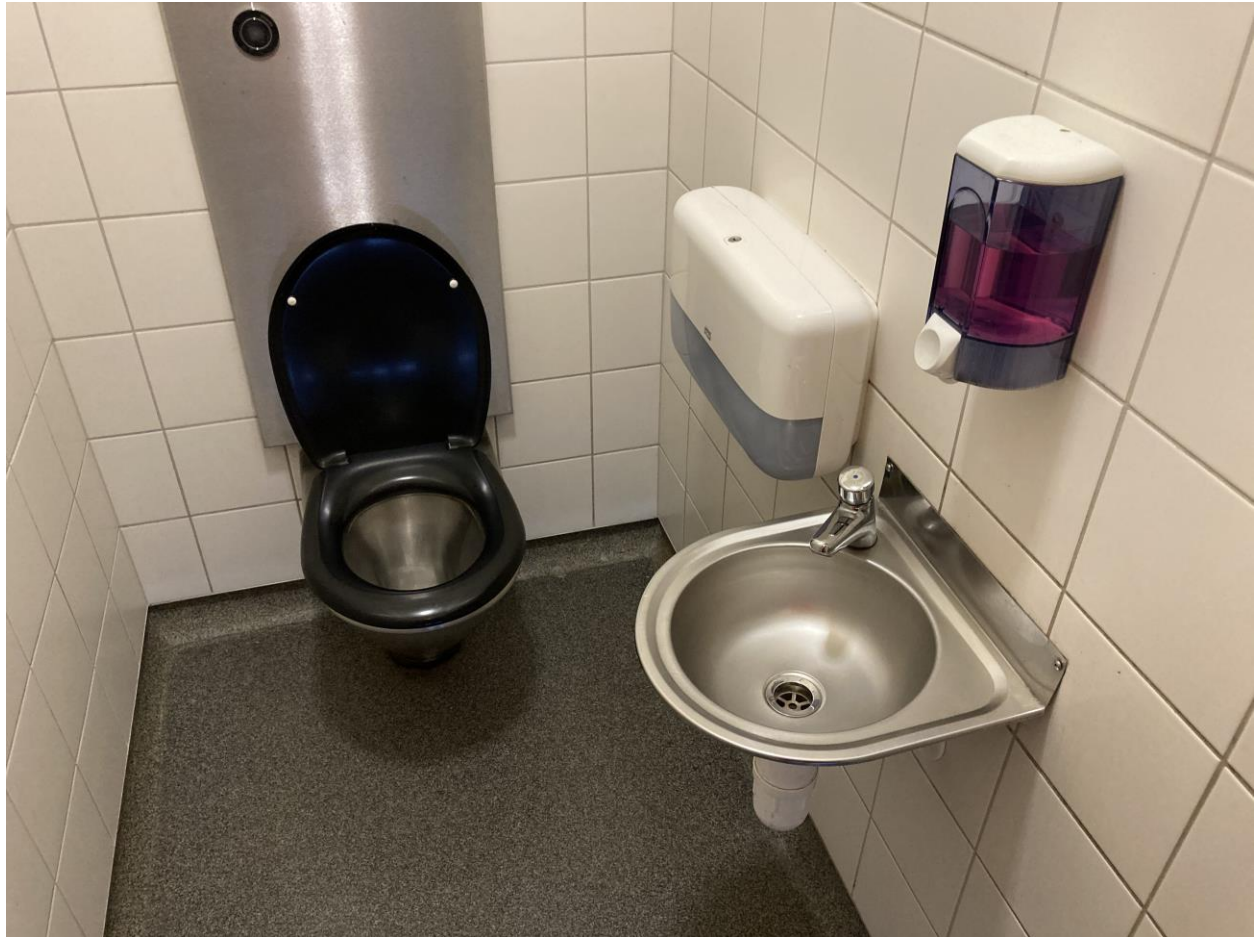
Figure S1-3: The most common type of toilet arrangements found in this 2020/2021 study ie, manual tap, liquid soap dispenser, manual flushing and a lid over the toilet bowl (photograph by first author, 2020)
