BRAKE TORQUE VARIATION DUE TO CALIPER MACHINING QUALITY

¹Toyota Motor Europe

ABSTRACT: One of the major concerns of brake NVH is Brake judder coming from Brake Torque Variation (BTV). This is a vibration that occurs during braking and can be felt by the driver through the steering, brake pedal or vehicle body. This can create a feeling of discomfort for the vehicle occupants.

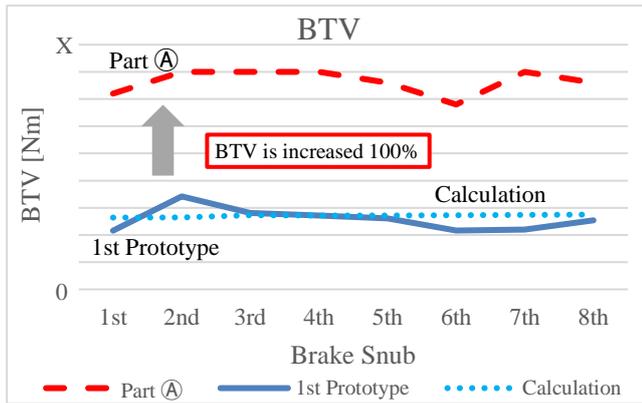
Figure 2: Brake torque variation results

The BTV value of a prototype part, Part (A), was double the first prototype result, as well as being double the theoretical calculation, illustrated in Figure 2. To calculate the theoretical BTV; caliper, pad and disc characteristics are considered. The design of the caliper and disc was not modified between the first prototype and Part (A), therefore the calculation and expectation remained the same as at the first prototype phase.

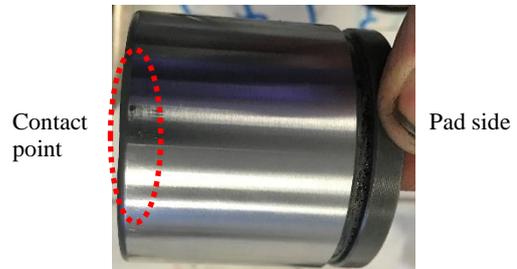
Figure 4: Piston with marking (Part (A))

Analysis of the sub-components showed that the piston had been in contact with the caliper housing piston bore. The marking on the piston is visible in Figure 4, and enlarged in Figure 5. Equivalent markings were also found on the bore of the caliper housing. This phenomenon can be found in floating type brake calipers and until now has not been highlighted as a concern. However, for this investigation it is worth noting.

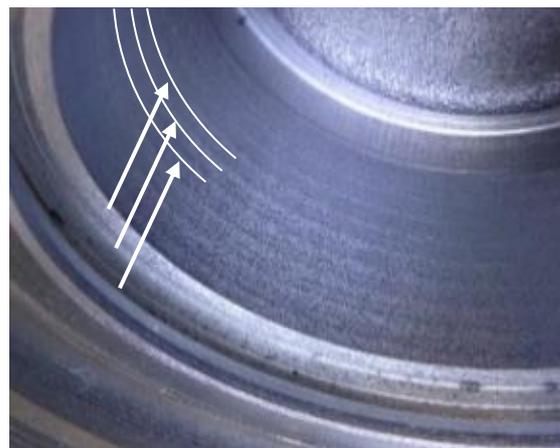
Figure 6: Caliper housing piston bore machining lines (Part (A))

Further analysis of the caliper housing piston bore shows machining lines in the bore which can be seen in Figure 6. These machining lines were visible on the actual tested parts, as well as on new, unused parts. However, they were not visible on the first prototype part tested in Figure 2. This gave a good hint that the surface machining condition could play a role in influencing the BTV. Hence this became the next investigation point.

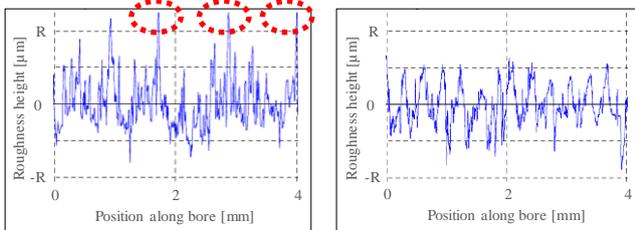
Figure 7: Surface profile of Part ① (visible machining lines)

On further analysis, the visible machining lines in the caliper housing piston bore, from Figure 6, could be identified as peaks on the surface roughness profile, and are highlighted in Figure 7. The surface roughness profile of a caliper housing without visible machining lines is shown in Figure 8, Part ②, and does not have the corresponding peaks. These peaks seemed to correspond with the roughness parameter Rpk; which is the mean height of the peaks protruding from the roughness profile.

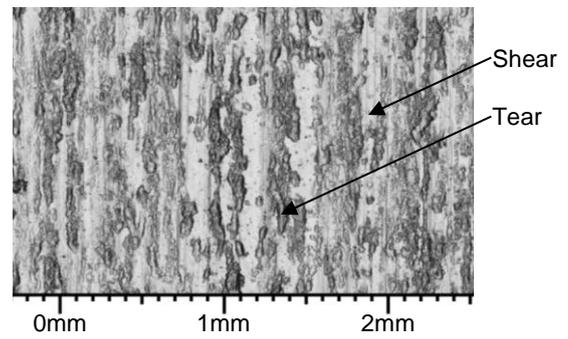
Figure 10: Area ①: 2D analysis of Part ① surface

The results are shown in the following figures. Figure 10 shows a 2D scan of the surface condition when viewed perpendicularly to the surface. The light-coloured area is indicative of shear occurring during machining. The dark area indicates that the material was

torn off which results in a poor surface finish. Ideally, the entire surface should have the light colour, as shear is the preferred mechanism for this type of machining.

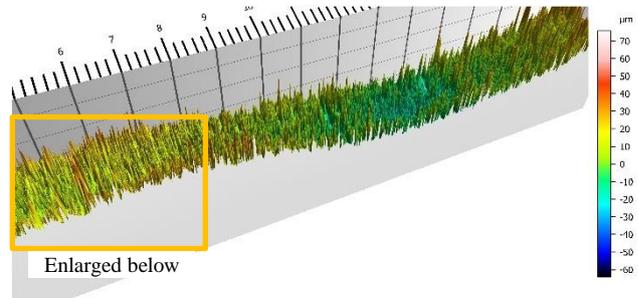
Figure 11: Area ①: 3D surface analysis of Part ①

The irregularities of the surface can also be seen in the 3D scan presented in Figure 11 and Figure 12. This gives a more detailed understanding of the surface condition than the one-dimensional roughness profile in Figure 7.

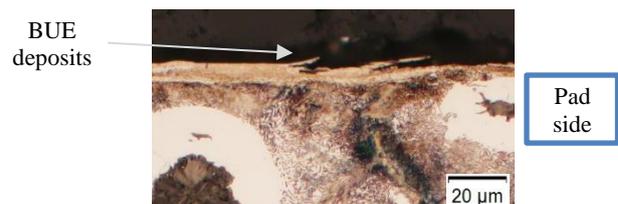
Figure 13: Area ②: Cross-section analysis of Part ① caliper housing piston bore

The cross-sectional analysis in Figure 13 gives a clearer view of the concern. Here it is possible to see small “spikes” about 20µm long. These are deposits which are the result of a machining phenomenon known as “built-up edge” (BUE). It is worth noting that these spikes have depth as well, but is not visible in the image.

BUE is an undesirable feature as it reduces machining accuracy, quality of the machined surface and damage to the cutting edge [7]. Therefore, the focus was to understand this phenomenon and attempt to eliminate it.

- The presence of built-up edge deposits in the caliper housing piston bore has been shown to double the BTV value for this caliper design. This increased sensitivity is created because the piston gets blocked on the sharp edges created by the built-up edge deposits. When the piston is blocked, it cannot move back into the caliper housing freely, thus increasing the caliper stiffness.

Tuning of these parameters could eliminate the BUE deposits in the caliper housing piston bore of this study.

- Methods to prevent BUE deposits on the machining surface are well known in the machining industry. The main parameters to consider are rotation speed, feed rate, cutting temperature, tool rake angle, and tool material. Tuning of these parameters is dependent on the machining equipment and components and is usually the responsibility of the manufacturing plant, but should not be neglected by the designer.

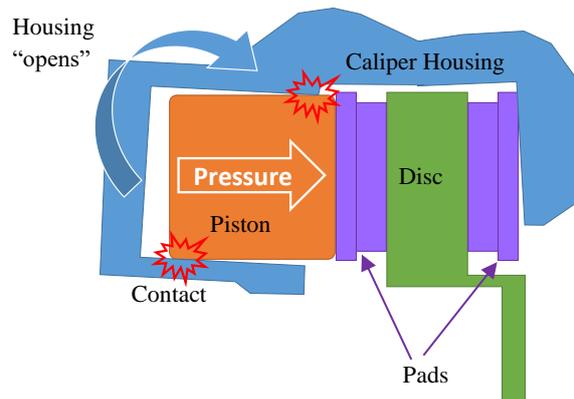
Figure 15: Piston and caliper movement

Referring to Figure 15, when pressure is applied, the housing "opens" slightly. The piston will then push flat against the pad. This combined opening and piston movement, reduces the internal clearance between the piston and the caliper housing piston bore, which allows the piston to contact the caliper housing piston bore. This can be exacerbated by taper wear of the pad.

The contact is most critical at the back of the piston; highlighted in Figure 15. At the contact position, the BUE deposits are orientated such that they prevent the piston from smoothly sliding back into the piston bore, as illustrated in Figure 16. Since the piston cannot slide smoothly, it has the effect of increasing the caliper stiffness which affects BTV.

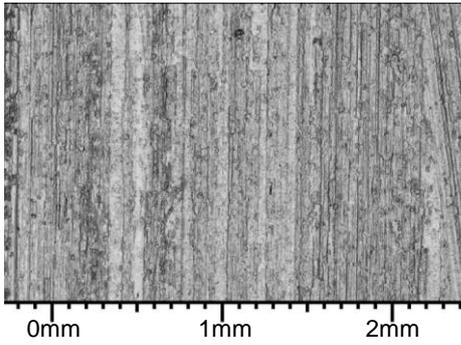
Figure 17: Area ①: 2D surface analysis of Part © - without BUE deposits

The surface condition of a part, Part ©, from the improved process was analysed using the same methods as in Figure 9. Figure 17 shows that the caliper housing piston bore has a more consistently machined surface, and is created mostly from the shearing action of the cutting tool. Comparing to Figure 10, this is a significant improvement.

The machining process for this caliper housing was tuned to eliminate BUE, considering the parameters mentioned in the previous section. This had a positive effect on BTV performance. The following will explain the theoretical mechanism and the final results.

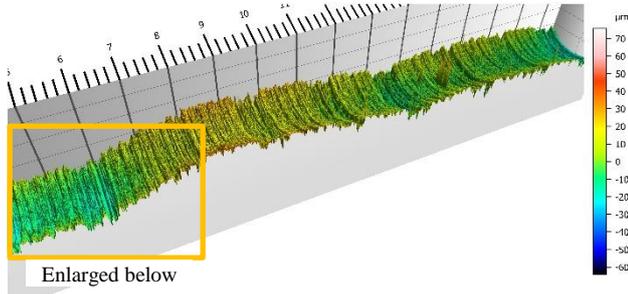
Figure 18: Area ①: 3D surface analysis of Part © - without BUE deposits

The improvement is again visible in Figure 18 and Figure 19. When compared to Figure 12, the surface condition is much more even.

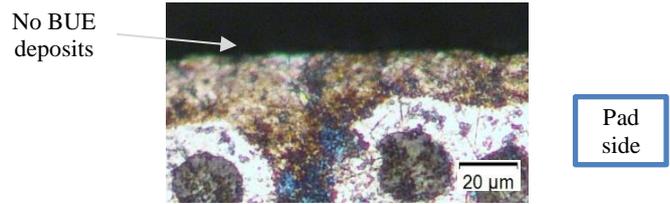
Figure 20: Area ②: Cross-section analysis of Part © (without BUE deposits)

The final confirmation is on the cross-section in Figure 20. There are no BUE deposits like those seen in Figure 13, thus confirming the process tuning was successful.

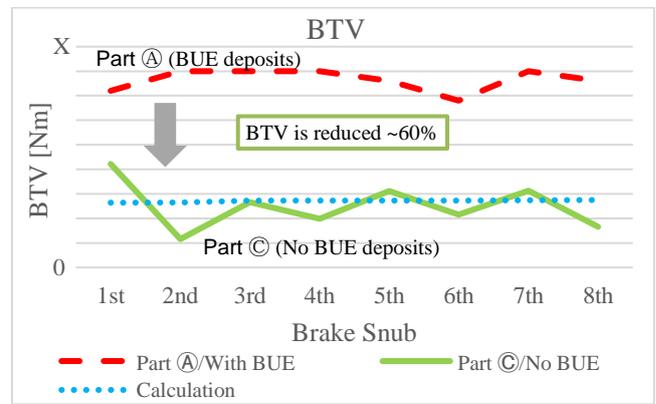
Figure 21: BTV reduction (BUE vs No BUE)

The theory was confirmed by measuring the BTV of the above parts, Part ©. The results in Figure 21 show that the BTV has returned to be in line with the first prototype result and the theoretical calculation.

Considering the roughness values, BUE deposits and final BTV values, it can be concluded that the main contributor for the BTV sensitivity was the BUE deposits. By eliminating these, the performance returned to the original expectation.
