Asbestos Management Report

11 Teapot Studios, Hoult's Yard, Newcastle upon Tyne NE6 2HL

Issued on: 19 Mar 2020

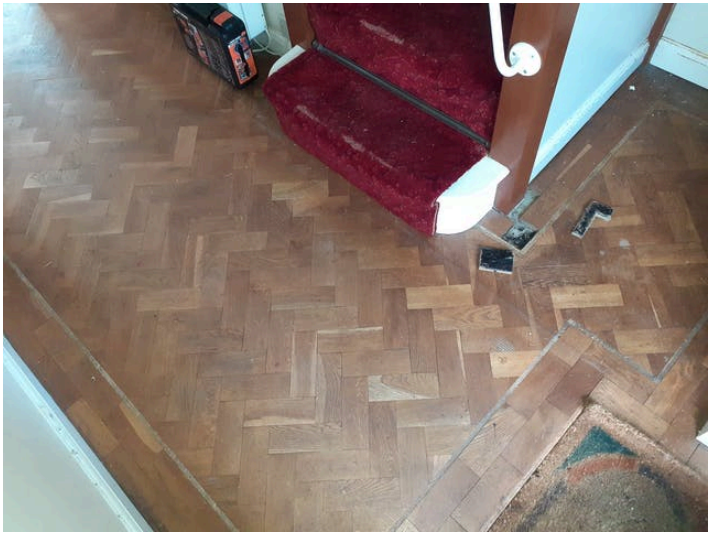
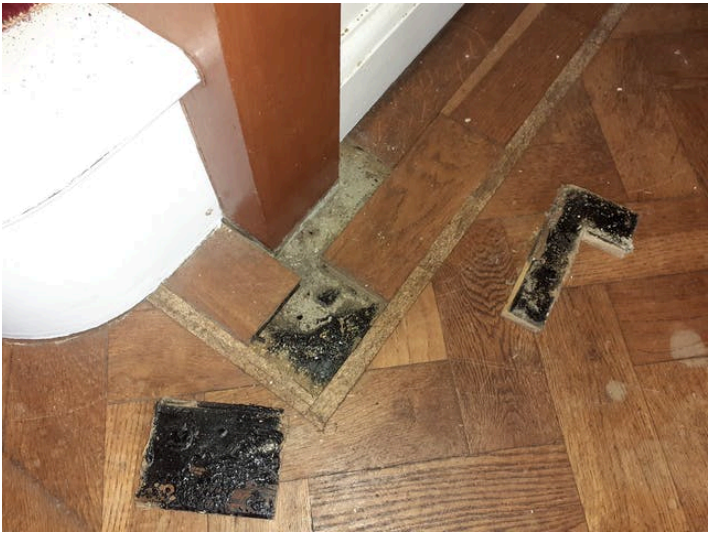
Building	Main Building	Level	0
Location	001 - Hall	Item	Adhesive to Parquet Flooring
Material	Bituminous Product	Extent	5 sq. m.

Strategy / Sample Id	Sample / 002	Fibre Type	NADIS

No Asbestos Detected in Sample

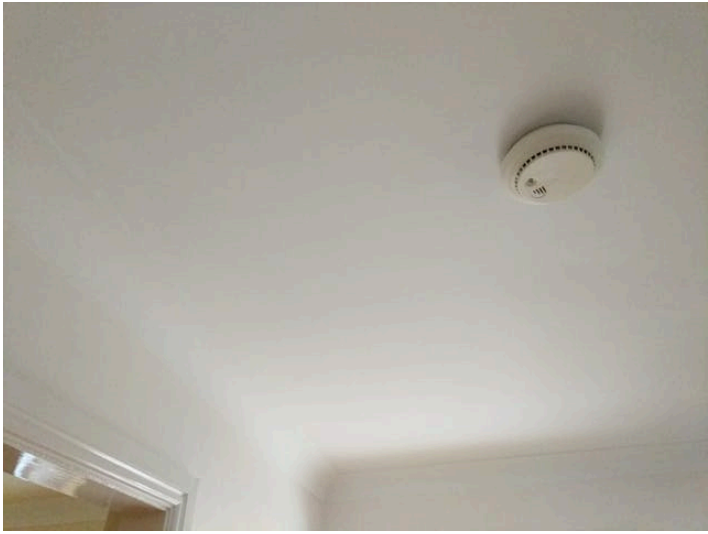
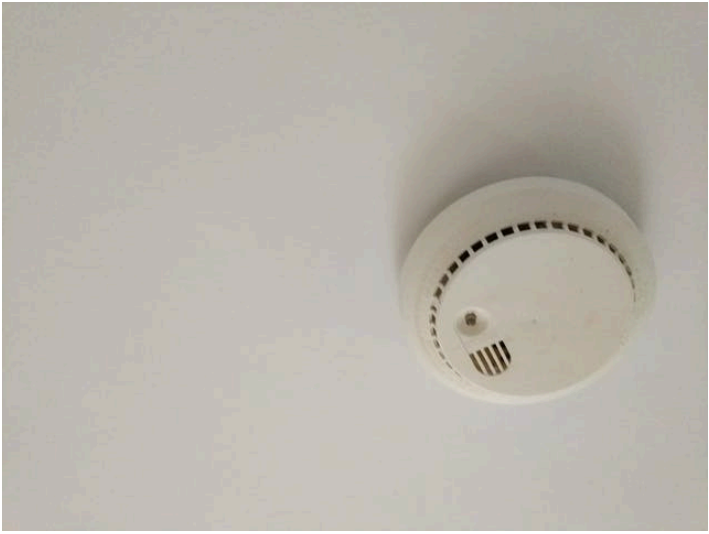
Building	Main Building	Level	0
Location	001 - Hall	Item	Ceiling
Material	Plasterboard	Extent

Strategy / Sample Id	Presume	Presumed Fibre Type	NAD

No Asbestos Detected in Sample

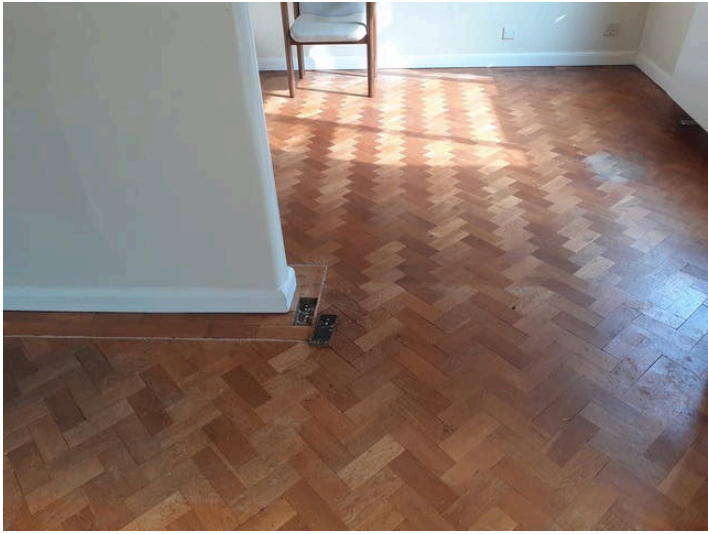
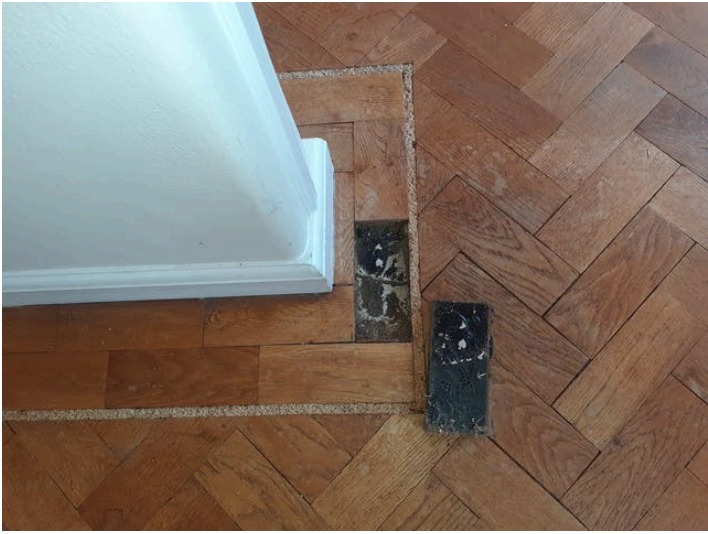
Building	Main Building	Level	0
Location	003 - Lounge / Dining Room	Item	Adhesive to Parquet Flooring
Material	Bituminous	Extent	27 sq. m.

Strategy / Sample Id	Cross Reference / 002	Fibre Type	NADIS

No Asbestos Detected in Sample

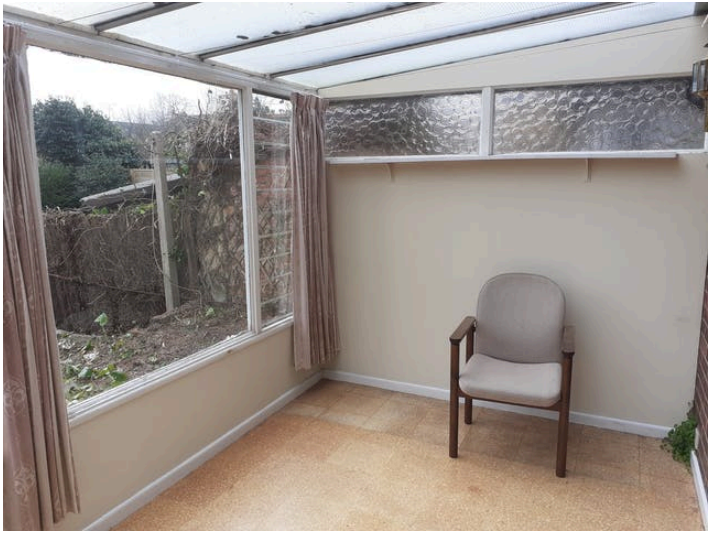
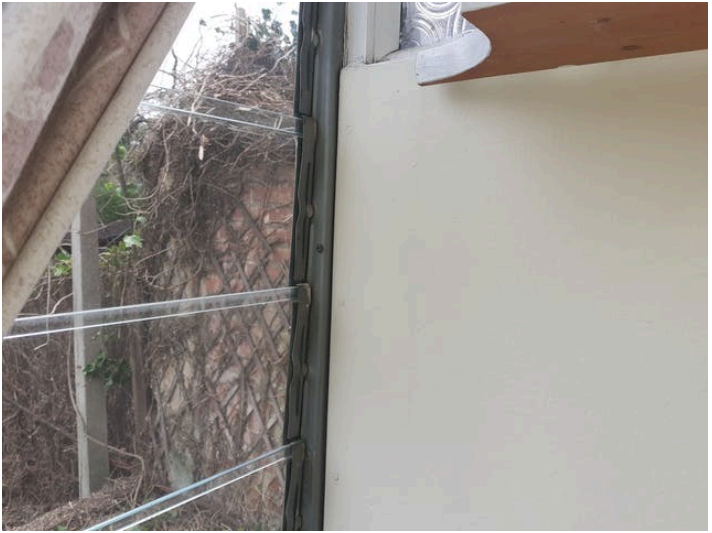
Building	Main Building	Level	0
Location	004 - Conservatory	Item	Walls
Material	Insulating Board	Extent	10 sq. m.

Strategy / Sample Id	Sample / 004	Fibre Type	Chrysotile
Recommendation	Remove under fully controlled conditions

Product Type (or Debris from Product)	2	Extent of Damage / Deterioration	1
Surface Type / Treatment	2	Asbestos Type	1
Material Score / Category	6 / Low

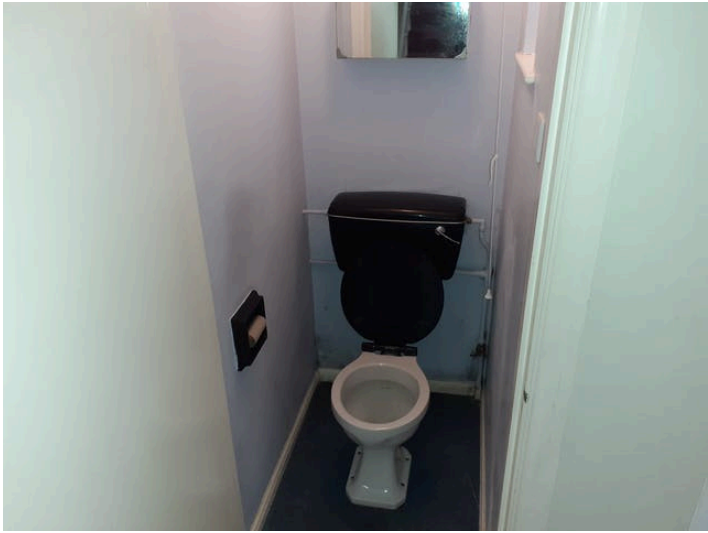
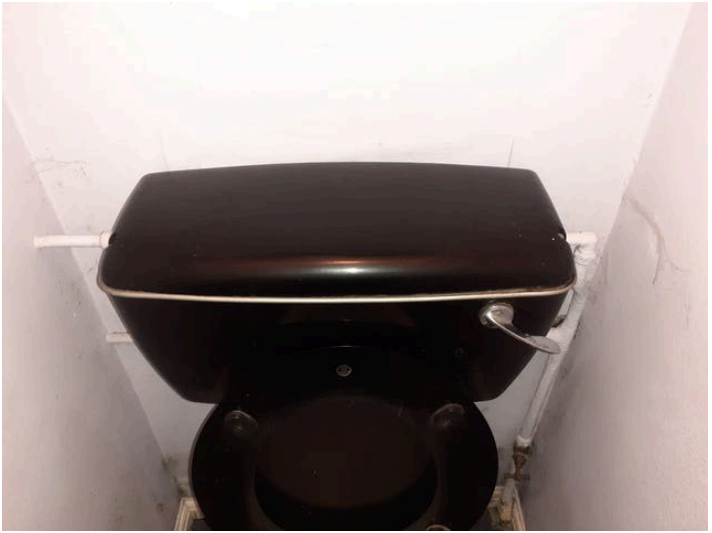
Building	Main Building	Level	0
Location	005 - WC	Item	Toilet Cistern
Material	Composite	Extent	1 No.

Strategy / Sample Id	Sample / 005	Fibre Type	Crocidolite
Recommendation	Remove under locally controlled conditions

Product Type (or Debris from Product)	3	Extent of Damage / Deterioration	3
Surface Type / Treatment	3	Asbestos Type	3
Material Score / Category	12 / High

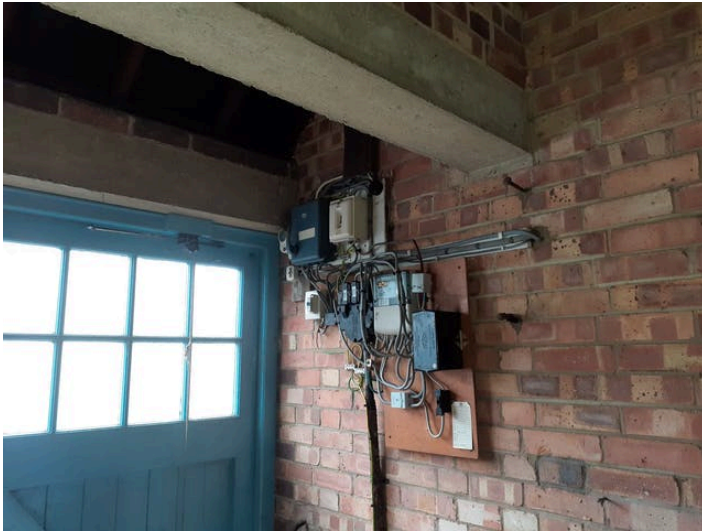
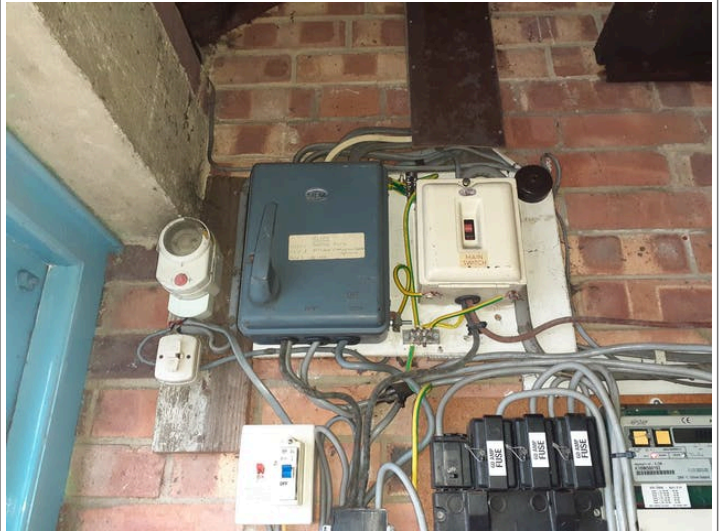
Building	Main Building	Level	0
Location	006 - Garage	Item	Electrics
Material	Flashguards	Extent	1 m.

Access / Notes	Limited Access / Live Service Supply		
Strategy / Sample Id	Presume	Presumed Fibre Type	Chrysotile
Recommendation	Remove under locally controlled conditions

Product Type (or Debris from Product)	1	Extent of Damage / Deterioration	1
Surface Type / Treatment	2	Asbestos Type	1
Material Score / Category	5 / Low
