## Section Summary

Number of sections	3
Total length of sewer network	566.75 ft
Inspected length of sewer network	566.75 ft
Not inspected length of sewer network	0.00 ft
Total abandoned inspections	1
Number of section inspection photos	25
Number of section inspection videos	3
Number of section inspection scans	0
Number of section inclination measurements	0

## Inspection report

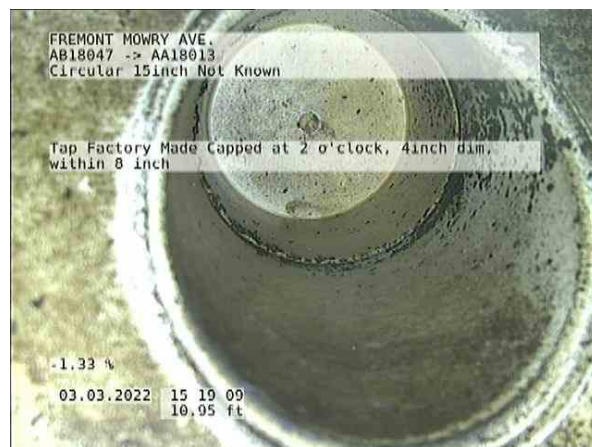
fac6e01e-de05-48c6-b3e1-b9a5d6d69ab0\_20220303\_152225\_406.jpg, 00:01:12, 8.51ft  
Tap Factory Made Capped at 2 o'clock, 4inch dim, within 8 inch

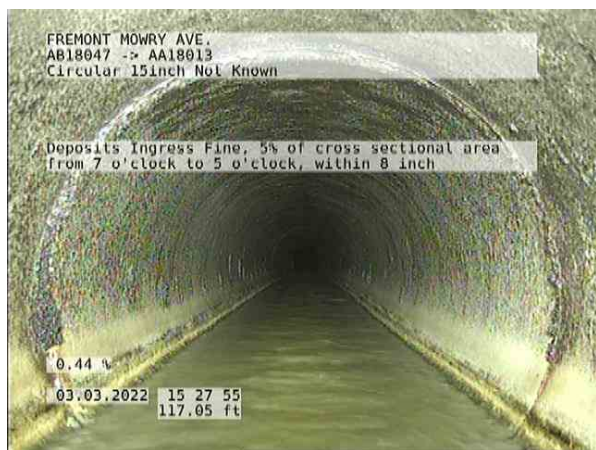
1838de70-8294-4df7-98fd-1d7064226b32\_20220303\_153111\_088.jpg, 00:08:25, 117.05ft  
Deposits Ingress Fine, 5% of cross sectional area from 7 o'clock to 5 o'clock, within 8 inch

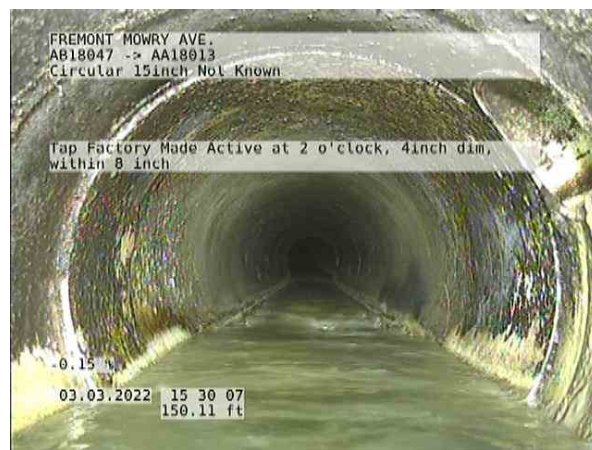
74ae5de5-e4f4-45e4-93a7-8cd8b4394856\_20220303\_153323\_034.jpg, 00:10:28, 150.11ft  
Tap Factory Made Active at 2 o'clock, 4inch dim, within 8 inch

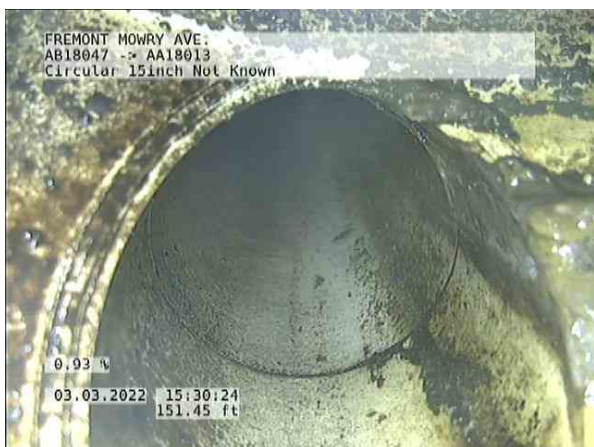
aabfb3fe-d1b5-436a-9cdf-de2d4b0cc9bb\_20220303\_153340\_421.jpg, 00:10:28, 150.11ft  
Tap Factory Made Active at 2 o'clock, 4inch dim, within 8 inch

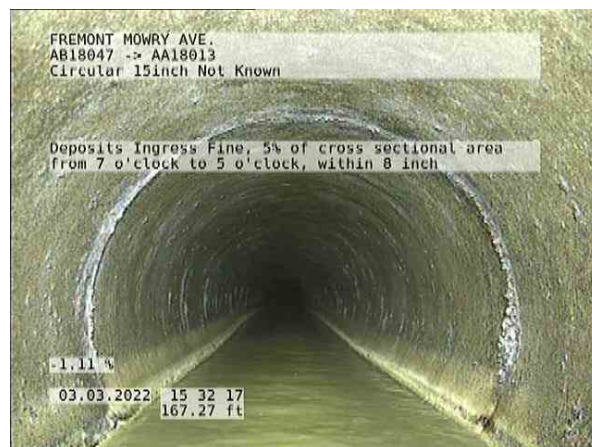
2109d321-afc0-49d1-a38f-2c0bfff81c31\_20220303\_153533\_419.jpg, 00:12:24, 167.27ft  
Deposits Ingress Fine, 5% of cross sectional area from 7 o'clock to 5 o'clock, within 8 inch

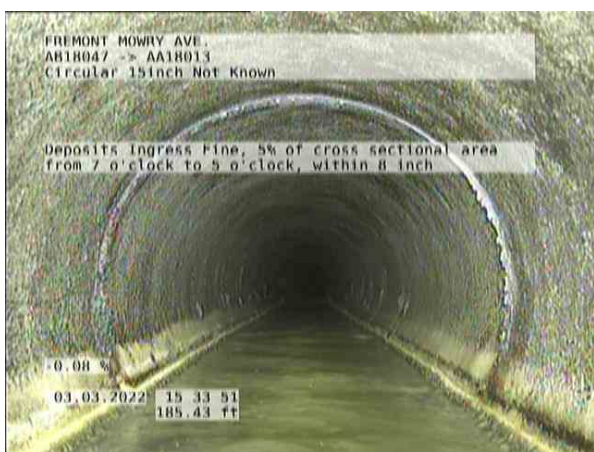
5f19e0a0-7829-4c2c-9981-7c6dbea3ed25\_20220303\_153707\_064.jpg, 00:13:46, 185.43ft  
Deposits Ingress Fine, 5% of cross sectional area from 7 o'clock to 5 o'clock, within 8 inch

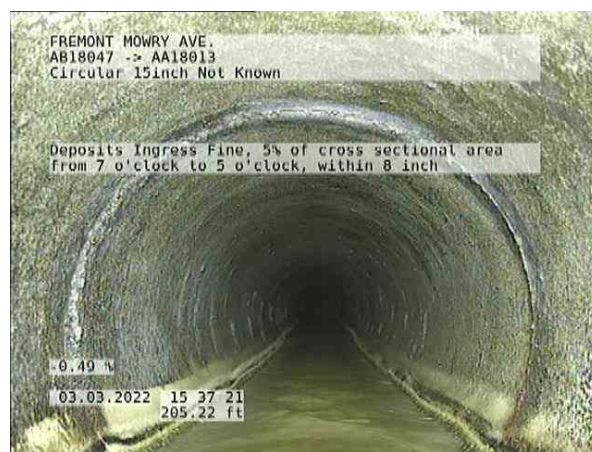
d9a2f252-7716-45fa-8ece-e5638fe02b04\_20220303\_154037\_007.jpg, 00:17:06, 205.22ft  
Deposits Ingress Fine, 5% of cross sectional area from 7 o'clock to 5 o'clock, within 8 inch

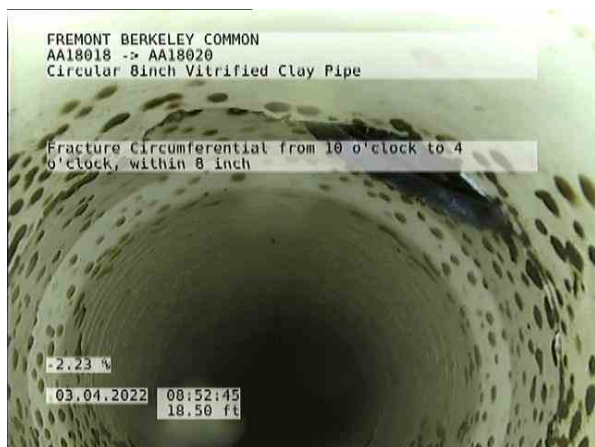
5c6b0456-86b4-4a46-bfb7-c0ec9aa5fcec\_20220304\_085606\_005.jpg, 00:03:50, 18.50ft  
Fracture Circumferential from 10 o'clock to 4 o'clock, within 8 inch

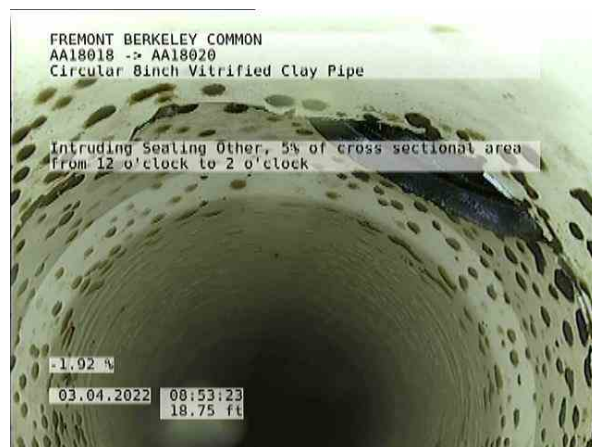
064060e0-ac33-4e4d-9616-a37397b29975\_20220304\_085643\_464.jpg, 00:04:02, 18.75ft  
Intruding Sealing Other, 5% of cross sectional area from 12 o'clock to 2 o'clock

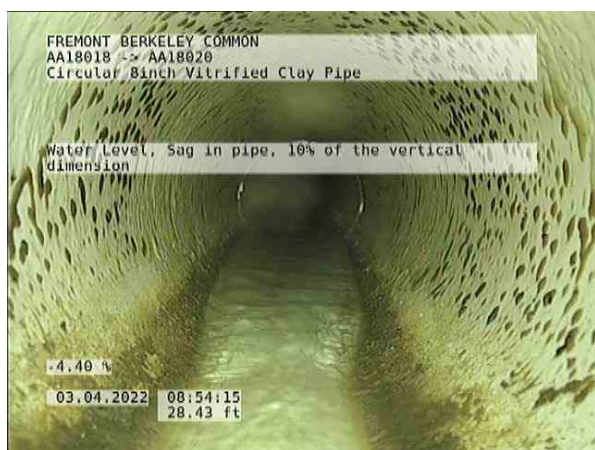
6607f3b2-b39a-4d0a-9e67-3f0fa5aec836\_20220304\_085735\_983.jpg, 00:04:48, 28.42ft  
Water Level, Sag in pipe, 10% of the vertical dimension

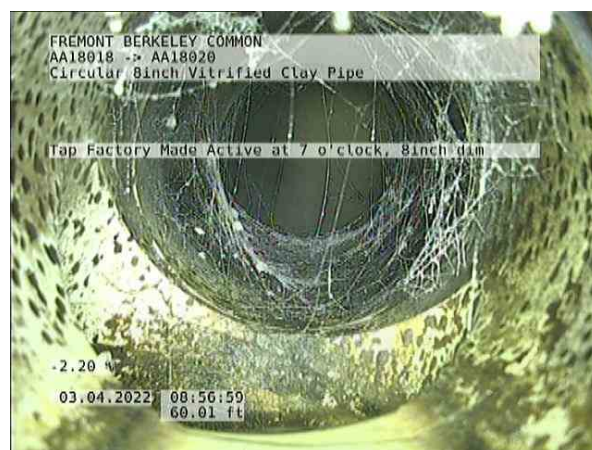
79d0968e-8e48-4028-9614-d1dea52b0461\_20220304\_090019\_482.jpg, 00:07:16, 60.00ft  
Tap Factory Made Active at 7 o'clock, 8inch dim

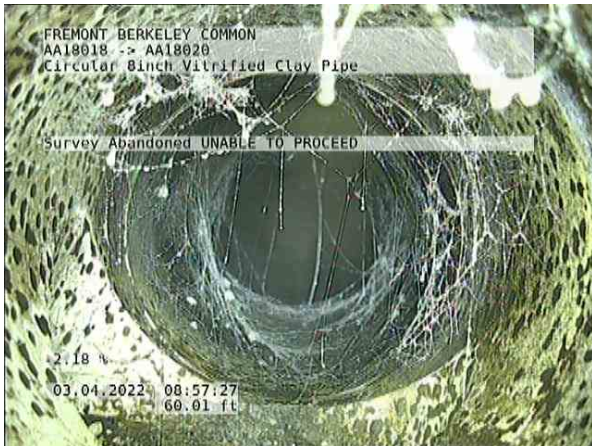
45976fa0-d858-4d87-a220-c4968c4dc0c5\_20220304\_090047  
\_891.jpg, 00:07:27, 60.01ft  
Survey Abandoned / UNABLE TO PROCEED

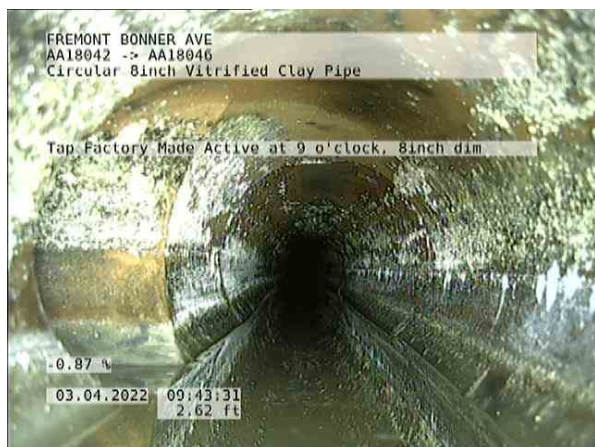
626b4da8-a746-4bd2-a730-53747eb5db4b\_20220304\_094650\_769.jpg, 00:00:56, 2.62ft  
Tap Factory Made Active at 9 o'clock, 8 inch dim

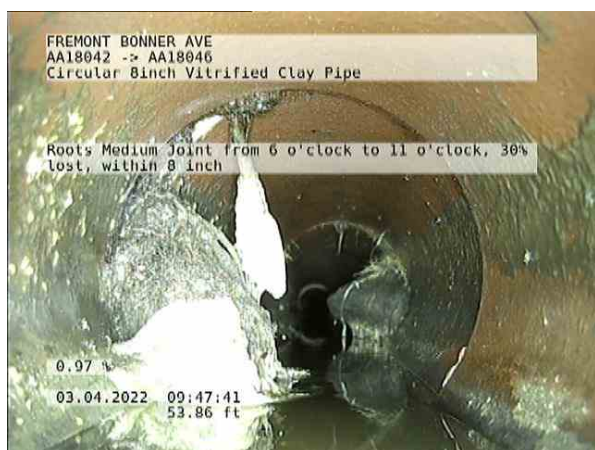
5559355e-fb83-4b22-821f-9f099dba9871\_20220304\_095100\_862.jpg, 00:04:32, 53.86ft  
Roots Medium Joint from 6 o'clock to 11 o'clock, 30% lost, within 8 inch

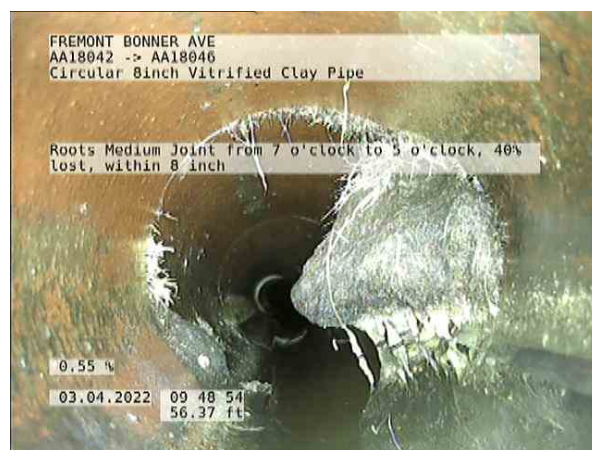
b52b294c-591d-4a22-9be7-f5875e7dddfc\_20220304\_095213\_923.jpg, 00:05:06, 56.37ft  
Roots Medium Joint from 7 o'clock to 5 o'clock, 40% lost, within 8 inch

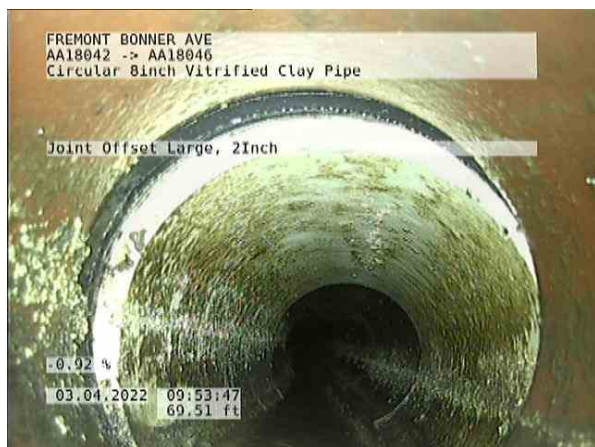
46879e3d-6281-4635-99bd-14b07bd756c6\_20220304\_095706\_522.jpg, 00:09:34, 69.51ft  
Joint Offset Large, 2Inch

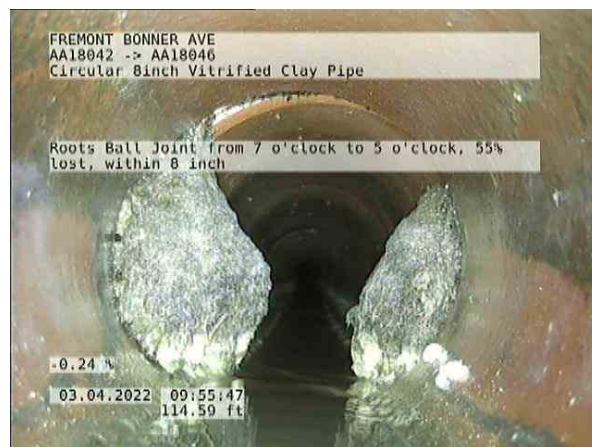
a57e27f6-9469-432a-b902-0b575c0a2d1b\_20220304\_095907\_076.jpg, 00:11:21, 114.59ft  
Roots Ball Joint from 7 o'clock to 5 o'clock, 55% lost, within 8 inch

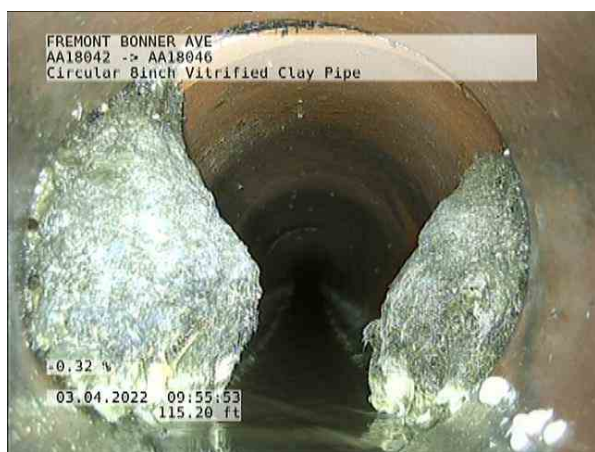
1518dc71-c044-4645-894f-5bed991453cd\_20220304\_095913\_074.jpg, 00:11:21, 114.59ft  
Roots Ball Joint from 7 o'clock to 5 o'clock, 55% lost, within 8 inch

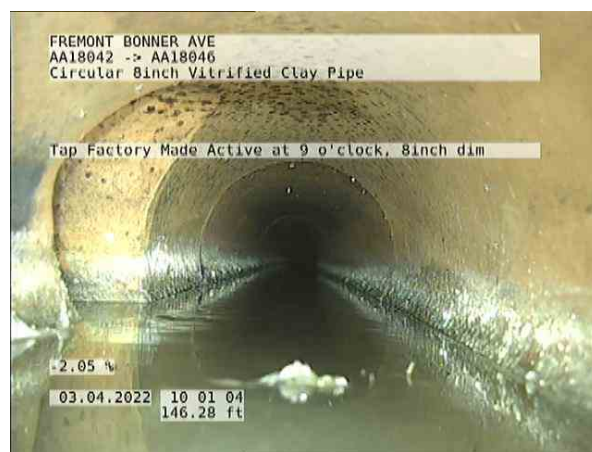
2f4053a4-b2d1-4c3b-a25c-60ad07f8817f\_20220304\_100423\_630.jpg, 00:16:15, 146.28ft  
Tap Factory Made Active at 9 o'clock, 8inch dim

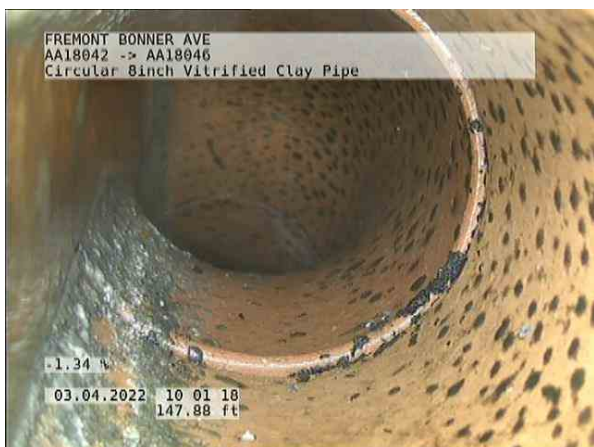
9c13d6b2-8cd5-4680-b772-597f4fdcee1a\_20220304\_100438\_032.jpg, 00:16:15, 146.28ft  
Tap Factory Made Active at 9 o'clock, 8inch dim

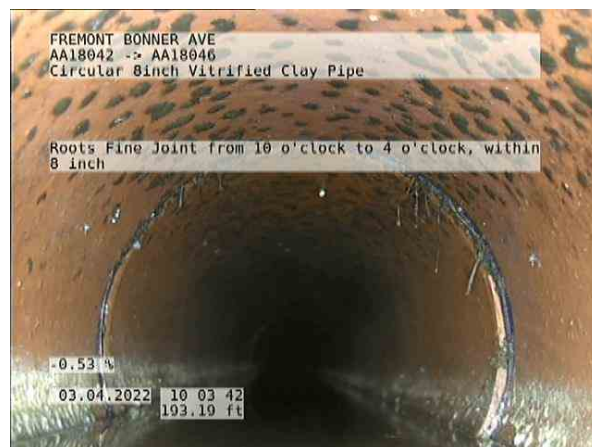
80d536cc-b314-45a4-a49e-69acfa214227\_20220304\_100702\_114.jpg, 00:18:46, 193.19ft  
Roots Fine Joint from 10 o'clock to 4 o'clock, within 8 inch

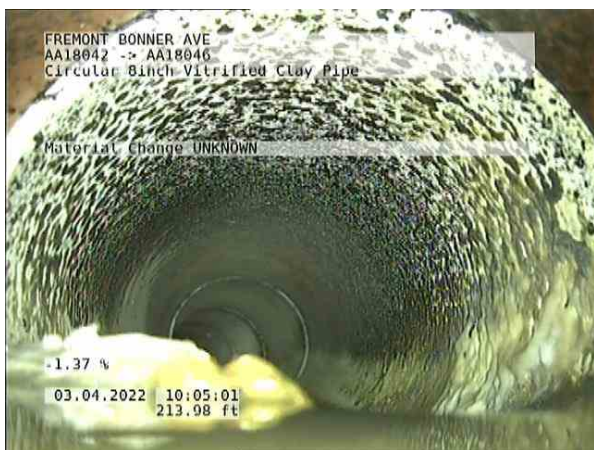
54b821e7-67d6-44a3-941b-98a3b7c02a09\_20220304\_100820\_292.jpg, 00:19:56, 213.98ft  
Material Change / UNKNOWN

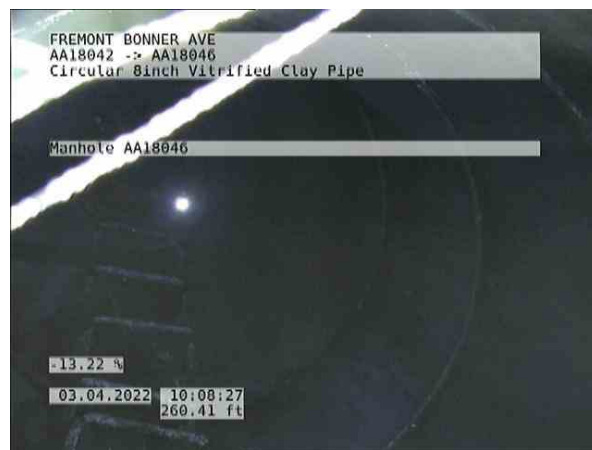
a263860c-a6a2-479e-9ff7-e554c19a1c0b\_20220304\_101146\_245.jpg, 00:23:10, 260.41ft  
Manhole / AA18046
