FACILITY CONDITION ASSESSMENT

SACRAMENTO ACCELERATED ACADEMY

5601 47th Avenue
Sacramento, California 95824

June 15, 2020

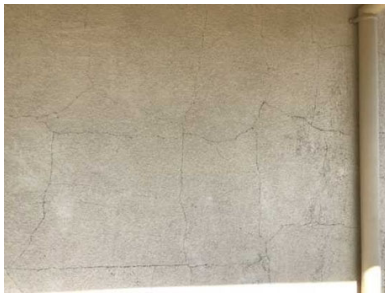
Exterior Wall in Poor condition.

Stucco, 1-2 Stories
Bldg B Classrooms 21-25 Building Exterior

The exterior stucco shows multiple cracks throughout - AssetCALC ID: 1462145

Uniformat Code: B2011
Recommendation: **Repair in 2019**

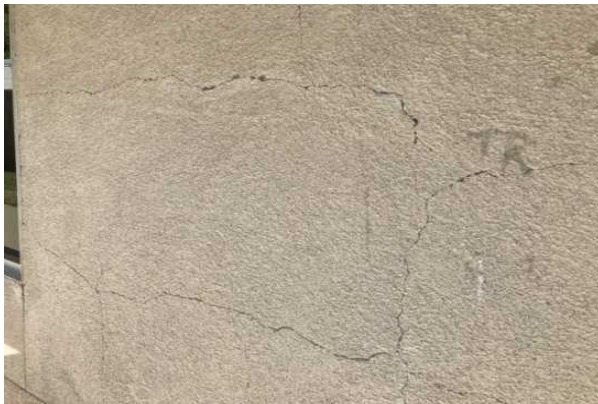
#9

The classroom buildings appear to be modular units, with metal roofs and stucco integral color exterior finishes. The roofs and windows are holding up very well, but the stucco exteriors show lots of cracking. The cracks are not large, but they appear throughout. Sealing the cracks within the next three years is highly recommended.

STUCCO CRACKING SEEN
THROUGHOUT 001-005

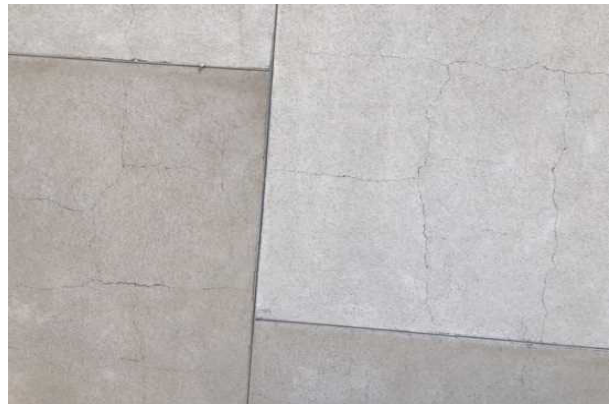
#10

STUCCO CRACKING SEEN
THROUGHOUT 001-005

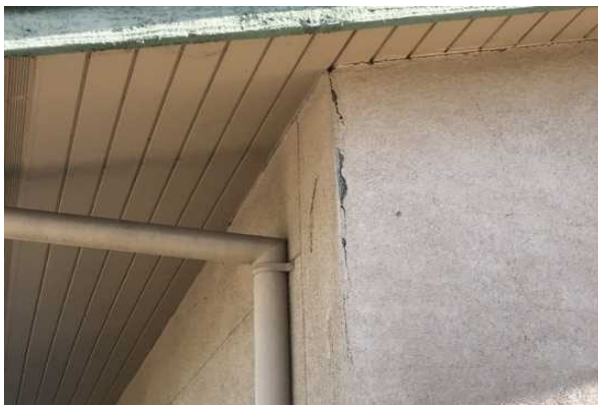
#11

STUCCO CRACKING SEEN
THROUGHOUT 001-005

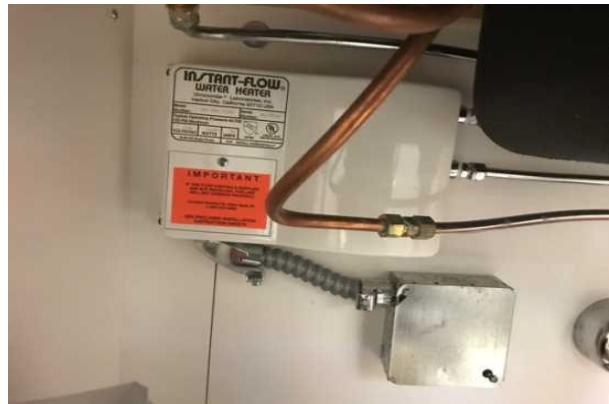
#16

RARELY HOOKED UP INSTANT
HOT WATER 001-005
