FACILITY CONDITION ASSESSMENT

SACRAMENTO CITY UNIFIED SCHOOL DISTRICT
5735 47th Avenue
Sacramento, California 95824

CAPITOL COLLEGIATE ACADEMY
2118 Meadowview Road
Sacramento, California 95832

June 12, 2020

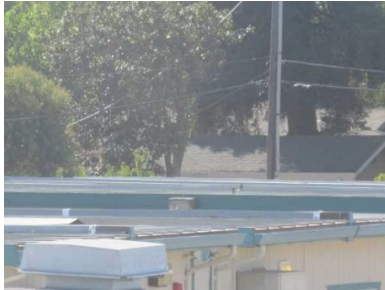
Metal
P08 Portable Clinic Roof

Roof in Poor condition.

Extensive ceiling tile staining and collapse from roof leaks. - AssetCALC ID: 1489953

Uniformat Code: B3011
Recommendation: **Replace in 2019**

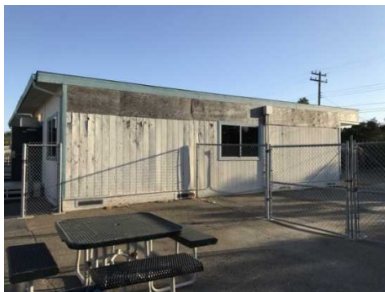
Wood Clapboard Siding, 1-2 Stories
P09 Portable Classrooms Building exterior

Exterior Wall in Poor condition.

Side wall needs replacement (south) - AssetCALC ID: 1490019

Uniformat Code: B2011
Recommendation: **Repair in 2019**

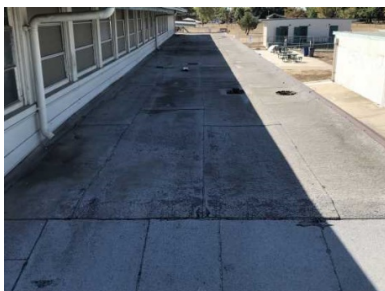
Modified Bituminous
006 Multipurpose Kitchen Roof

Roof in Poor condition.

No leaks reported, but heavy surface wear and cracking. - AssetCALC ID: 1490036

Uniformat Code: B3011
Recommendation: **Replace in 2021**

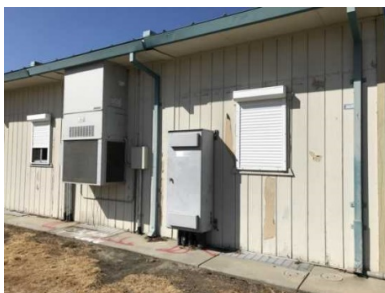
any Painted Surface, 1-2 Stories
P01 Portable Classrooms 11 to 15 Building exterior

Exterior Wall in Poor condition.

Peeling paint. - AssetCALC ID: 1489924

Uniformat Code: B2011
Recommendation: **Prep & Paint in 2020**

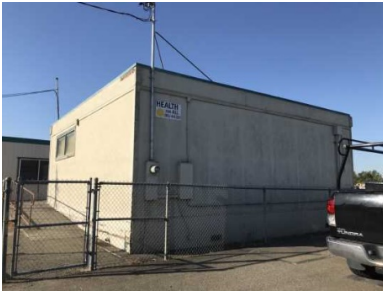
any Painted Surface, 1-2 Stories
P08 Portable Clinic Building exterior

Exterior Wall in Poor condition.

Needs painting and minor repair - AssetCALC ID: 1490114

Uniformat Code: B2011
Recommendation: **Prep & Paint in 2020**

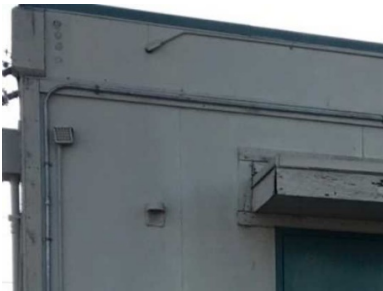
Exterior Flood (any type w/ LED Replacement),
100 W
P08 Portable Clinic Building exterior

Light Fixture in Poor condition.

Inoperable - AssetCALC ID: 1489876

Uniformat Code: D5022
Recommendation: **Replace in 2019**

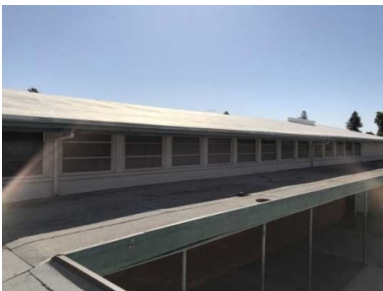
Aluminum Double-Glazed 12 SF, 1-2 Stories
006 Multipurpose Building exterior

Window in Poor condition.

Windows do not close - AssetCALC ID: 1489963

Uniformat Code: B2021
Recommendation: **Replace in 2019**

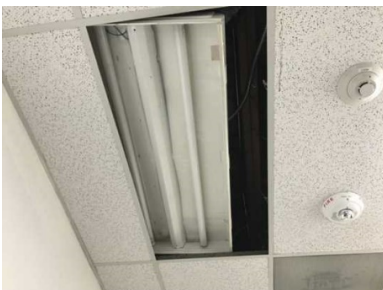
Interior, Medium Density & Standard Fixtures
P08 Portable Clinic Throughout building

Lighting System in Poor condition.

Disturbed - AssetCALC ID: 1489945

Uniformat Code: D5029
Recommendation: **Replace in 2019**

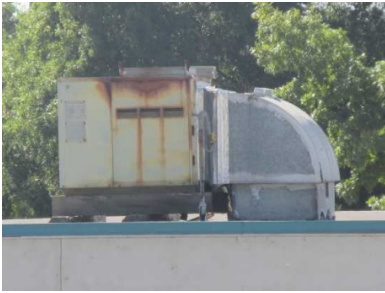
5 TON
P08 Portable Clinic Roof

**Packaged Unit (RTU) in Poor condition.**

Unit is rusted and appears inoperable - AssetCALC ID: 1490005

Uniformat Code: D3052
Recommendation: **Replace in 2019**

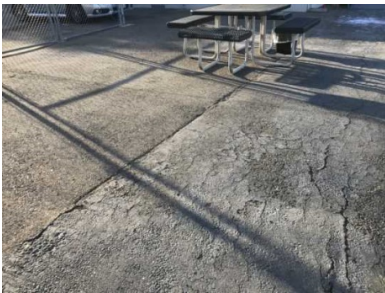
Sidewalk, Asphalt
Site

**Pedestrian Pavement in Poor condition.**

Extensive cracking and surface deterioration - AssetCALC ID: 1490040

Uniformat Code: G2031
Recommendation: **Replace in 2020**

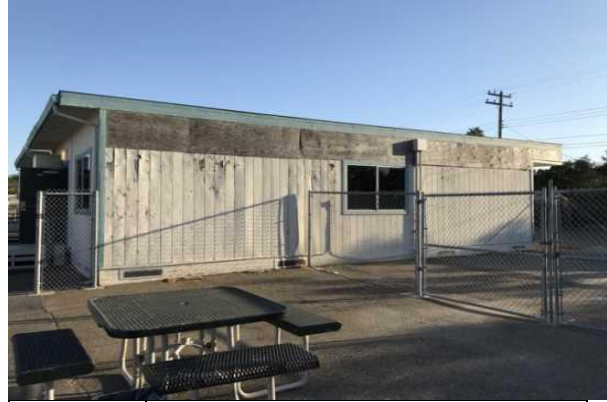
#14

Portable Classrooms (P09): Systems Summary		
HVAC	Wall-mounted heat pump	Fair
Fire Suppression	Fire extinguishers	Good
Electrical	Source & Distribution: Fed from main service, with copper wiring Interior Lighting: T-8 Emergency: None	Fair
Fire Alarm	Smoke detectors, alarms, strobes, back-up emergency lights	Fair
Equipment/Special	None	--
Accessibility	Presently it does not appear an accessibility study is needed for this property.	
Key Issues and Findings	Wood siding on right side is damaged and must be replaced.

DAMAGED WALL, P09
