FACILITY CONDITION ASSESSMENT

EDWARD KELLY PRESCHOOL
3340 Bradshaw Road
Sacramento, California 95827

June 9, 2020

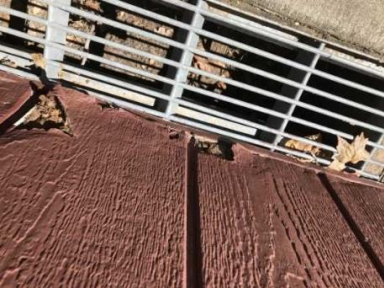
Exterior Wall in Poor condition.

Wood Clapboard Siding, 1-2 Stories
P06 Head Start Building exterior

Siding on east façade has rot at the bottom. Door trim at West restroom doors has rot. - AssetCALC ID: 1412767

Uniformat Code: B2011
Recommendation: **Repair in 2019**

Cost Estimate: \$4,400

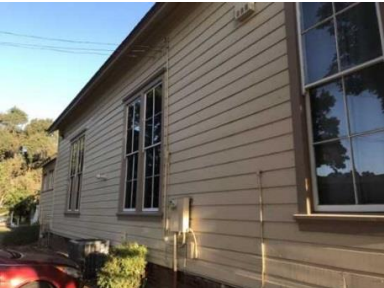
Exterior Wall in Poor condition.

Wood Clapboard Siding, 1-2 Stories
Preschool Building Exterior

Wood clapboard siding is starting to bow and pull away from building. - AssetCALC ID: 1466018

Uniformat Code: B2011
Recommendation: **Replace in 2020**

Cost Estimate: \$216,000

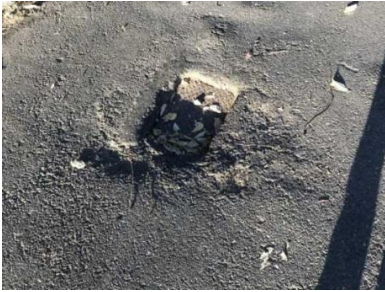
Parking Lots in Poor condition.

Asphalt Pavement
Site Site

Two major potholes of failing asphalt - AssetCALC ID: 1466003

Uniformat Code: G2022
Recommendation: **Cut & Patch in 2019**

Cost Estimate: \$1,900

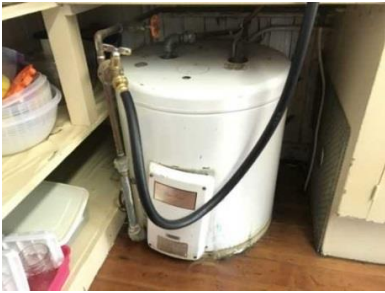
Water Heater in Poor condition.

16 - 29 GAL
Preschool Kitchen

The unit is well past the manufactures expected useful life should be replaced with a more efficient unit. - AssetCALC ID: 1466021

Uniformat Code: D2023
Recommendation: **Replace in 2019**

Cost Estimate: \$900

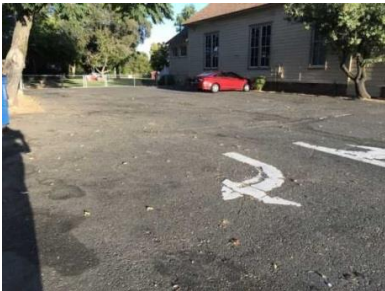
Parking Lots in Poor condition.

Asphalt Pavement
Site Site

Significant cracking and potholes. - AssetCALC ID: 1466005

Uniformat Code: G2022
Recommendation: **Mill & Overlay in 2020**

Cost Estimate: \$50,400

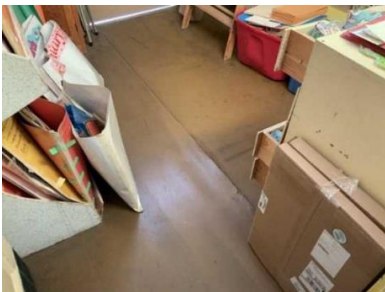
Interior Floor Finish in Poor condition.

Plywood
Preschool Throughout building

Floor is cracked and sagging - AssetCALC ID: 1421236

Uniformat Code: C3024
Recommendation: **Replace in 2021**

Cost Estimate: \$1,100
