FACILITY CONDITION ASSESSMENT

SACRAMENTO CITY UNIFIED SCHOOL DISTRICT

ALICE BIRNEY PUBLIC WALDORF

June 10, 2020

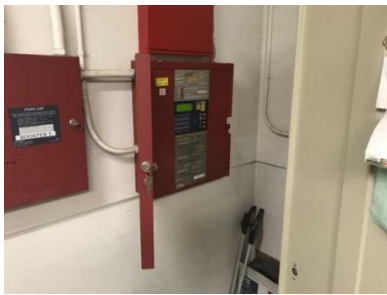
Addressable
001 Office and Kindergarten Boiler-B001

Fire Alarm Control Panel in Poor condition.

Replace fire life safety equipment based on excessive age. - AssetCALC ID: 1454197

Uniformat Code: D5037
Recommendation: **Replace in 2019**

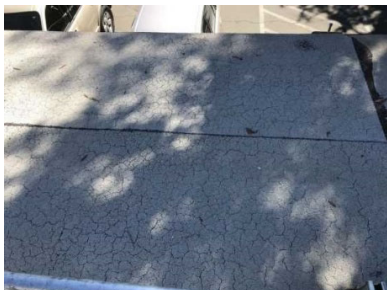
Modified Bituminous
002 Multipurpose Roof

Roof in Poor condition.

Surface deterioration and cracking - AssetCALC ID: 1448236

Uniformat Code: B3011
Recommendation: **Replace in 2021**

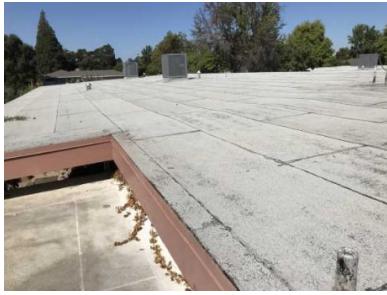
Modified Bituminous
001 Office and Kindergarten Roof

Roof in Poor condition.

Heavy surface deterioration . Quantity includes associated covered walkway extending north to next building.
- AssetCALC ID: 1448484

Uniformat Code: B3011
Recommendation: **Replace in 2021**

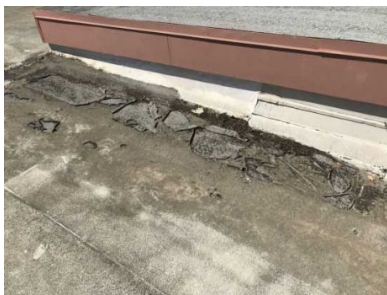
Modified Bituminous
003 Classrooms 3 to 7 Roof

Roof in Poor condition.

Excessive surface wear. Quantity includes associated covered walkway extending north to next building and noted damaged to underside decking from apparent prior or current roof leak at covered walkway. Replace small area of deteriorated roof deck plank. - AssetCALC ID: 1448462

Uniformat Code: B3011
Recommendation: **Replace in 2021**

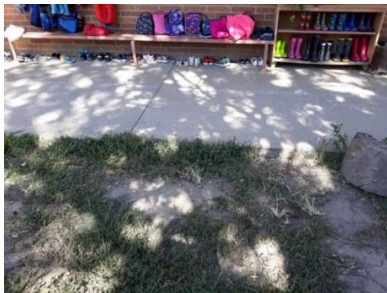
Sidewalk, Concrete Sections/Small Areas
003 Classrooms 3 to 7 Bldg 03, rooms 4-5

Pedestrian Pavement in Poor condition.

Concrete tilts toward building and rainwater collects on sidewalk and at building wall and doorway. Replace concrete with properly sloped concrete. - AssetCALC ID: 1448339

Uniformat Code: G2031
Recommendation: **Replace in 2020**

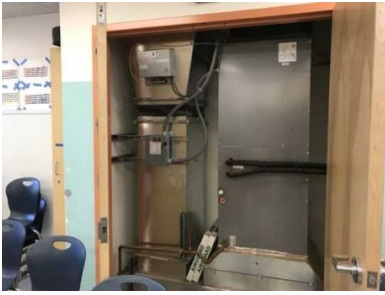
Mechanical/HVAC, General
P06 Portable Classroom 19 Throughout
building

The moisture issue at Building P06 may be from insufficient ventilation. The classroom has an interior fan coil unit and two gravity vents on the roof, but no outside air intake was observed. Costs are included in the cost tables for a mechanical review of the building, including amounts to remedy the problem.

Recommended Follow-up Study: Mechanical/HVAC, General

Excessive moisture and humidity, Condensation and moisture collects on stringed instruments. There appears to be no fresh air intake in portable classroom. The roof has two gravity vents but apparently no fresh air. Proposed cost includes cost to fix the problem. - AssetCALC ID: 1448227

Uniformat Code: P000X
Recommendation: **Design in 2019**

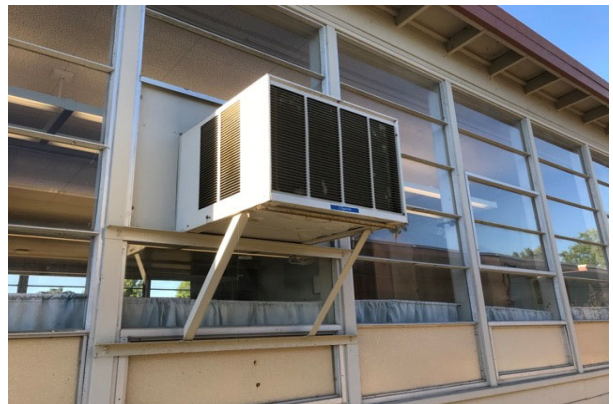
#28 AIR CONDITIONER, WINDOW/THRU-WALL, 1.5 TO 2 TON, REPLACE

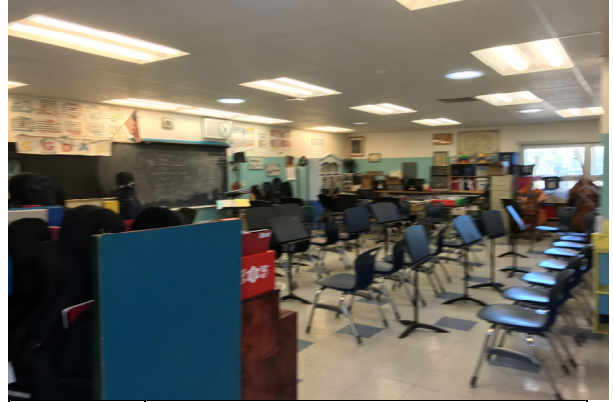
The portable buildings were overall in fair condition, including interior finishes, roofs and windows. Building P06, the strings classroom, experiences excessive humidity, and moisture condenses on the stringed musical instruments. The situation may be due to insufficient ventilation, which is discussed in the next section of this discussion.

#38 STRINGS CLASSROOM, BUILDING P06
