FACILITY CONDITION ASSESSMENT

SACRAMENTO CITY UNIFIED SCHOOL DISTRICT
5735 47th Avenue
Sacramento, California 95824

AMERICAN LEGION
3801 Broadway
Sacramento, California 95817

June 17, 2020

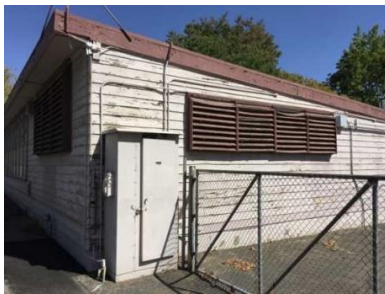
Exterior Wall in Poor condition.

Wood Clapboard Siding, 1-2 Stories
00C V Wing Building Exterior

Exterior wall siding is dry rotting - AssetCALC ID: 1446194

Uniformat Code: B2011
Recommendation: **Replace in 2020**

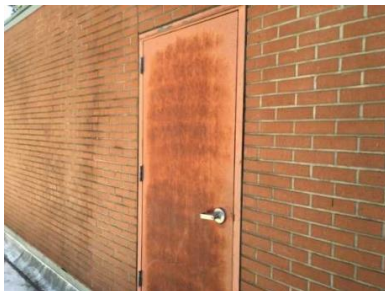
Exterior Door in Poor condition.

Steel
00A/00E Main Building Roof

Roof doors are significantly rusted - AssetCALC ID: 1443057

Uniformat Code: B2032
Recommendation: **Replace in 2021**

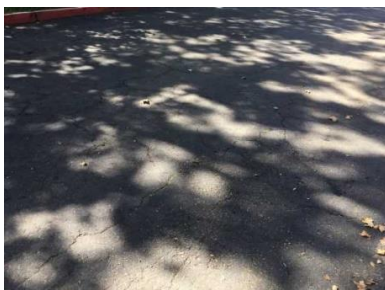
Parking Lots in Poor condition.

Asphalt Pavement
Site South parking lot

Asphalt pavement in the south parking lot is worn and has significant alligator cracking - AssetCALC ID: 1447256

Uniformat Code: G2022
Recommendation: **Mill & Overlay in 2020**

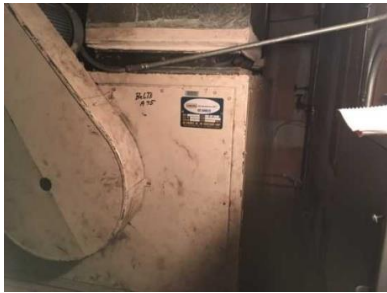
Air Handler (AHU) in Poor condition.

9100 CFM
00B Auditorium Attic

Air handler does not function well and evidence of leaks observed - AssetCALC ID: 1446222

Uniformat Code: D3041
Recommendation: **Replace in 2020**

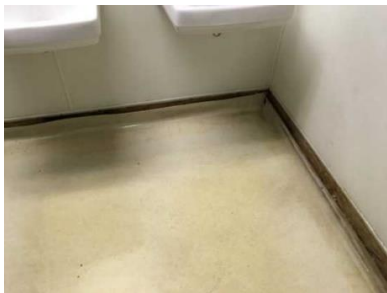
Interior Floor Finish in Poor condition.

Vinyl Sheet
P02 Restrooms

Flooring is peeling off - AssetCALC ID: 1446183

Uniformat Code: C3024
Recommendation: **Replace in 2019**

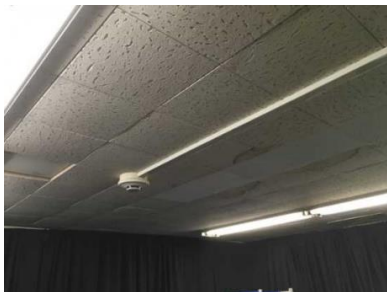
Interior Ceiling Finish in Poor condition.

Hard Tile Ceiling w/ ACT
00B Auditorium C011

Loose and damaged tiles - AssetCALC ID: 1446223

Uniformat Code: C3032
Recommendation: **Replace in 2020**

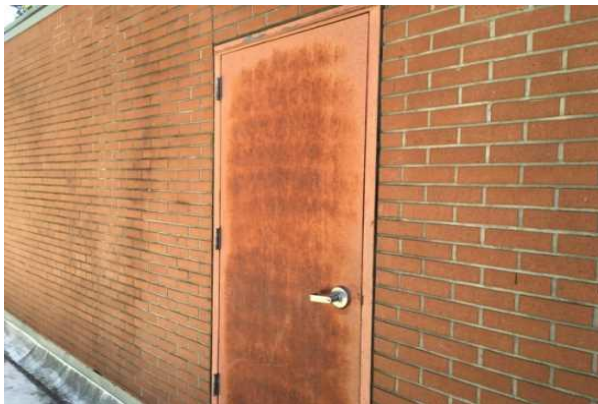
#27

RUSTED STEEL ROOF DOORS

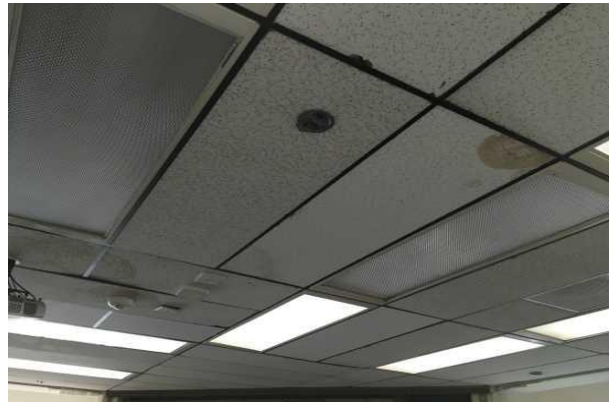
#34

EVIDENCE OF ROOF LEAKS

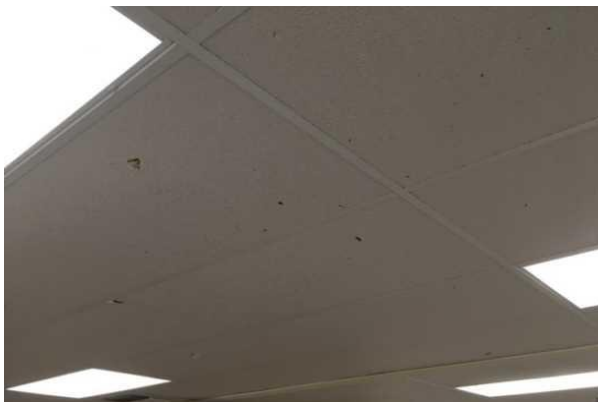
#35

HOLES IN ACT

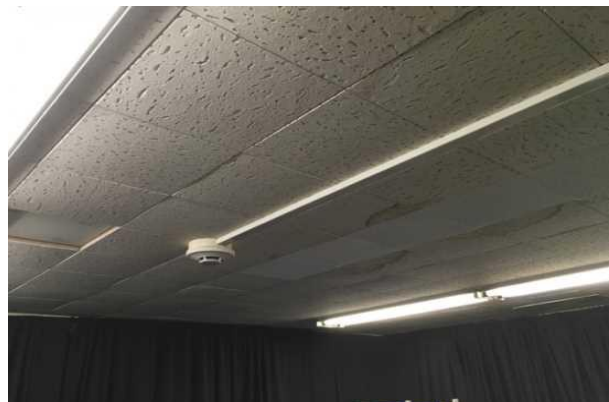
#36

DAMAGED AND LOOSE HARD
TILE CEILING

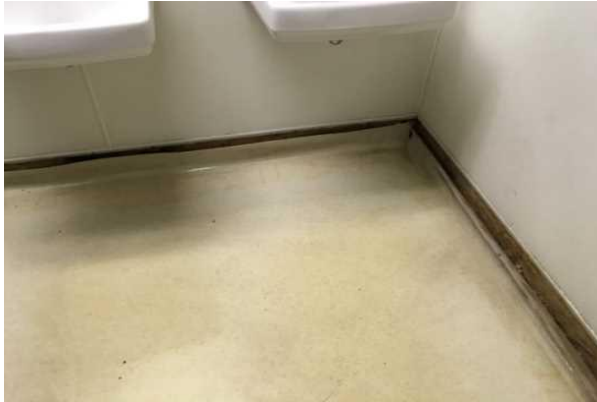
#37

PEELING VINYL SHEETING
FLOORING

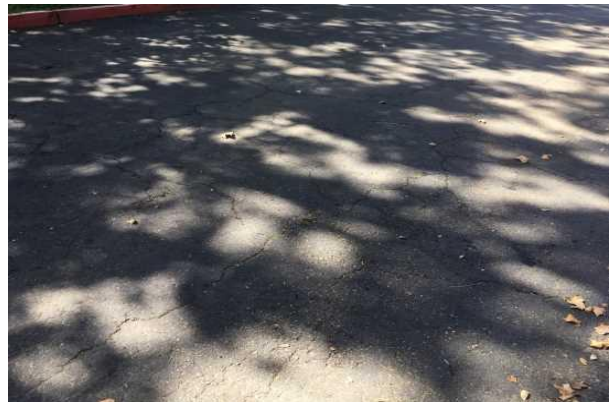
#66

ASPHALT PAVEMENT
ALLIGATOR CRACKING

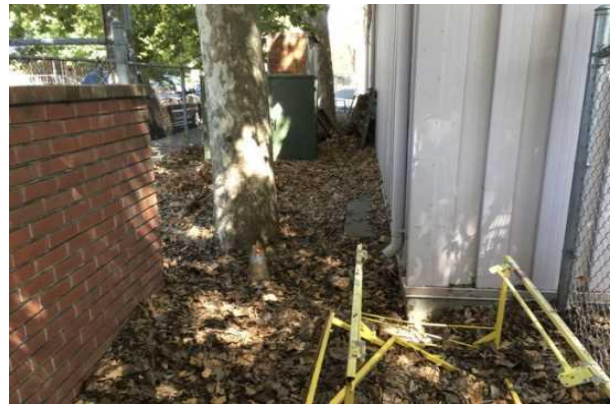
#72

EXCESS DEBRIS AND TRASH ON
SITE
