FACILITY CONDITION ASSESSMENT

Sacramento City Unified School District
5735 47th Avenue
Sacramento, California 95824

G.W. CARVER SCHOOL OF ARTS AND SCIENCE
10101 Systems Parkway
Sacramento, California 95827

June 15, 2020

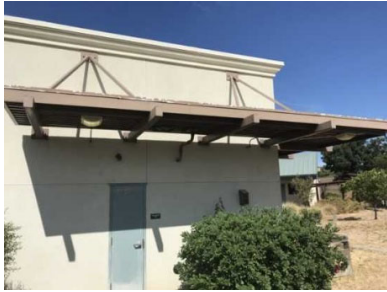
Metal per SF
Classrooms 500s (E) 500s

Awning in Poor condition.

Paint is peeling off metal canopies. Canopies should be repainted to prevent weather deterioration. - AssetCALC ID: 1348820

Uniformat Code: B3019
Recommendation: **Refinish in 2020**

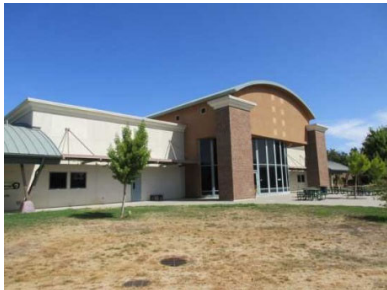
Metal per SF
Library and Classrooms 800s (F) Building exterior

Awning in Poor condition.

Paint is peeling off metal canopies. Canopies should be repainted to prevent weather deterioration. - AssetCALC ID: 1370141

Uniformat Code: B3019
Recommendation: **Refinish in 2020**

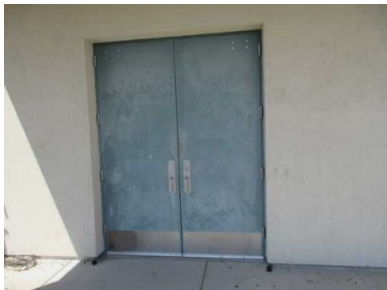
Steel
Admin/Gym (A) Building exterior

Exterior Door in Poor condition.

Paint is faded and coming off to touch. Doors should be refinished to extend/maintain life. - AssetCALC ID: 1370304

Uniformat Code: B2032
Recommendation: **Refinish in 2019**

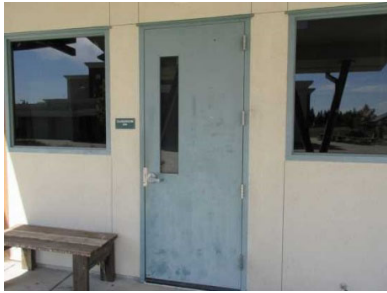
Steel
Classrooms 200s (B) Throughout

Exterior Door in Poor condition.

Paint is fading and in need of refinishing. - AssetCALC ID: 1355029

Uniformat Code: B2032
Recommendation: **Refinish in 2019**

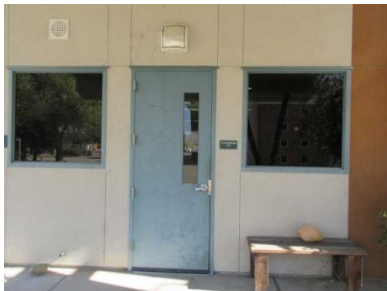
Steel
Classrooms 300s (C) Throughout

Exterior Door in Poor condition.

Paint is fading and in need of refinishing. - AssetCALC ID: 1355884

Uniformat Code: B2032
Recommendation: **Refinish in 2019**

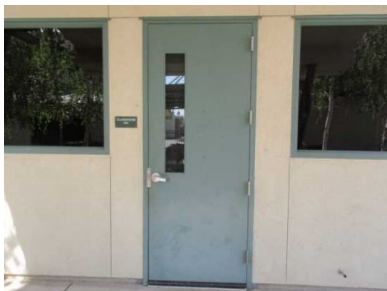
Steel
Classrooms 400s (D) Throughout

Exterior Door in Poor condition.

Paint is fading and in need of refinishing. - AssetCALC ID: 1355895

Uniformat Code: B2032
Recommendation: **Refinish in 2019**

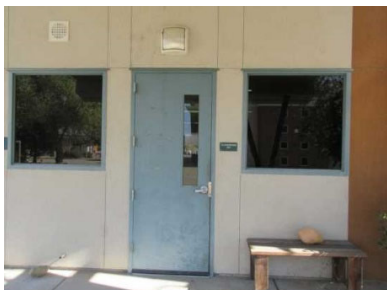
Steel
Classrooms 500s (E) Throughout

Exterior Door in Poor condition.

Paint is fading and in need of refinishing. - AssetCALC ID: 1355906

Uniformat Code: B2032
Recommendation: **Refinish in 2019**
