# FACILITY CONDITION ASSESSMENT

SACRAMENTO CITY UNIFIED SCHOOL DISTRICT  
5735 47<sup>th</sup> Avenue  
Sacramento, California 95824

HIRAM JOHNSON HIGH SCHOOL  
6879 14th Avenue  
Sacramento, California 95820

June 17, 2020

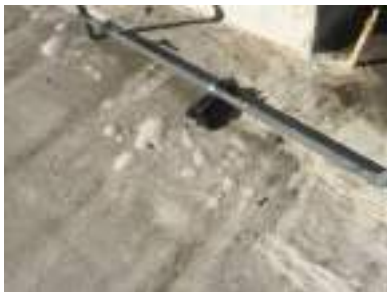
Single-Ply TPO/PVC Membrane  
001 A Wing, B Wing 001-Roof

**Roof in Poor condition.**

The roof is overall fair condition, with spots of roof membrane tears and blisters. - AssetCALC ID: 1496105

Uniformat Code: B3011  
Recommendation: **Replace in 2021**

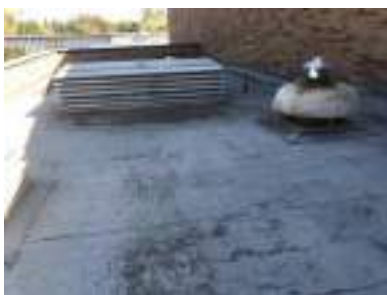
Modified Bituminous  
16B Music Building 16B-Roof

**Roof in Poor condition.**

The roof membrane is starting to wear through, evidence of leaks on the interior - AssetCALC ID: 1493562

Uniformat Code: B3011  
Recommendation: **Replace in 2020**

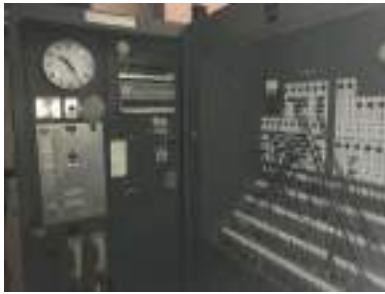
Average or Low Density/Complexity  
16A Auditorium 16A-Throughout building

### Electrical Wiring & Switches in Poor condition.

Lighting is antiquated and may not be up to code. - AssetCALC ID: 1497923

Uniformat Code: D5019  
Recommendation: **Replace in 2020**

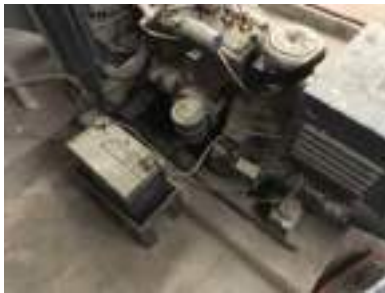
10 kW  
16A Auditorium 16A-B001-Boiler room

### Generator in Poor condition.

Defunct, abandoned in place. - AssetCALC ID: 1493482

Uniformat Code: D5092  
Recommendation: **Replace in 2019**

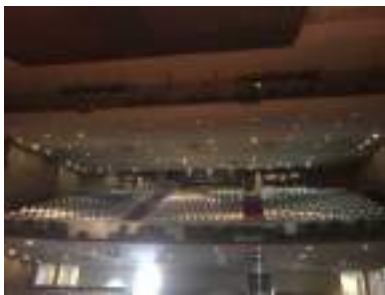
Interior, Medium Density & Standard Fixtures  
16A Auditorium 16A-Throughout building

### Lighting System in Poor condition.

Lighting is inadequate and antiquated. - AssetCALC ID: 1497933

Uniformat Code: D5029  
Recommendation: **Replace in 2020**

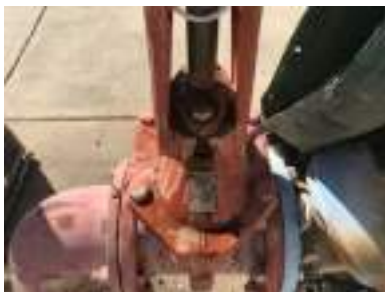
6 INCH  
Site

### Backflow Preventer in Poor condition.

Leak in valve body. - AssetCALC ID: 1493698

Uniformat Code: D2021  
Recommendation: **Replace in 2020**

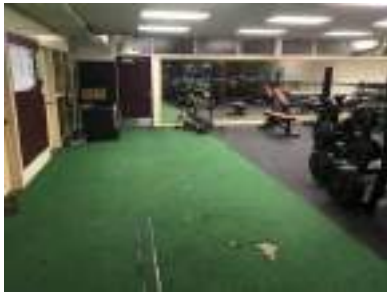
Vinyl Sheetting  
011 S Wing W 011-Throughout building

**Interior Floor Finish in Poor condition.**

High traffic and heavy use have worn through material - AssetCALC ID: 1497701

Uniformat Code: C3024  
Recommendation: **Replace in 2020**

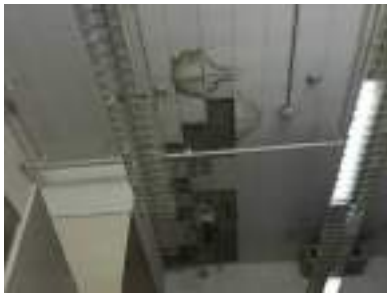
Hard Tile Ceiling w/ ACT  
16A Auditorium 16A-Throughout building

**Interior Ceiling Finish in Poor condition.**

Failed hard tiles due to roof leak - AssetCALC ID: 1497947

Uniformat Code: C3032  
Recommendation: **Replace in 2019**
