FACILITY CONDITION ASSESSMENT

ISADOR COHEN ELEMENTARY SCHOOL
9025 Salmon Falls Drive
Sacramento, California 95826

EMG | A Bureau Veritas Company
10461 Mill Run Circle, Suite 1100
Owings Mills, Maryland 21117
800.733.0660
www.emgcorp.com

June 17, 2020

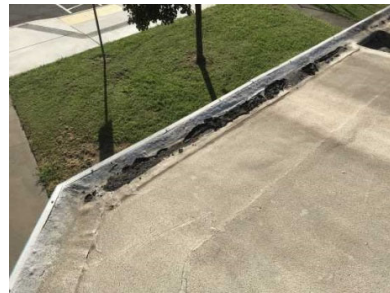
Single-Ply TPO/PVC Membrane
001 Main Building 001-Roof

Roof in Poor condition.

Standing water has caused damage to TPO membrane. - AssetCALC ID: 1459367

Uniformat Code: B3011
Recommendation: **Repair/Replace in 2019**

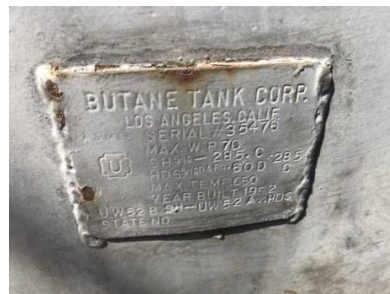
2200 GAL
Site

Water Storage Tank in Poor condition.

Irrigation system is well past EUL. - AssetCALC ID: 1411355

Uniformat Code: D2023
Recommendation: **Replace in 2021**
