FACILITY CONDITION ASSESSMENT

JOHN STILL ELEMENTARY (WEST CAMPUS)
2200 John Still Drive
Sacramento, California 95832

June 10, 2020

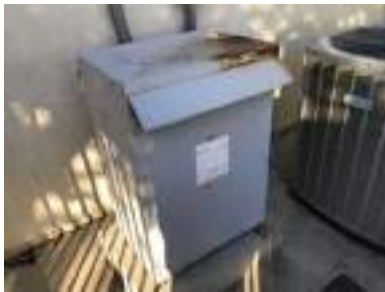
Secondary Transformer in Poor condition.

75 kVA
Building D Building exterior

Rusty cover. - AssetCALC ID: 1475304

Uniformat Code: D5012
Recommendation: **Replace in 2020**

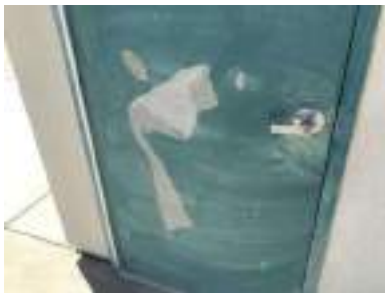
Exterior Door in Poor condition.

Hollow Metal
Restrooms Building Building Exterior

Uniformat Code: B2032
Recommendation: **Refinish in 2020**
