FACILITY CONDITION ASSESSMENT

SACRAMENTO CITY UNIFIED SCHOOL DISTRICT
5735 47th Avenue
Sacramento, California 95824

KIT CARSON INTERNATIONAL ACADEMY
5301 N Street
Sacramento, California 95819

June 9, 2020

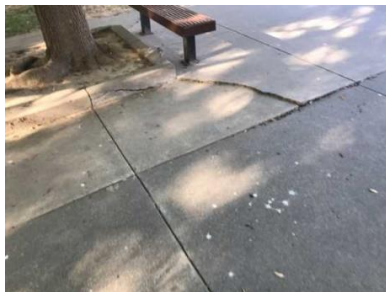
Sidewalk, Concrete Sections/Small Areas
Site Quad

Pedestrian Pavement in Poor condition.

Multiple locations noted with trip hazards in central quad. Repair trip hazards. - AssetCALC ID: 1425809

Uniformat Code: G2031
Recommendation: **Replace in 2019**

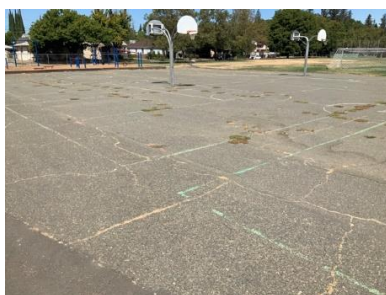
Asphalt
Site

Play Surfaces & Sports Courts in Poor condition.

Surface shows cracking and deterioration. - AssetCALC ID: 1417021

Uniformat Code: G2047
Recommendation: **Seal & Stripe in 2021**

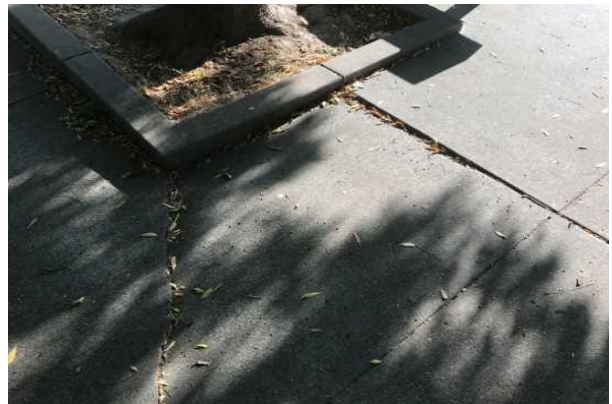
#42	TRIP HAZARDS, CENTRAL QUAD
-----	----------------------------

Lot Size	9.67 acres (estimated)	
Parking Spaces	49 total spaces all in open lots; three of which are accessible	
<i>System</i>	<i>Description</i>	<i>Condition</i>
Pavement/Flatwork	Asphalt parking lots with areas of concrete and concrete sidewalks, curbs, ramps, and stairs	--
Site Development	Property entrance signage, chain link fencing with gates, Playgrounds and sports courts, fencing, and site lights Limited park benches, trash receptacles	--
Landscaping and Topography	Moderate landscaping features Irrigation is present No retaining walls Flat	--
Utilities	Municipal water and sewer Local utility-provided electric and natural gas	--
Site Lighting	Building-mounted: LED, HPS, and metal halide Pole mounted light fixture	--
Ancillary Structures	Pre-fabricated storage sheds	--
Accessibility	Presently it does not appear an accessibility study is needed for the exterior site areas. See Appendix C.	
Key Issues and Findings	Multiple trip hazards noted in central quad.
