FACILITY CONDITION ASSESSMENT

SACRAMENTO CITY UNIFIED SCHOOL DISTRICT

LUTHER BURBANK HIGH SCHOOL

June 16, 2020

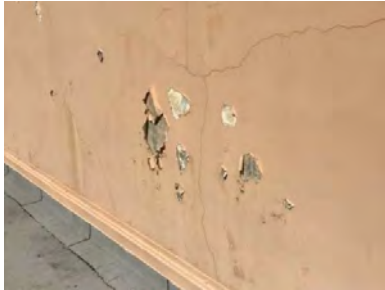
Exterior Wall in Failed condition.

any Painted Surface
014 Gymnasium Building exterior

Paint has started to fail and peel on the exterior walls. - AssetCALC ID: 1468009

Uniformat Code: B2011
Recommendation: **Prep & Paint in 2019**

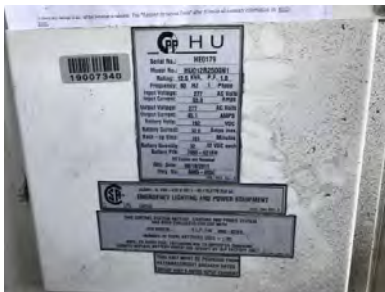
Uninterruptible Power Supply (UPS) in Poor condition.

12.5 kVA
Site

Client reported that the UPS system is failing. - AssetCALC ID: 1468086

Uniformat Code: D5092
Recommendation: **Replace in 2020**

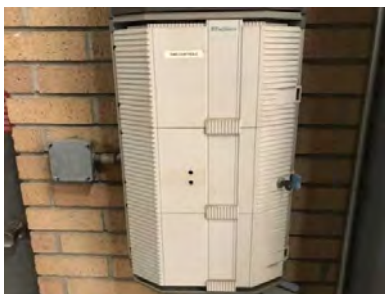
BAS/HVAC Controls in Poor condition.

Extensive/Robust BMS
012 Theater Room M004

EMS system is outdated and failing. - AssetCALC ID: 1467868

Uniformat Code: D3068
Recommendation: **Upgrade in 2021**

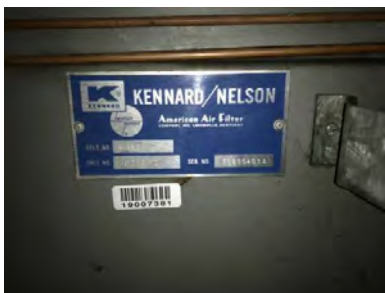
Air Handler (AHU) in Poor condition.

Interior, 25,000 CFM
012 Theater Mechanical room M001

Air handler is nearing the end of its remaining useful life and is recommended for replacement. - AssetCALC ID: 1468592

Uniformat Code: D3041
Recommendation: **Replace in 2021**

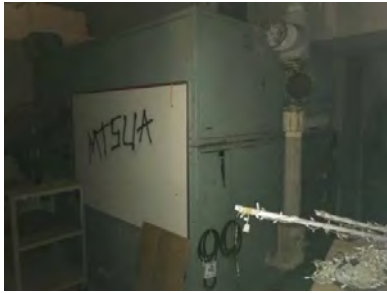
Air Handler (AHU) in Poor condition.

Interior, 25,000 CFM
012 Theater Mechanical room M001

Air handler is nearing the end of its remaining useful life and is recommended for replacement. - AssetCALC ID: 1468637

Uniformat Code: D3041
Recommendation: **Replace in 2021**

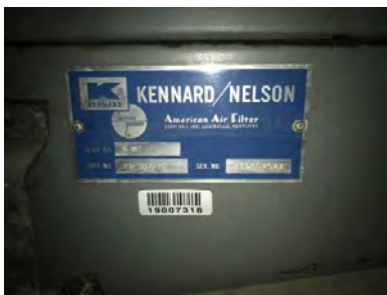
Air Handler (AHU) in Poor condition.

Interior, 25,000 CFM
012 Theater Attic

Air handler is nearing the end of its remaining useful life and is recommended for replacement. - AssetCALC ID: 1468431

Uniformat Code: D3041
Recommendation: **Replace in 2021**

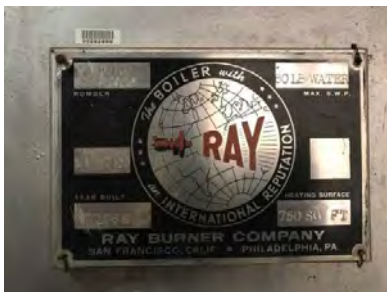
Gas Heater in Poor condition.

Swimming Pool, 750 MBH
014 Gymnasium Pool Storage Tank Room

Boiler is at the end of its remaining useful life. Boiler is also decommissioned but can be used as needed. - AssetCALC ID: 1468171

Uniformat Code: F1041
Recommendation: **Replace in 2020**

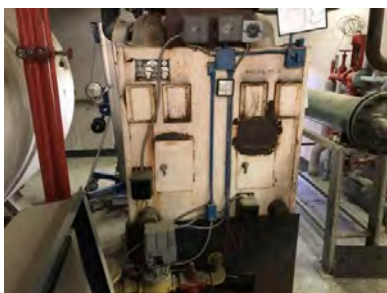
Gas Heater in Poor condition.

Swimming Pool, 840 MBH
014 Gymnasium Pool Storage Tank Room

Boiler is rusted and at the end of its remaining useful life. Boiler is also decommissioned but can be used as needed. - AssetCALC ID: 1468714

Uniformat Code: F1041
Recommendation: **Replace in 2020**

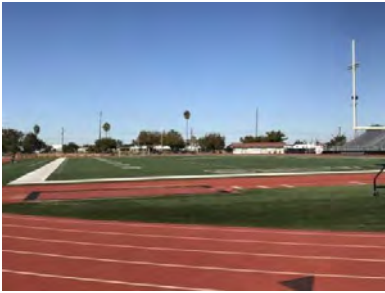
Play Surfaces in Poor condition.

Artificial Turf, 1/2" Pile, 5/16" Pad
Site

Client has reported that the turf is failing and due to replacement. - AssetCALC ID: 1468053

Uniformat Code: G2047
Recommendation: **Replace in 2020**

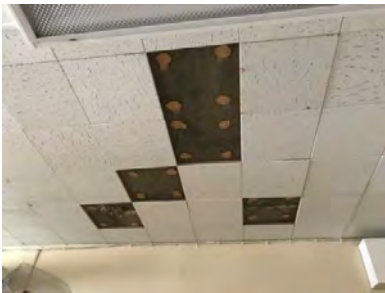
Interior Ceiling Finish in Poor condition.

Hard Tile Ceiling w/ ACT
001W Administration, Classrooms 201-211
Throughout Building

Hard tile ACT is missing in numerous locations throughout building. - AssetCALC ID: 1478698

Uniformat Code: C3032
Recommendation: **Replace in 2020**
