# FACILITY CONDITION ASSESSMENT

SACRAMENTO CITY UNIFIED SCHOOL DISTRICT  
5735 47<sup>th</sup> Avenue  
Sacramento, California 95824

## WOODBINE ELEMENTARY SCHOOL

June 17, 2020

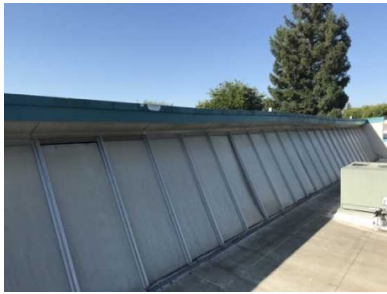
### Roof Skylight in Poor condition.

per SF of glazing  
003 Classrooms 1-5, Admin/Principal  
Clerestory

The single pane fiberglass panels are coming loose and provide no insulative barrier to the outside. - AssetCALC ID: 1440788

Uniformat Code: B3021  
Recommendation: **Replace in 2019**

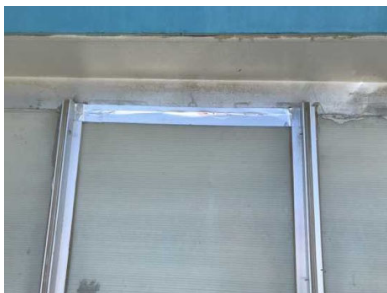
### Roof Skylight in Poor condition.

per SF of glazing  
002 Classroom 7, Toilets Building Exterior-clerestory

Clerestory are currently single ply /panel fiberglass, that comes loose and is not properly secured. - AssetCALC ID: 1440749

Uniformat Code: B3021  
Recommendation: **Replace in 2019**
