Check In

Property inspected by Azim Rahmonov

Reference: 3628

Flat 123
Sample street
London
E14 9ET

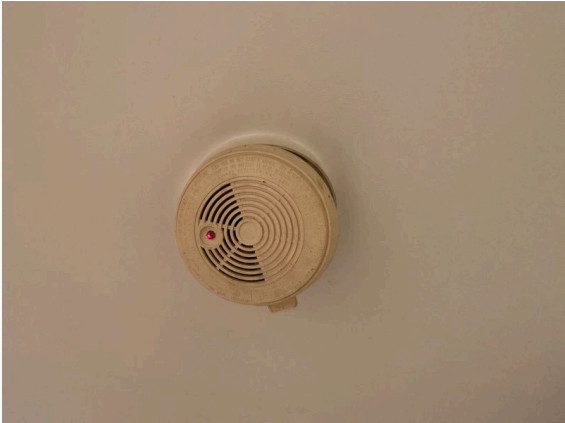
Ref # 2.1

2. ALARMS		
Item	Location	Test Result
2.1 Smoke Alarm	Entrance hall	Loose/ hanging Tested and alarm heard
2.2 Heat Alarm	Kitchen	Tested and alarm heard
2.3 Carbon Monoxide Alarm	Kitchen	Tested and alarm heard

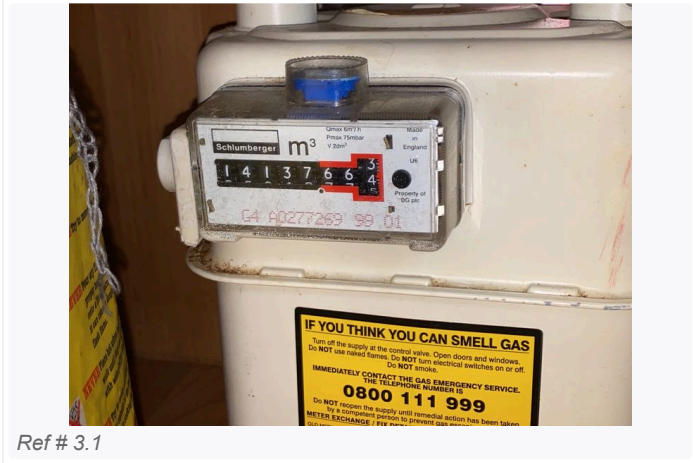
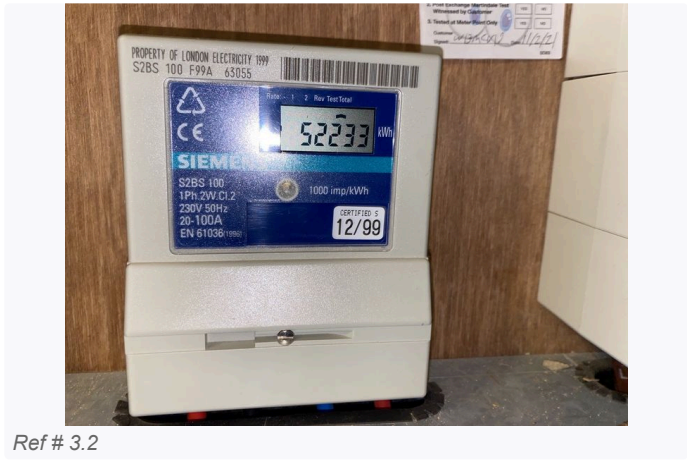
3. METERS		
Item	Serial Number	Reading
3.1 Gas Meter	Location: Kitchen units Serial number: G4A02772699901	14137.664
3.2 Electric Meter	Location: Communal cupboard (ground floor) Serial number: S2BS100F99A63055	52233

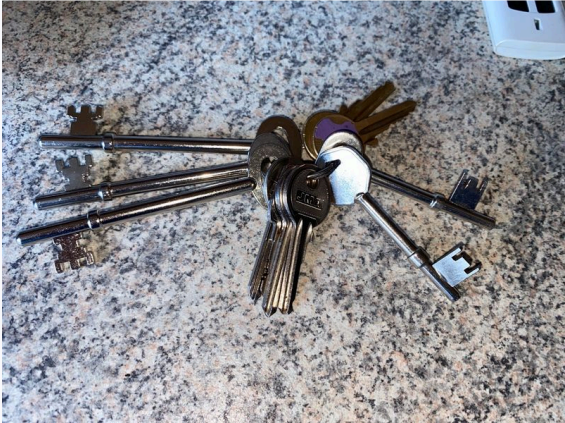
<div>Ref # 4.1</div></div>

4. KEYS	
Item	Description
4.1 Check In keys list	<div>5 x Yale keys</div> <div>1 x Letterbox key</div> <div>2 x Chubb keys</div> <div>3 x FB2/FB1 keys</div> <div>Returned to Concierge</div>
<div>

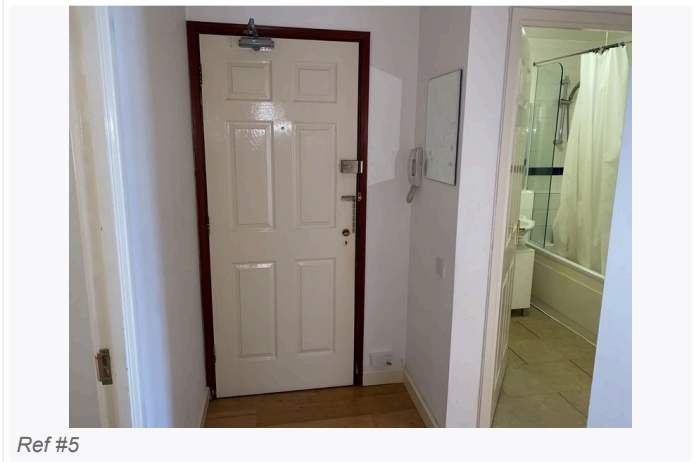
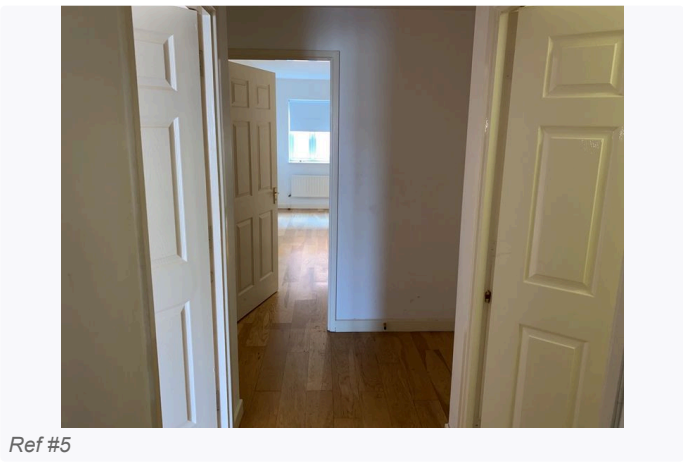
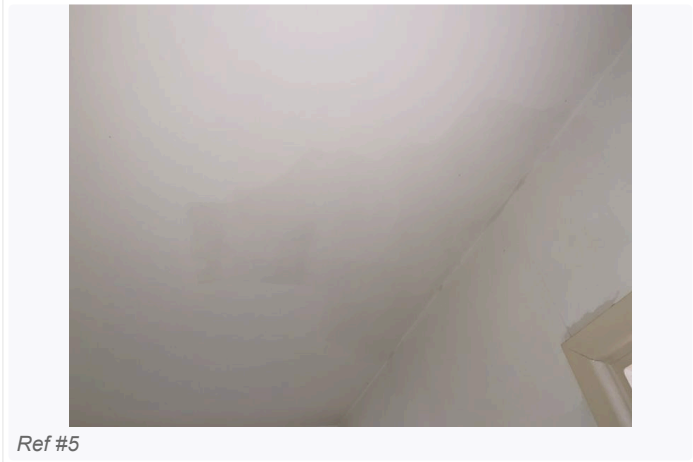
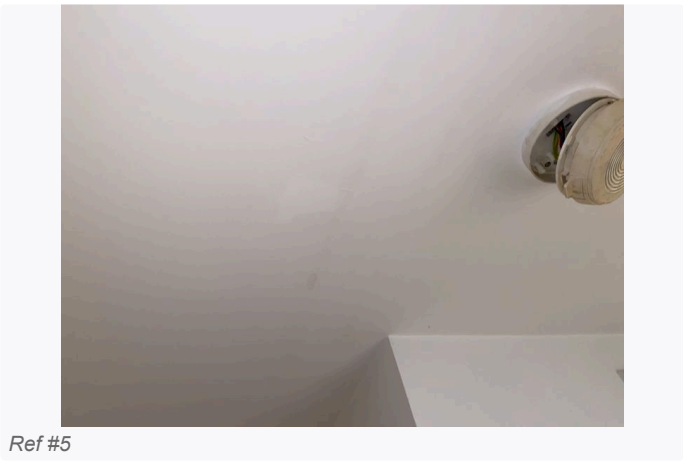
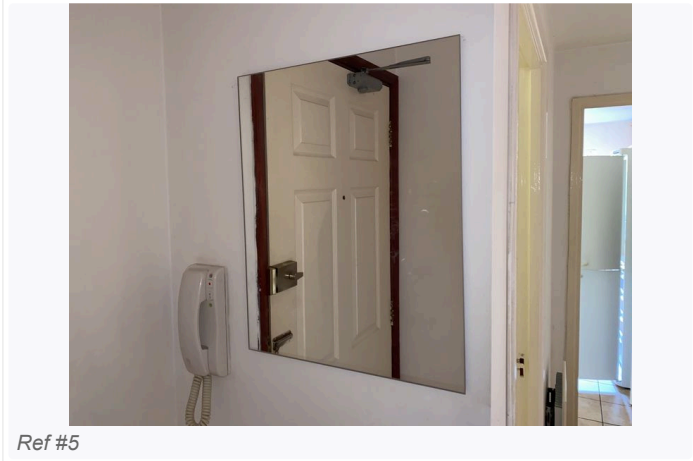
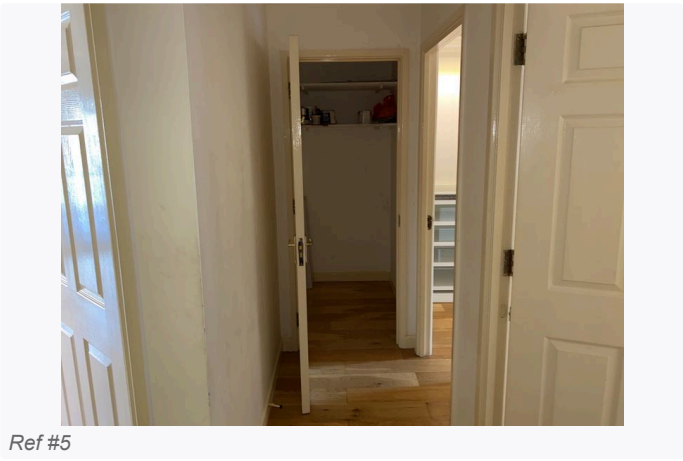
5. HALLWAY		
Item	Description	Condition
5.1 Front Door & Surround Exterior	As per supporting document	Door frame is showing small scratches and small chips to edges Cobweb at high level to exterior door frame

5.2 Ceiling	As per supporting document	Settlement crack to right hand side of reception Light cobwebs to edge of ceiling Over painted chip to edge of spotlight

5.3 Lighting	As per supporting document	Not working
5.4 Walls	As per supporting document	Nail hole at high level right hand side of entrance Light settlement crack above bedroom Light cobwebs at high level in places Settlement crack at high level to right hand side of kitchen 2 x filler holes between reception and kitchen

5.5 Skirting Boards / Woodwork	As per supporting document	Cable clipped to top edges of skirting board to left hand side of entrance and either side of kitchen Crack to top edges to right hand side of bedroom Light dust to top with some debris Further cracks to top edge left hand side of reception Both doorstops are loose

5.6 Flooring	As per supporting document	Light debris type dust to floor White and black smudge mark to left hand side of reception
5.7 Heating	As per supporting document	Light rub mark to top and light dust to front at low level

5.8 Switches / Sockets	As per supporting document	Light grubby mark and light dust to light switch
5.9 Entryphone	As per supporting document	Paint speckles to top and dust to top

5.10 Mirror	As per supporting document	Not clean
5.11 Built-In Cupboard	As per supporting document	Fire chain detached to door 2 x noticeable dents at mid level hinged edge to interior door Dust to door panels Miscellaneous painting tin and few items seen into interior Dust to switches

5.12 Smoke alarm	As per supporting document	Hanging/ loose

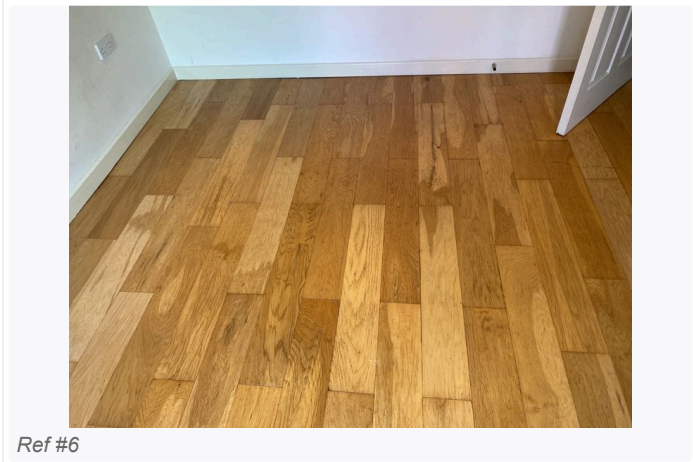
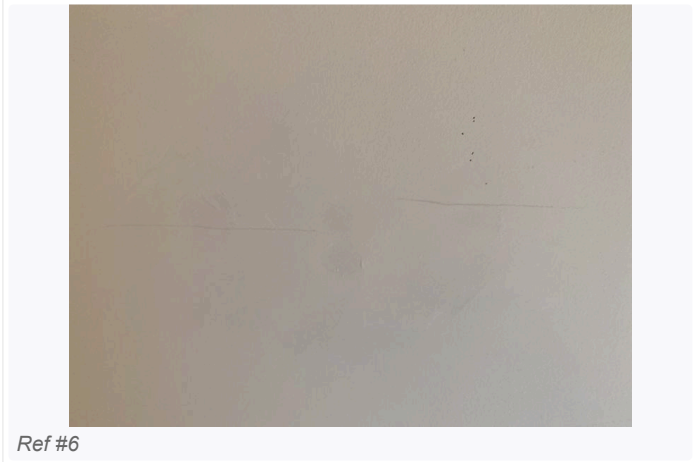
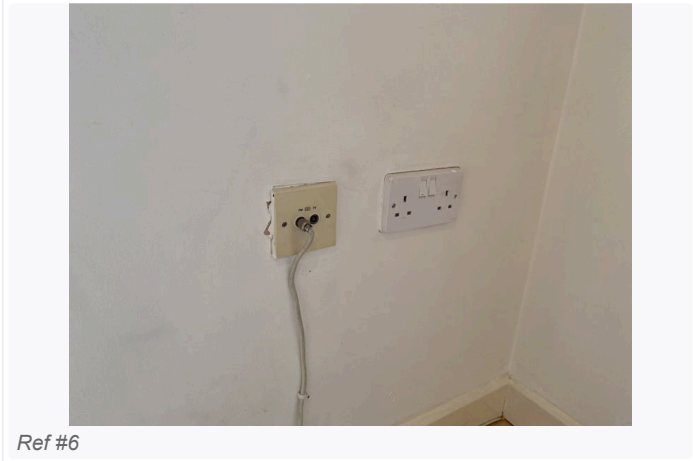
6. RECEPTION ROOM		
Item	Description	Condition
6.1 Door	As per supporting document	<p>Small black mark at mid level to exterior door</p> <p>Light beige mark at high level above handle to exterior door</p> <p>Further scuffs seen mid to low level to exterior</p> <p>Touch-up mark and 4 x filler holes at high level above handle to interior</p> <p>Light dust to door panels</p>

6.2 Door Frame	As per supporting document	<p>1 x small angle chip and 1 x noticeable angle chip at mid level left hand side interior</p> <p>Further light scuffs seen in places to door and frame</p> <p>Light chips to edges</p> <p>Over painted detached fire chain seen to hinge edge</p> <p>Touch-up mark and 2 x over painted filler holes at high level left hand side of interior</p> <p>Over painted angle dents at high level to interior</p> <p>Dust to top edge of door frame</p>

6.3 Ceiling	As per supporting document	<p>Dark finger marks to right hand side light fitting</p> <p>Cobweb seen to edges more noticeable to right hand side edge of wall</p> <p>Odd cream mark above entrance</p> <p>Further light patchy paintwork to ceiling throughout</p>

6.4 Lighting	As per supporting document	3 x spotlights are not working
6.5 Walls	As per supporting document	<p>Walls are appears to be repainted during the tenancy</p> <p>Patchy paintworks to all walls</p> <p>2 x noticeable over painted filler holes to left hand side wall eye level when facing the windows</p> <p>Cable protruding and filler hole seen at low level left hand side of balcony door</p> <p>Cable hole, cable protruding and cable clip at low level right hand side of balcony door</p> <p>1 x nail hole at high level opposite of entrance</p> <p>4 x plastic clips at low level left hand side of entrance</p> <p>Few spot marks at mid level right hand side forward from entrance</p> <p>Over painted poorly finished filler hole above heating at eye level right hand side wall when facing the windows</p> <p>Over painted filler hole at high level right hand side of balcony door</p> <p>6 x nails and pencil marks</p> <p>1 x nail hole above balcony door is not seen</p> <p>Scuff, rub marks shaded and usage marks still remains more heavier to right hand side of entrance wall and opposite entrance</p>

6.6 Skirting Boards / Woodwork	As per supporting document	<p>Light cracks to top edges and to joins</p> <p>Cable clipped to left hand side of window and left hand side wall when facing the windows</p> <p>Cut-out section/noticeable gap between floor and skirting board to left hand side balcony door</p> <p>Cable protruding with cable hole to bottom edge right hand side of balcony door</p> <p>Light dust to top in places</p>

6.7 Flooring	As per supporting document	Light dust/debris to floor White marks to left hand side of balcony door Left hand side forward from balcony door Sticker residue to left hand side of heating Floor requires further cleaning Light paint speckles seen near right hand side edge of floor
6.8 Heating	As per supporting document	Black scuffs to front with scratches Noticeable paint chipping to front
6.9 Switches / Sockets	As per supporting document	Paint marked to sockets Light dust to top Grubby mark to light switch
6.10 Windows/Balcony Door	As per supporting document	Not clean Further cleaning required Handles are loose Grey shaded mark and cracking to edge of frame
6.11 Thermostat	As per supporting document	Noticeable dust top top
6.12 Additional Items at Check-In	Wall mounted white metal curtain rail with matching finials	No curtain seen

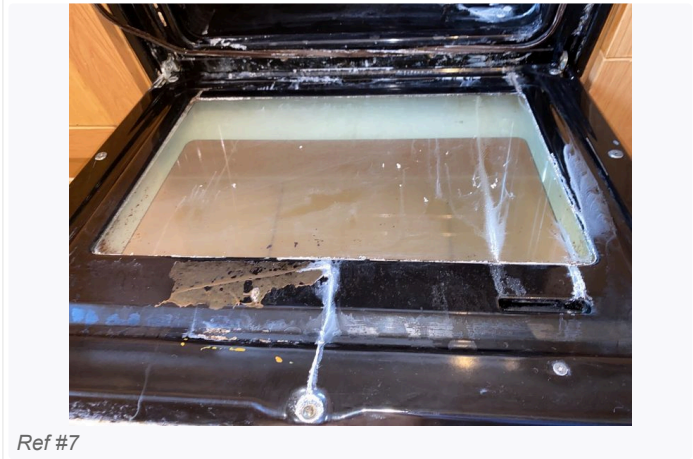
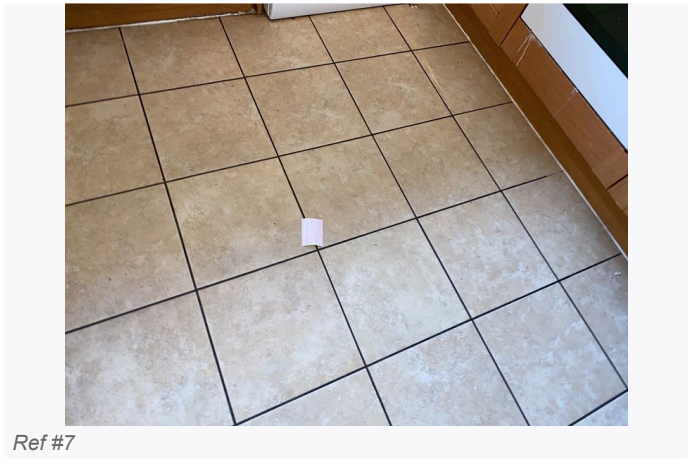
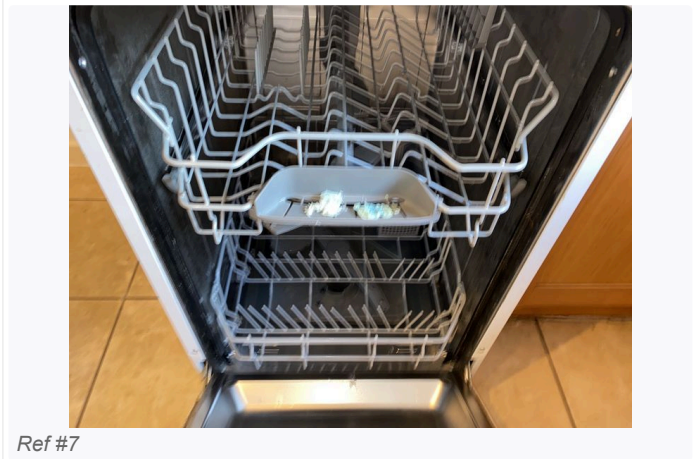
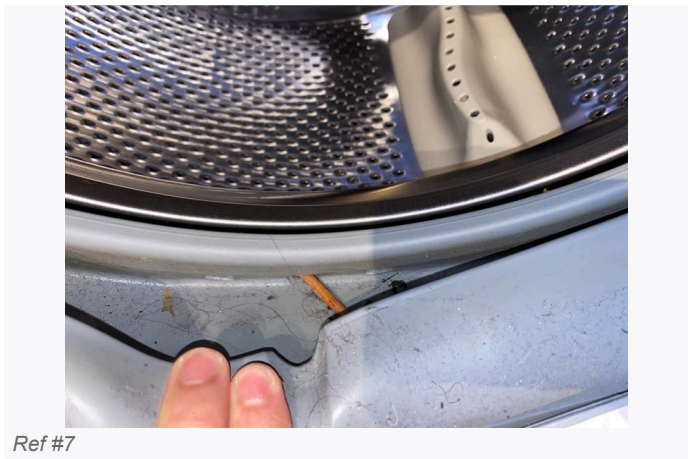
7. KITCHEN		
Item	Description	Condition
7.1 Door	As per supporting document	Fire chain detached Over painted to hinge edge Chip at high level right hand side of exterior Light dust to door panels and grubby mark above handle to exterior door Heavy purple/grey marks above handle to interior door Drip marks at low level to interior door

7.2 Door Frame	As per supporting document	Over painted fire chain removal mark right hand side inner edge of door frame Chips to edges Cable clipped to edge to exterior door frame Crack to joins at high level right hand side Light rub marks seen Noticeable angle chips/scratch to top inner edge of door frame right hand side

7.3 Ceiling	As per supporting document	Filler hole to far left hand side corner Noticeable patchy paintwork to edge of kitchen units Further over painted noticeable defect near light fitting Splash mark to centre and above hob Cobwebs to corners

7.4 Walls	As per supporting document	Part white painted - light splash mark above heating Noticeable over painted repair/filler hole mark at chest level to left hand side corner 2 x noticeable over painted defects at chest level left hand side wall when facing the windows Drip marks at low level to left hand side wall Greasy splash mark at high level right hand side of entrance Part tiled walls - black plastic bracket to right hand side of window

7.5 Skirting Boards / Woodwork	As per supporting document	Light dust to top more noticeable behind dishwasher Over painted screw visible right hand side forward from entrance and light crack to top edges

7.6 Flooring	As per supporting document	Debris and dust to floor Cracking to sealant to edges Floor requires further cleaning Tiles are slightly shaded in places Blue mark in front of heating

7.7 Heating	As per supporting document	Off-white/cream shaded mark at low level to front Light dust to top Paint marks to right hand side valve cap
7.8 Switches / Sockets	As per supporting document	Paint marks to edges Light debris type dust to top Crack to double socket to right hand side hob

7.9 Windows	As per supporting document	Not clean

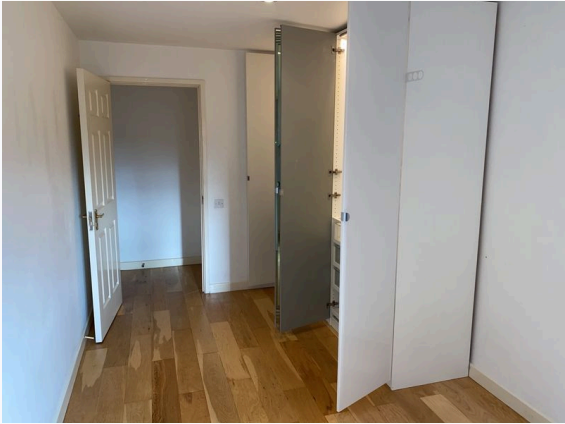
<div>Ref #8</div></div><div>

8. BEDROOM		
Item	Description	Condition
8.1 Door	As per supporting document	Fire chain removed and over painted Paint marks to hinges Angle chip at high level right hand side exterior Black mark and angle wear mid level leading edge to door Dust to door panels Brown grubby mark at eye level to interior door Door would benefit with further light cleaning

8.2 Door Frame	As per supporting document	Over painted fire chain removal marks seen to inner edge of door frame Angle chips to edges Light angle rub marks seen to low level

8.3 Ceiling	As per supporting document	Chip to 1 x step forward from entrance Rub mark and light scuffs above wardrobe Light patchy paintwork to ceiling More noticeable patchy paintwork and grey mark near right hand side wall 2 x pinholes to right hand side window to edge of ceiling 1 x pinhole to left hand side edge of ceiling Light cobwebs to edges in places 2 x pinholes to right hand side from centre to ceiling

8.4 Walls	As per supporting document	Patchy paintworks Noticeable to over painted repair mark/filler holes at high level right hand side wall 3 x pinholes at high level right hand side of window Light stress cracking seen at high level left hand side of window Noticeable grubby finger marks above heating/ below window sill Over painted defects/chip at high level left hand side corner of the window Approximately 8 x pinholes at high level left hand side wall when facing the windows 2 x noticeable over painted paint chips and 1 x paint chip at right hand side wardrobe Further finger marks type shaded usage marks at mid to low level

8.5 Skirting Boards / Woodwork	As per supporting document	Gap between floor and skirting board
8.6 Flooring	As per supporting document	Cleaning smear seen to floor Very minor debris seen to floor Further scratches seen in places with some scuffs White dust around heating pipes

8.7 Heating	As per supporting document	Further paint chips to edges Paint marks to controls Further chips and scratches at low level right hand side
8.8 Switches / Sockets	As per supporting document	Paint marked Light dust to double socket to right hand side wall and left hand side wall

8. BEDROOM (CONT.)		
8.9 Windows	As per supporting document	Not clean Shaded and discolouration to frames Caps to screws are missing to both handles Paint marks to frames Ring marks and spot marks to window sill

8.10 Curtains/Blinds	As per supporting document	Heavily black marks, drip marks and spot mark seen Dust seen to blind Cleaning required
8.11 Built-In Wardrobe	As per supporting document	Exterior doors are not clean Mirrored doors to interior Now grey painted and showing patchy paintworks Over painted defects Paint marks to hinge edges to interior doors Bottom hinge to second from left hand side door Detached/damaged Black line scuffs to interior of first left hand side door Cleaning smear and light dust to interior Light hair debris and dust to interior drawers
<div><div>

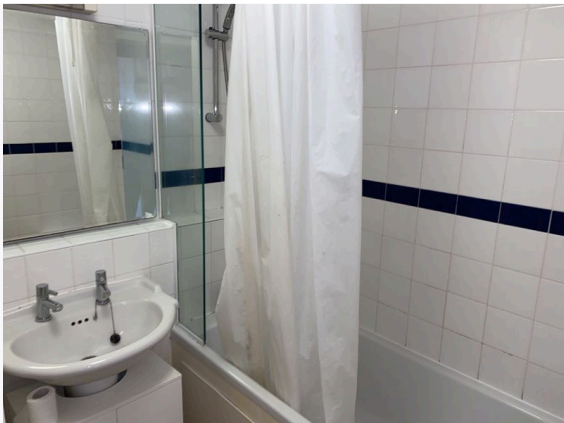
<p>Ref #9</p>

9. BATHROOM		
Item	Description	Condition
9.1 Door	As per supporting document	Door lightly expanded to bottom edge to interior door Fire chain detached Scuff at mid level left hand side exterior

9.2 Door Frame	As per supporting document	Fire chain removal mark mid level left hand side inner edge of door frame Cable clipped to exterior door frame

9.3 Lighting	As per supporting document	Light debris type mark to interior shade Black dot mark seen to shade
9.3.1	As per supporting document	Wall mounted light - not working Discolouration to pull cord

9.4 Walls	As per supporting document	Cracks to grouting above bath Drip marks behind sink Further 2 x screws/filler hole at high level right hand side above skirting board Black mark to top edge right hand side of sink Noticeable chips to bottom edge right hand side of sink

9.5 Skirting Boards / Woodwork	As per supporting document	Doorstop - slightly loose
9.6 Flooring	As per supporting document	Light debris and dust seen to floor Spot marks to right hand side of WC Purple/blue marks seen to right hand side of sink Cracking to sealant to edges Further blue/purple spot mark in front of bath

9.7 Heating	As per supporting document	Few drip marks and to front
9.8 Switches / Sockets	As per supporting document	Paint mark to light switch
9.9 Bath	As per supporting document	Water marks to bath Further water marks to sealant behind bathtub Tarnished to showerhead hose and slightly to showerhead Shower rising rail is loose Water marks to chrome ware Bath panel is loose and not flush to bath panels around shower screen Water mark and historical cleaning smear seen

9.10 Sink	As per supporting document	Water mark to sink Scales underside of mixer tap White mark to pop-up plug
9.11 WC	As per supporting document	Seat and lid loose Lightly dusty to toilet around bowl Light rub marks around seat and lid hinges

9.12 Mirror	As per supporting document	Water marked/splash mark
9.13 Under Sink Unit	As per supporting document	Spot marks to top surface Lightly dusty to top

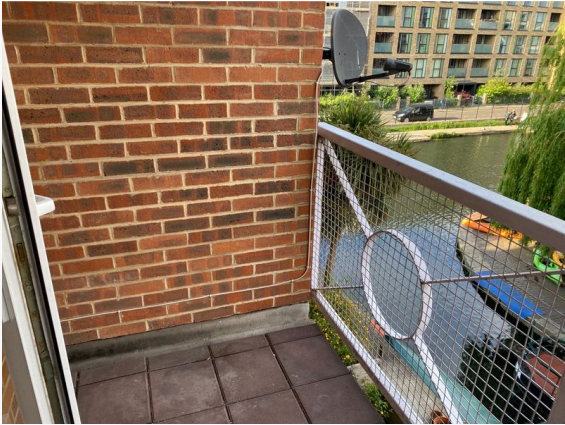
<p>Ref #10</p></div><div>

10. BALCONY		
Item	Description	Condition
10.0.1	As per supporting document	
<div><div>
