## XX FIELD - WELL LL-265 *Corrosion Behaviour of Stainless Steel Materials in Downhole Conditions*

**COUPON ANALYSIS REPORT**  
**WEIGHT LOSS**  
**TENSILE TESTS**  
**INTERGRANULAR CRACKING**  
**STRESS CORROSION CRACKING**

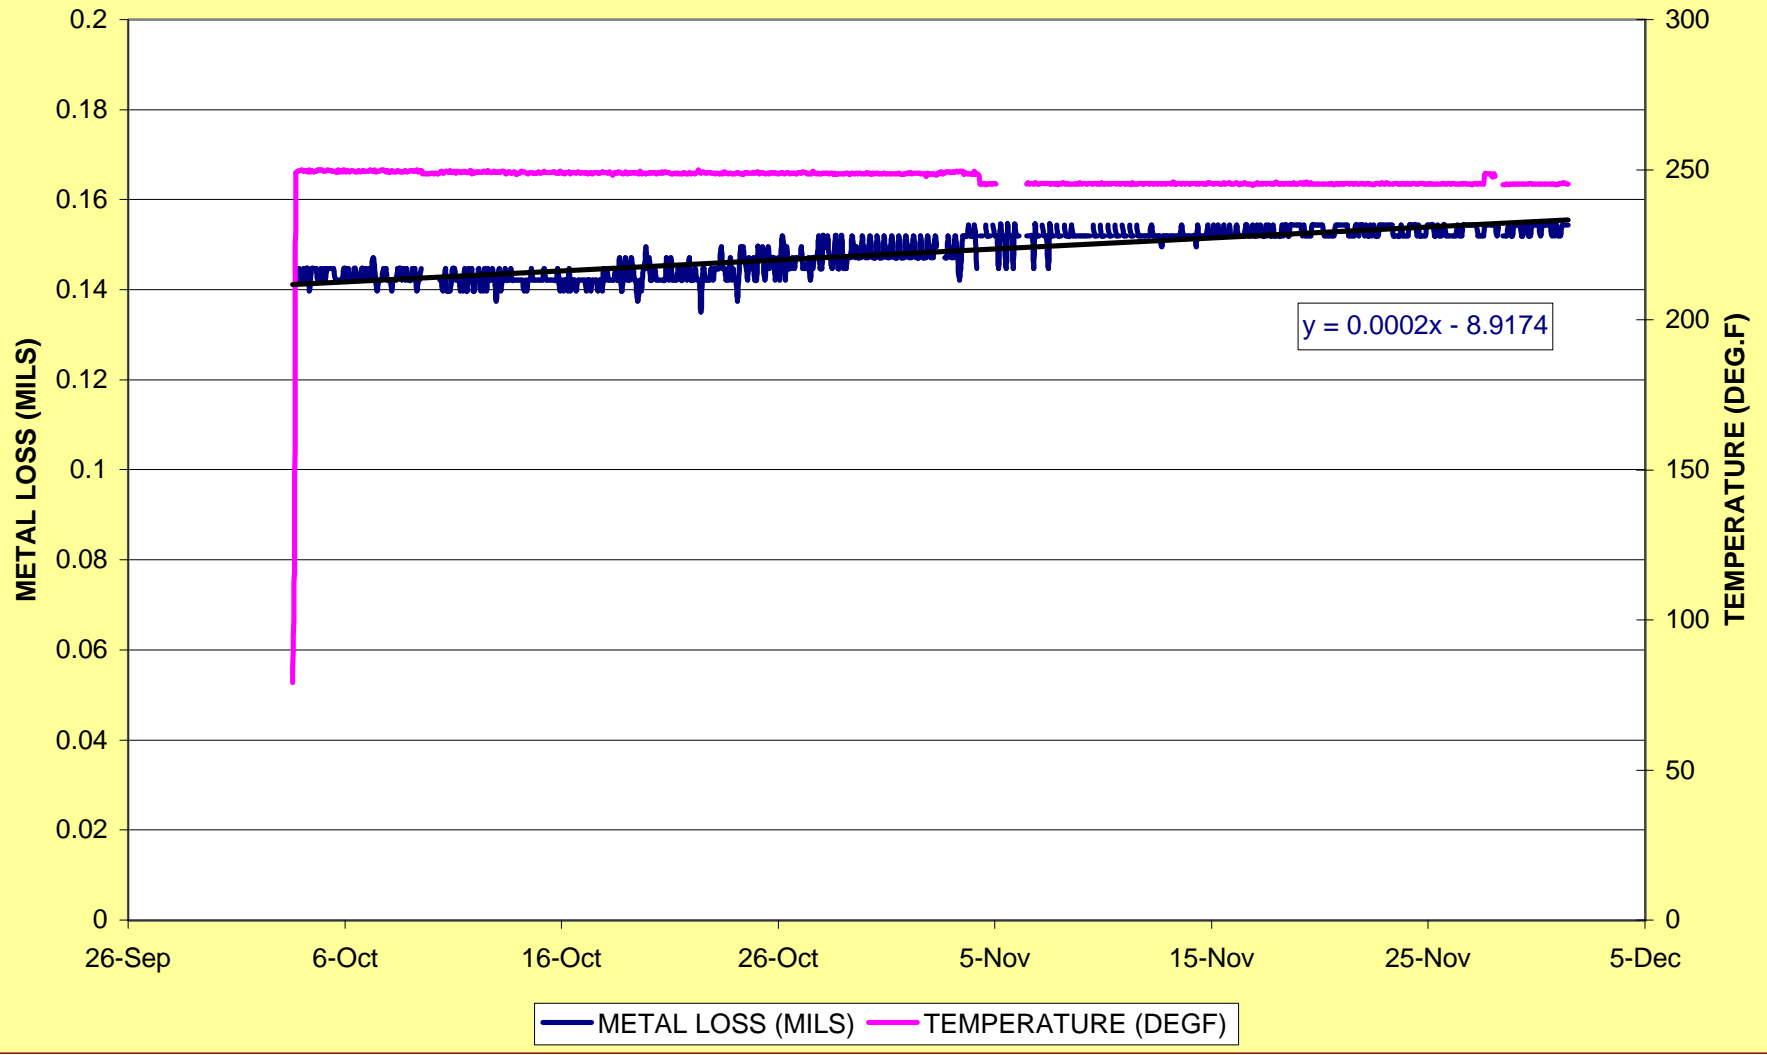
# WELL LL-265 DOWNHOLE CORROSION

The uniform corrosion rate is negligible for all materials, as shown by the Table hereunder.

The temperature at the probe depth is practically constant at 250 deg F.

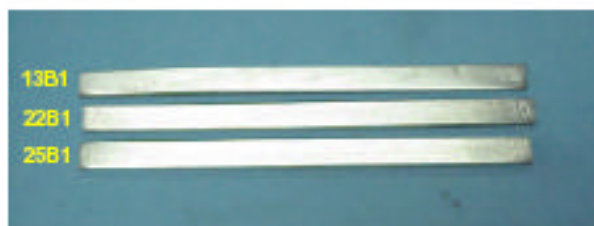
Figure 20 – General view of the bent coupons identified as 13B1, 22B1, 25B1 before loading into the bending fixtures; note all the samples display the normal metallic luster expected in the as-machined condition

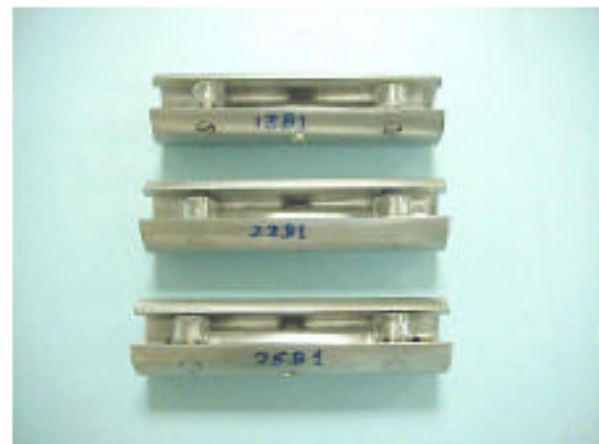
Figure 21 – General view of the bent coupons after stressing in the bending fixtures; the view presented is before exposure to the down hole environment; the bending fixtures are identified as 13B1, 22B1, 25B1

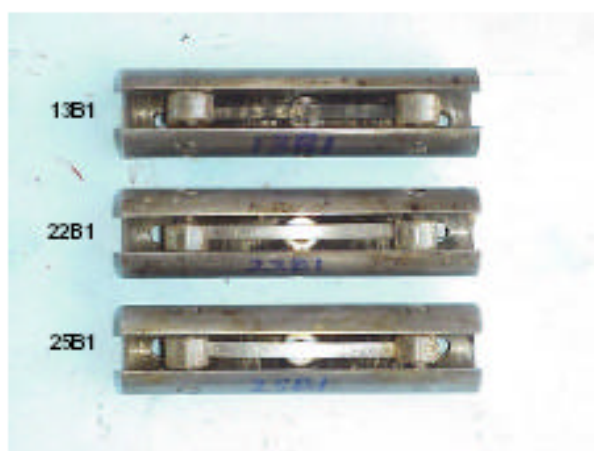
The test coupon displays no cracks.

Figure 22 – General view of the bent coupons identified as 13B1, 22B1, 25B1 after exposure to down hole environment in the stressed condition; note the dull/dark color of the coupon 13B1, and bright metallic luster of the coupons 22B1 and 25B1

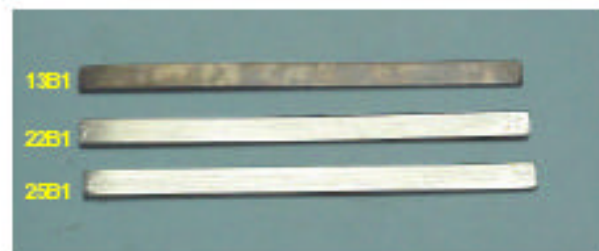
Figure 23 – General view of the bent coupons identified as 13B1, 22B1, 25B1 after exposure to the down hole environment in the stressed condition; the coupons were removed from the fixtures (see Figure 22); note coupon identified as 13B1 displays discoloration whereas the other two coupons display original bright metallic luster

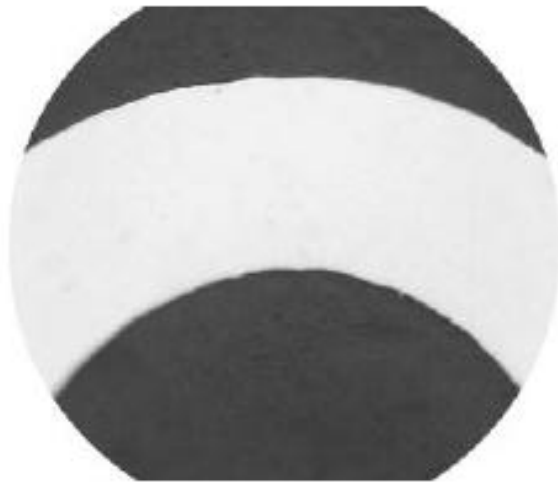
Figure 17 – Stereomicroscopic view of the etched metallographic section from the bend location of the normal coupon identified as 25A1

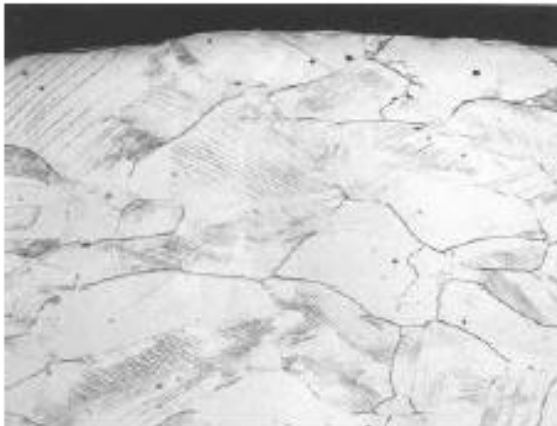
Figure 18 – Micrograph of the normal coupon identified as 25A1 taken near/at the bend location; the micrograph displays a typical austenitic structure, which is normal for the austenitic alloy; note the elongated grains towards the surface and slip bands within the grains resulting from deformation due to bending of the original annealed strip; there is no evidence of cracking or microstructural degradation due to the exposure; Original magnification – 100x

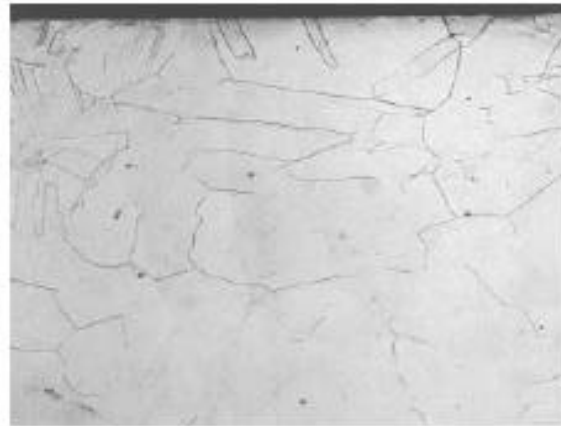
Figure 19 – General microstructure of the normal coupon identified as 25A1 away from the bend location displays a relatively equiaxed austenitic grain structure, which is representative of the original material; Original magnification – 100x

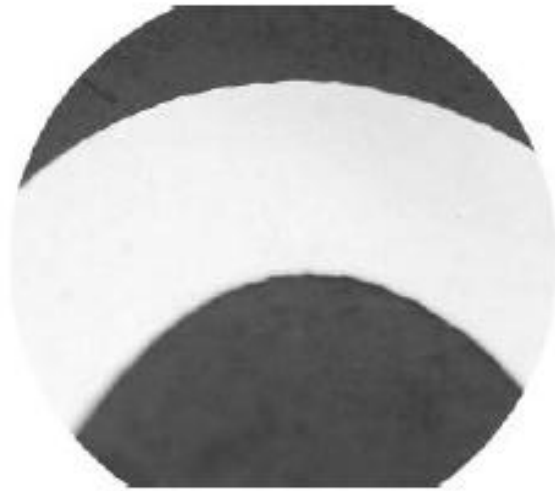
The test coupon was sectioned parallel to the longitudinal axis. The section was examined in the unetched and etched conditions on stereo and metallurgical microscopes. The section displays no evidence of the presence of fissures and cracks. The section displays an austenitic structure, which is normal for the material.

Figure 14 – Stereomicroscopic view of the etched metallographic section from the bend location of the normal coupon identified as 22A1

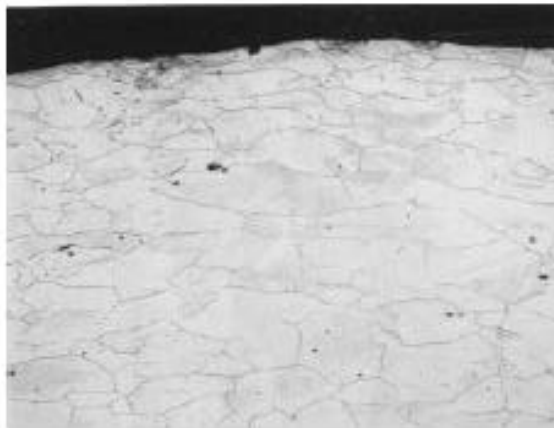
Figure 15 – Micrograph of the normal coupon identified as 22A1 taken near/at the bend location; the micrograph displays a typical austenitic structure, which is normal for the austenitic alloy; note the elongated grains towards the surface and slip bands within the grains resulting from deformation due to bending of the original annealed strip; there is no evidence of cracking or microstructural degradation due to the exposure; Original magnification – 100x

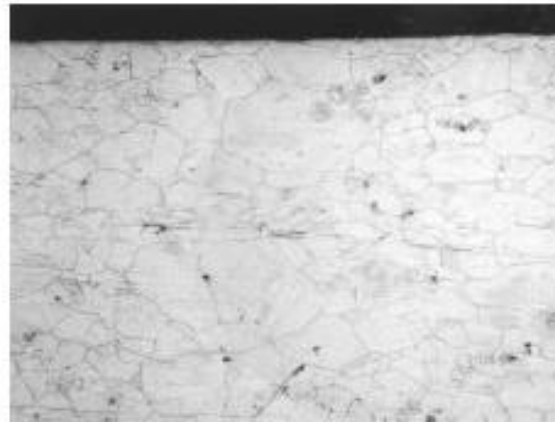
Figure 16 – General microstructure of the normal coupon identified as 22A1 away from the bend location displays a relatively equiaxed austenitic grain structure, which is representative of the original material; Original magnification – 100x

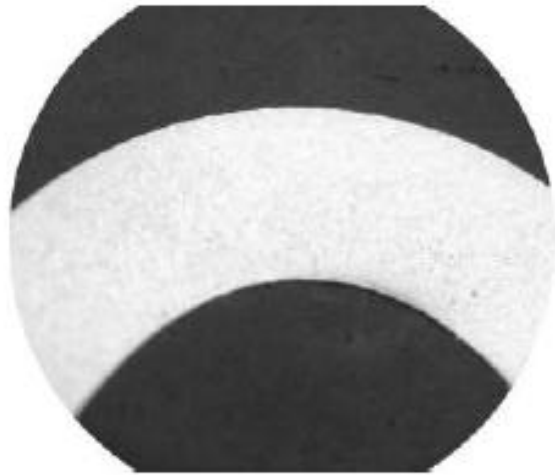
The test coupon was sectioned parallel to the longitudinal axis. The section was examined in the unetched and etched conditions on stereo and metallurgical microscopes. The section displays no evidence of the presence of cracks. The section displays a quenched and tempered structure, which is normal for the material.

Figure 11 – Stereomicroscopic view of the etched metallographic section from the bend location of the normal coupon identified as 13A1

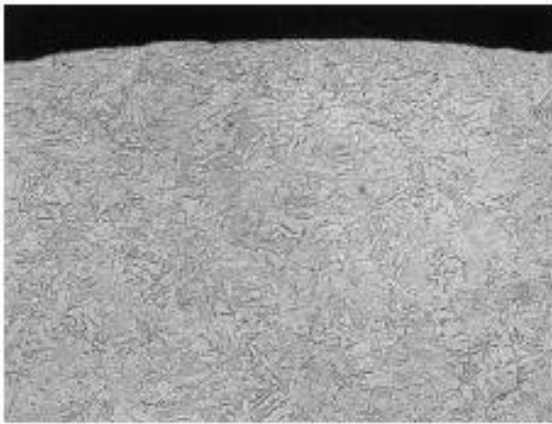
Figure 12 – Micrograph of the normal coupon identified as 13A1 taken near/at the bend location; the micrograph displays a typical quenched and tempered structure, which is normal for martensitic stainless steel; Original magnification – 100x

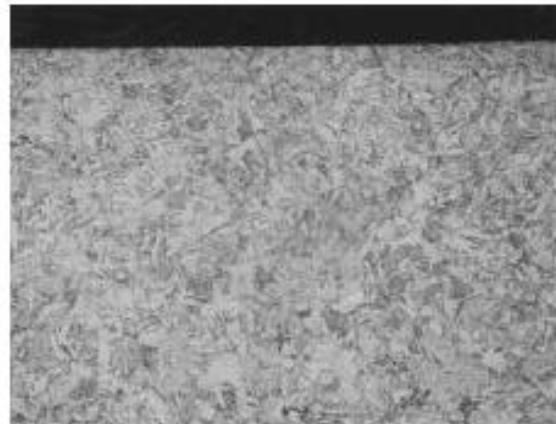
Figure 13 – Micrograph of the normal coupon identified as 13A1 taken away from the bend location; the micrograph displays a typical quenched and tempered structure, which is normal for martensitic stainless steel; Original magnification – 100x

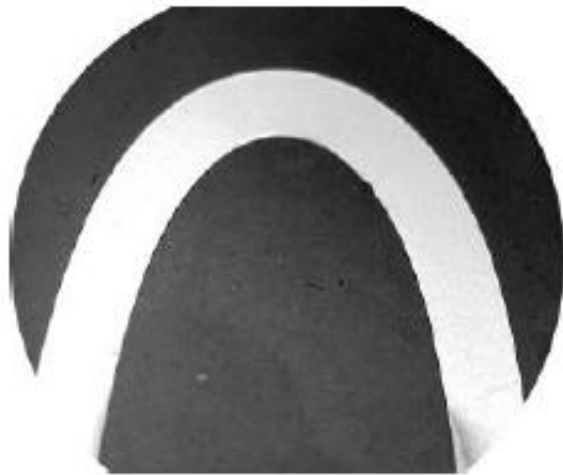
Figure 7 – Stereomicroscopic view of the polished section of normal coupon identified as 13A1; the section displays no evidence of cracks

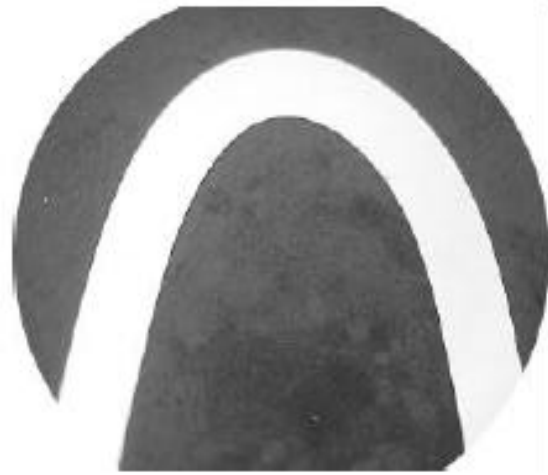
Figure 8 – Close view of the polished section of the normal coupon identified as 22A1; the section displays no evidence of cracks

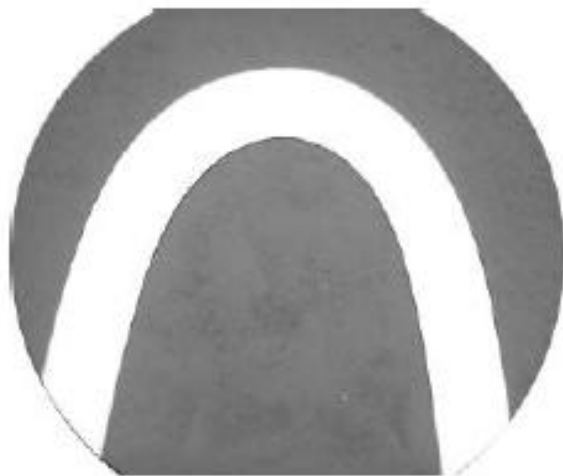
Figure 9 – Close view of the polished section of the normal coupon identified as 25A1; the section display no evidence of cracks

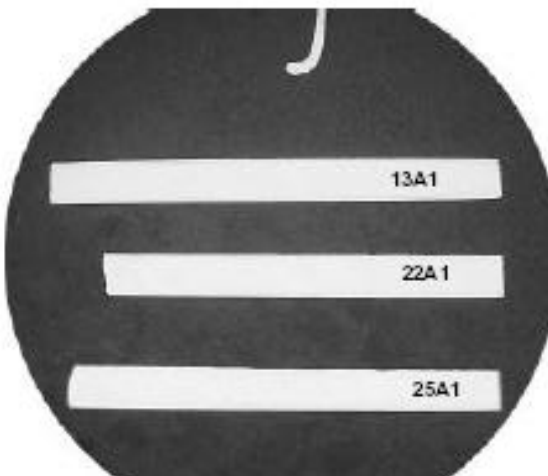
Figure 10 – General view of the polished micro-sections of the normal coupons identified as 13A1, 22A1, 25A1; these sections were removed away from the bend locations (un-deformed locations of the bend tested normal coupons) and subjected to microstructural examination

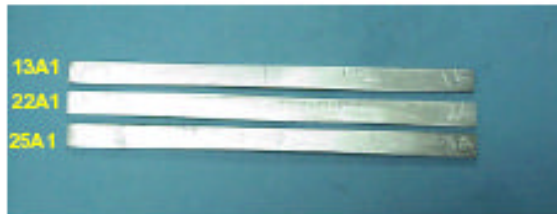
Figure 3 – General view of the normal coupons identified as 13A1, 22A1, 25A1 before exposure to the down hole environment; note all the samples display the normal metallic luster expected in the as-machined condition

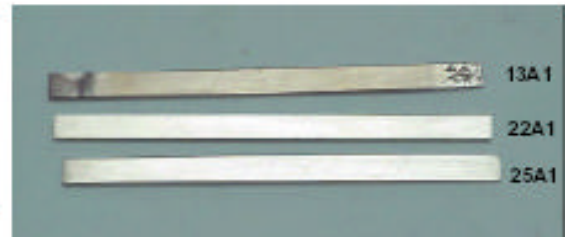
1. All three coupons (13A1, 13B1 and 13C1), normal, bent and cylindrical, display evidence of discoloration after exposure to the down hole environment. The coupons display a dark color when compared with the original bright metallic luster of the coupons before exposure.
2. There is no evidence of cracking or pitting in any of the coupons.

1. All three coupons (22A1, 22B1 and 22C1), normal, bent and cylindrical, display original bright metallic luster of the coupons after exposure to the down hole environment. There is no meaningful change in the surface features due to the exposure.
2. There is no evidence of cracking or pitting in any of the coupons.

Figure 4 – General view of the normal coupons identified as 13A1, 22A1, 25A1 after exposure to the down hole environment; note coupon identified as 13A1 displays discoloration whereas other two coupons display the original bright metallic luster

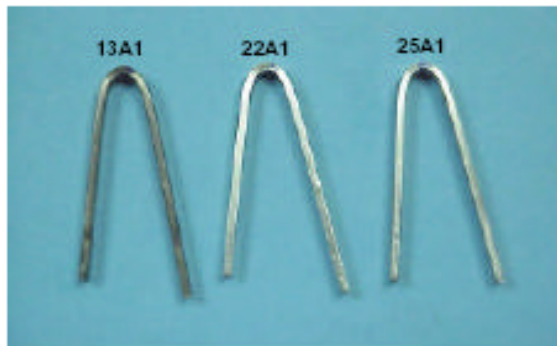
The surfaces of the test coupon were examined on a stereomicroscope. The test coupon displays no evidence of the presence of fissures and/or cracks.

Figure 5 – General view of the normal coupons identified as 13A1, 22A1, 25A1 after the bend test following ASTM A262 Practice E as a guideline; the test coupons displayed no evidence of fissures and cracks on bending

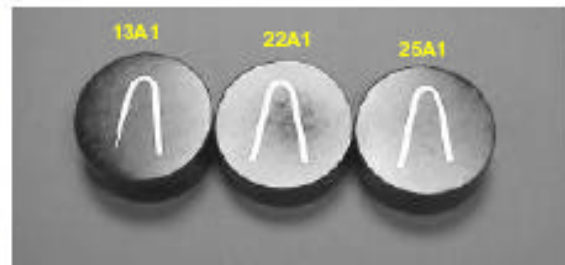
Figure 6 – Polished microsections from the bend/deformed locations of the normal coupons 13A1, 22A1 and 25A1

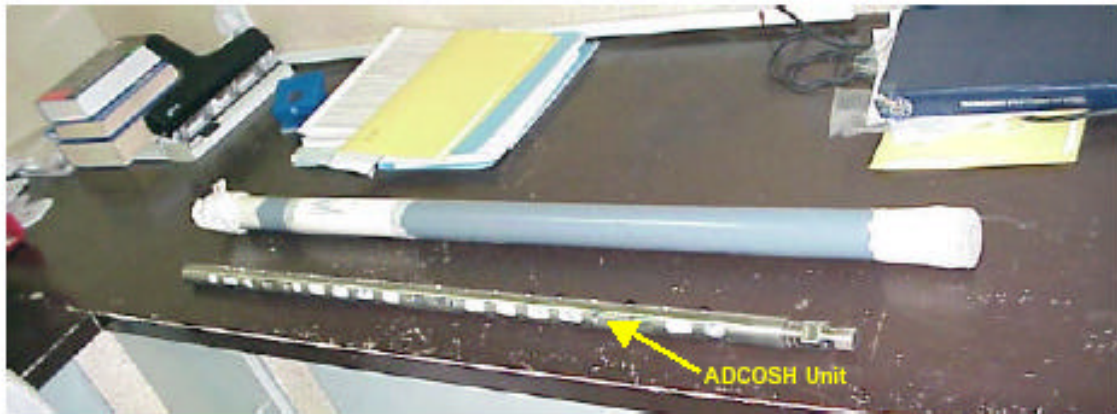
Figure 1 – General view of the coupon holder (ADCOSH Unit) with test coupons inserted and the ends plugged; this view of the coupon holder was taken before delivery of the coupons for exposure to the down hole environment; the test coupons were prepared and supplied by the client; Lonestar Technical Services carried out various procedures before insertion of the test coupon in the coupon holder (see Tables 1, 2 and 3)

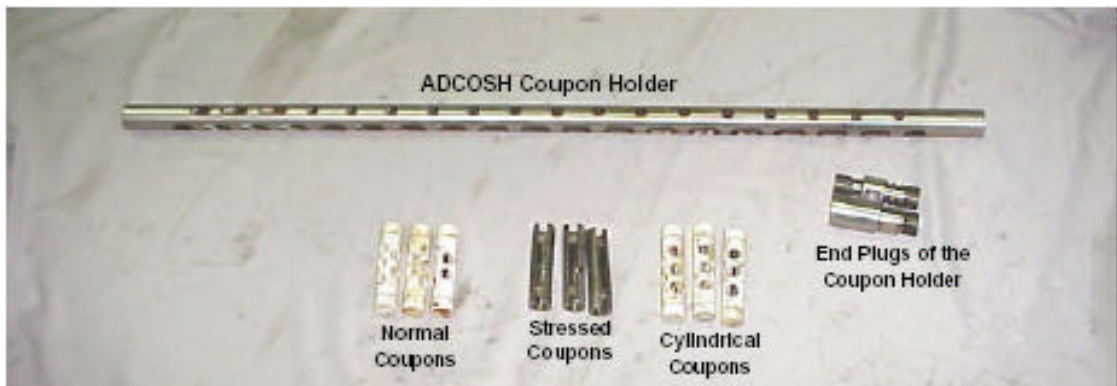
Figure 2 – General view of the coupon holder (ADCOSH Unit) and the test coupons separated on receipt from the client after exposure to the down hole environment; the test coupons are in three respective insertion fixtures; the normal and cylindrical coupons are contained inside their respective 'Teflon' holders (white colored) and the bent coupons are in the bending fixtures (dark colored, constructed from stainless steel with coupon contacting parts in glass as per guidelines of NACE TM0177)
