**MANDATORY BULLETIN No.**  
**SAFETY ALERT**

**EV97-028a R1 SR**  
**SPORTSTAR – 030a R1 SR**  
**Harmony LSA-008a R1 SR**

- 1. CONCERNING:** All the aircraft of **Eurostar, SportStar and Harmony** types.  
Note: Revision 1 Issue adds Fig. 10 and clarifies point 2. Required material for repair according to point 1.3.  
The issue has no effect on technical content of the bulletin.
- 2. REASON:** Insufficient insertion of the wing flap drive pins into the guides in flaps can cause wear of the guides and subsequent problems in operation. **In the extreme case the loss of flaps controllability can occur.**
- 3. MEASURES:**

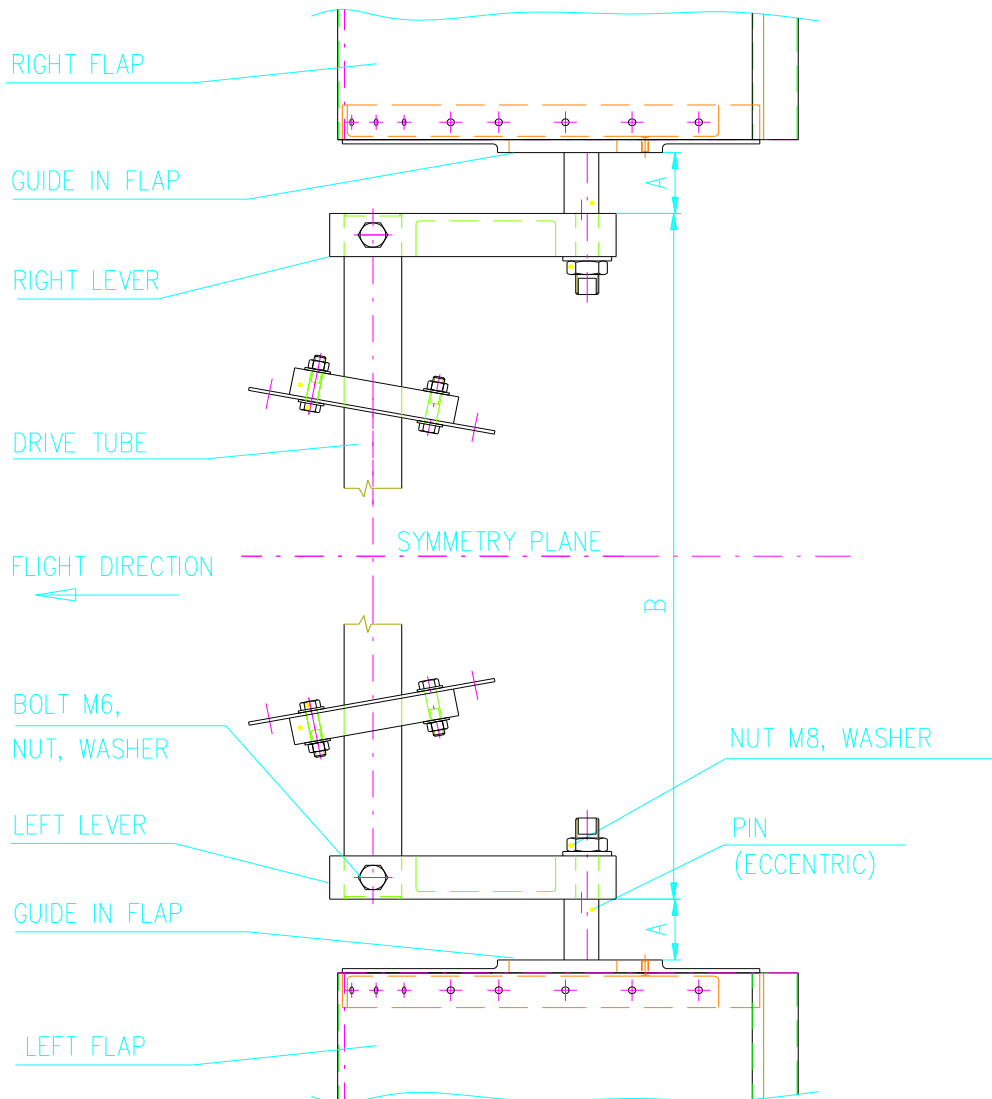
Fig.1

According to Fig. 1 check the play (clearance) between the drive lever with the pin and the nearest surface of the guide in the flap rib – **dimension A**. Check this play for each flap, always at full deflection of flap 50°.

**Insertion of the pins is conforming if dimension A is smaller than 17 mm.**

In this case just record the check performance according to the bulletin in the Aircraft Logbook.

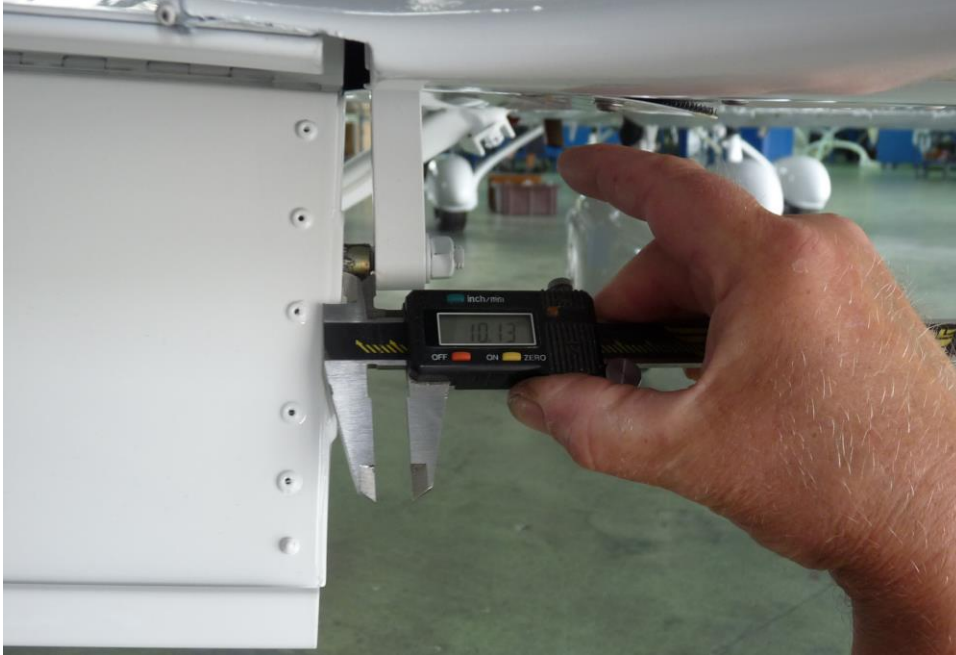
Fig. 2 – Measuring of dimension A at the left flap.

If the measured **dimension A** is bigger than 17 and smaller than 20 mm, continue according to point 1.2; if the measured **dimension A** is bigger than 20 mm, continue according to point 1.3.

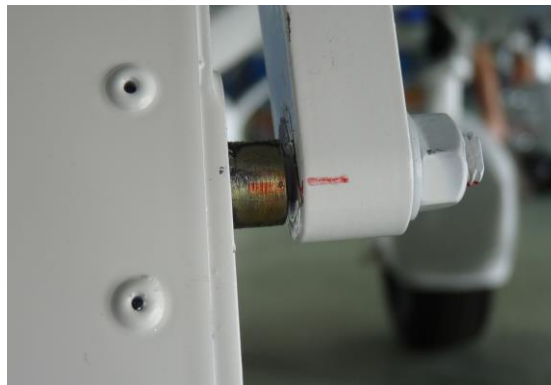
Fig. 3 – Marking of pin angular displacement position

1. According to Fig. 3 mark the position of pin angular displacement (the pin is eccentric). Carry out the marking with an indelible felt-tip pen by means of marks located against each other on the pin and on the lever.
2. Release the nut securing the pin.
3. Unscrew the pin by 1 up to 2 turns. Be careful that the marks on the pin and on the lever are located against each other. By this the play between the pin offset and the lever is increased – see Fig. 4. This play mustn't exceed the value of 3 mm.

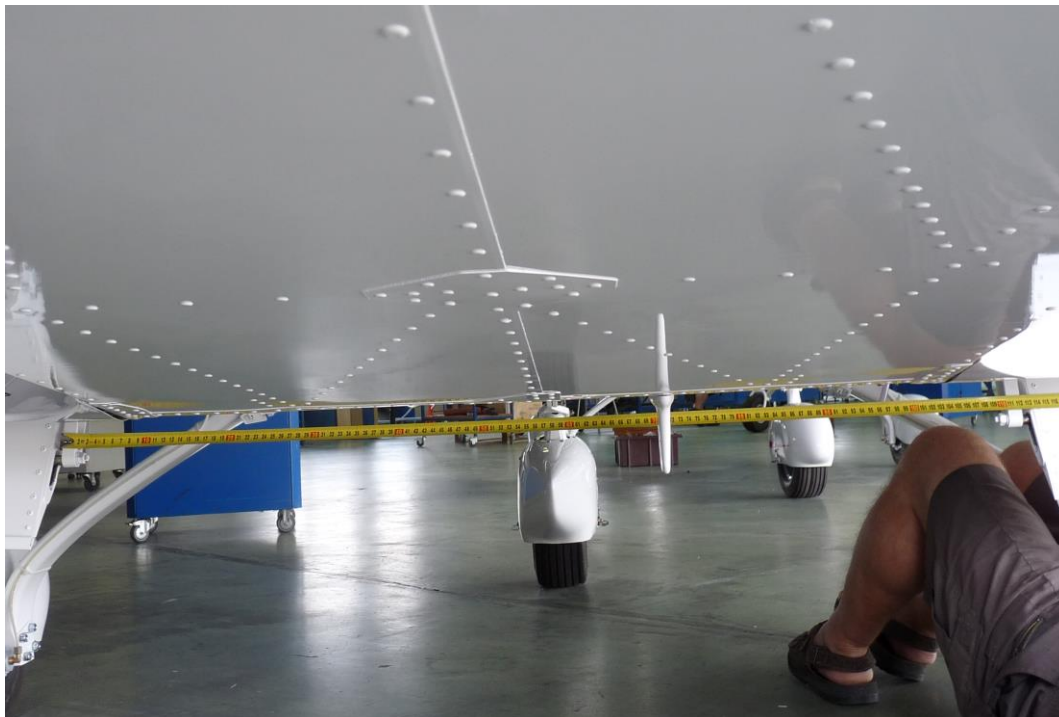
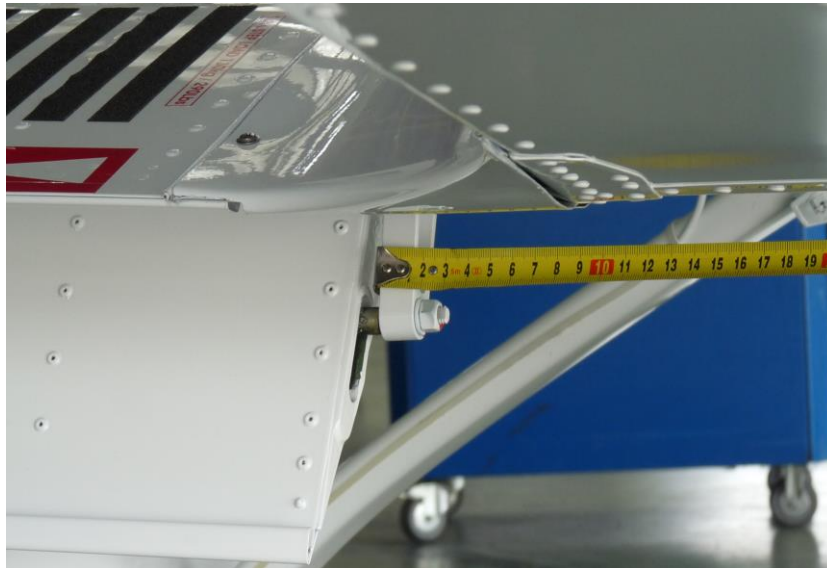
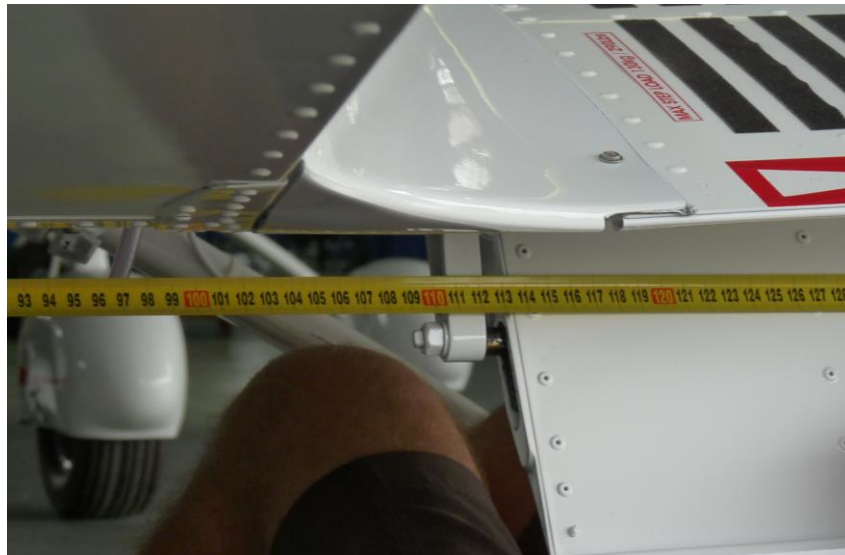
If measured dimension A is bigger than 20 mm, continue by measuring the distance between the outside edges of the left lever and the right lever with the pin – **dimension B** according to Fig. 5, 6, 7.

Fig. 5 – Measuring of dimension B

**Immediately contact the manufacturer** and inform him about the measured values of dimensions **A** and **B**. Provide the manufacturer also with the photo of the lever with the pin at the end and inform whether the lever has the stiffening rib on the edge or in the middle.

**The manufacturer will subsequently determine the procedure for repairing** the nonconforming condition (e.g. by referring to the appropriate point of the bulletin), eventually will send the parts needed for the repair as soon as possible.
