REPORT ON – "BUSHFIRE BEHAVIOUR AND HOUSE DAMAGE AND DESTRUCTION DURING THE PARKERVILLE. MT HELENA & STONEVILLE BUSHFIRE ON THE 12 JANUARY 2014"

ENVIRONMENTAL PROTECTION BRANCH

AUTHOR: RALPH SMITH

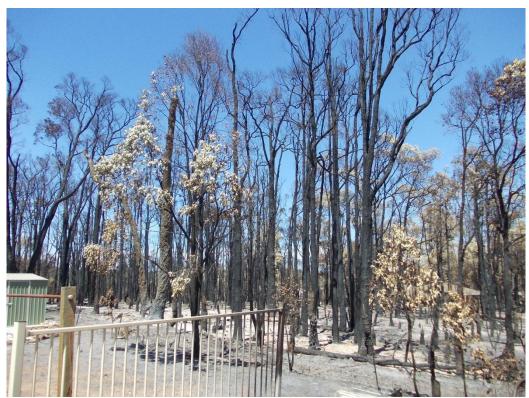
Figure 1: Crown defoliation as an indicator of fire behaviour.

There is a relationship between the bushfire behaviour, flame length, scorch height and defoliation of the trees and scrub. As can be seen in the above photograph, there are areas of defoliation in the 10 metre to 15 metre high trees. The white ash on the ground further confirms a hot fire ran through the area.

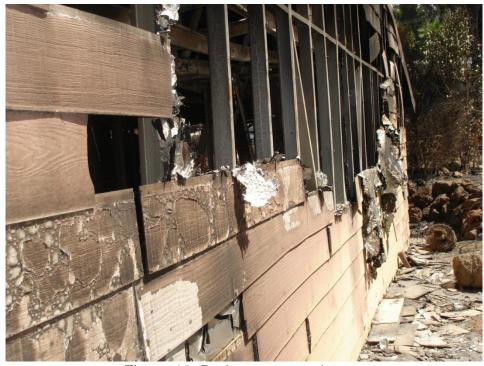
The impact of the flame and heat induced from the burning vegetation can have subsequent impact on cement sheeting, causing it to break and expose the lining of the house. This gap then creates an opening for embers, radiant heat or direct flame contact to enter the home and ignite any suitable fuels. The cracking and breaking of narrow cement sheets appears to have been a fairly consistent outcome when these products were exposed to reasonable levels of radiant heat or direct flame contact, particularly when they were not lined. Most of the cement sheets were less than 6mm thick.

Figure 13 clearly demonstrate the failure of the cellulose cement wall to withstand the fire. During the analysis care was taken to ensure that the fire travel indicators confirmed that the fire had entered the house from the outside and not from fire within the building. The walls were sarked and it appears that sarking in some instances may not make cellulose cement walls suitable as a construction material where the building will be subject to reasonable level of radiant heat or direct flame contact.

Figure 13: Broken cement sheets.

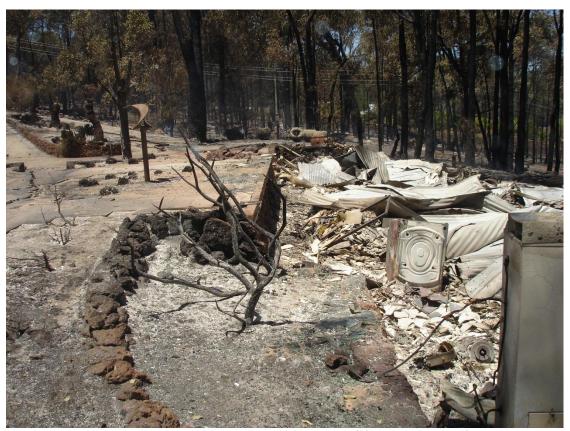
There were virtually no fences (non-combustible or combustible) or barriers to prevent the radiant heat or direct flame contact impacting directly onto the home in the areas where the vegetation was too close or too heavy. The fuel load was partially managed, with some owner intervention immediately adjacent to some of the dwellings, but generally diminished further out from the dwelling. This type of fuel load management (or lack of it) in many areas of the fire-affected location was fairly consistent and not uniformly applied to the level as recommended by DFES.

Figure 14: Demonstrating the absence of fire restricting fence lines.

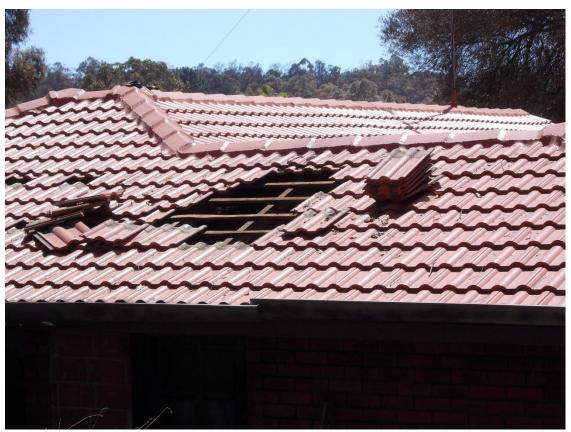
There were many homes that survived the fire unscathed or with minimal damage as a direct result of firefighter and/or occupier intervention, and the level of construction standard, such as boxed eaves. This general construction standard and construction era was different to that at the Margaret River and Roleystone/Kelmscott fires, but still not to the required level described in AS 3959.

Figure 15: A house that was saved by firefighter intervention.

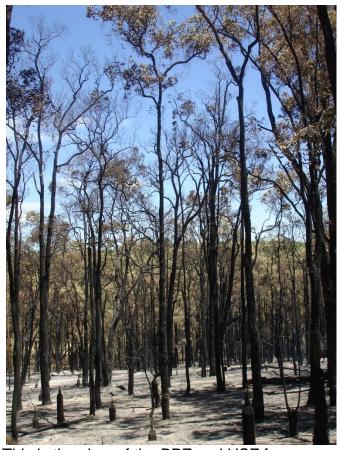
Figure 16: This is the view of the BPZ and HSZ from near to a house.

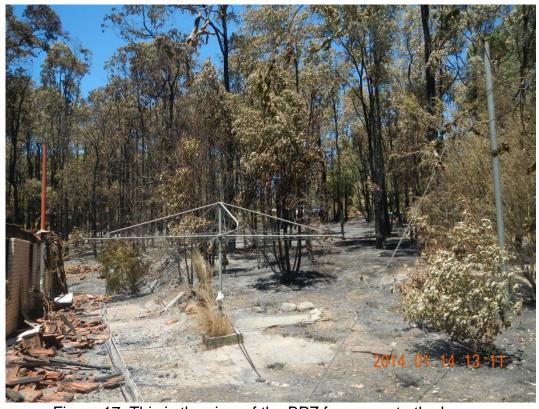
Figure 17: This is the view of the BPZ from near to the house.

The house in figure 17 was destroyed and, as can be seen, there is significant vegetation within the BPZ. The HSZ also contained a very high fuel load that was continuous to the house.

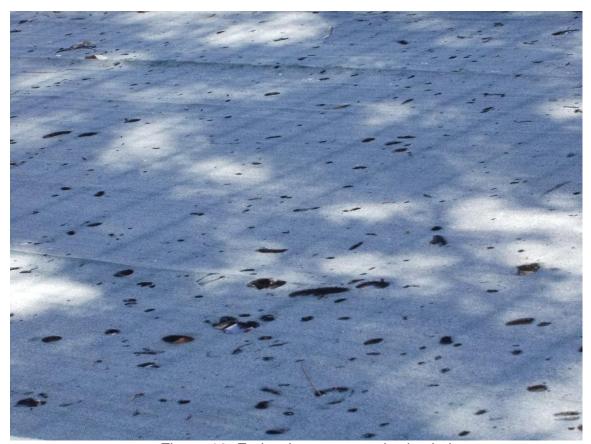
Figure 18: Ember impact onto shade cloth.

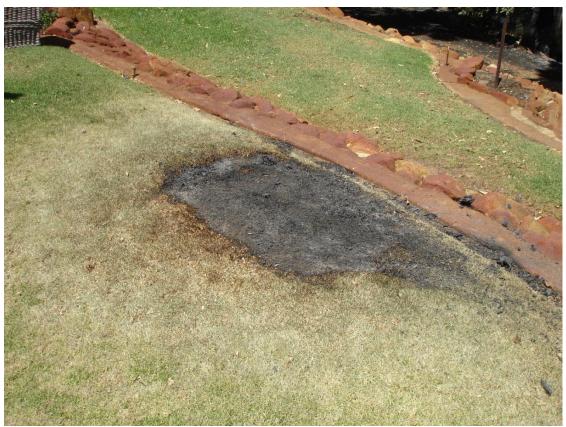
Figure 19: The effect of embers falling onto green grass.

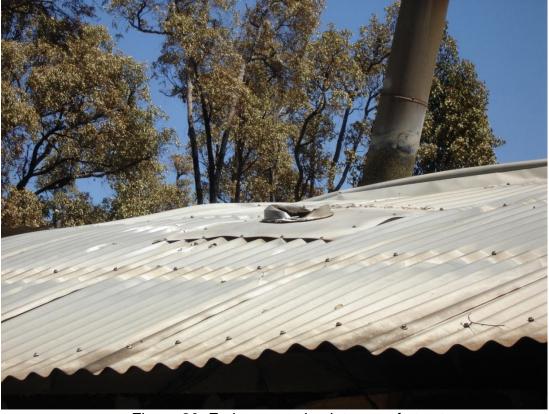
Figure 20: Embers entering into a roof structure.

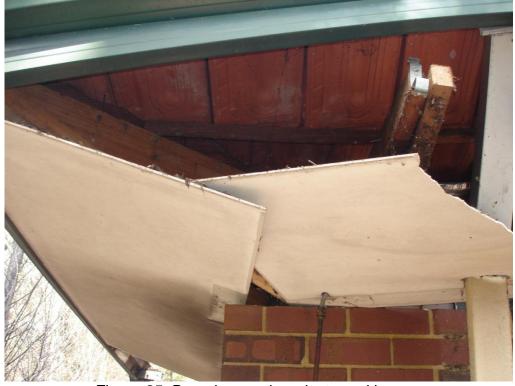
Figure 25: Boxed eaves in a destroyed house.

The boxed eaves in the destroyed house indicates (as shown in figure 25) a fire entry point other than through the boxed eaves.

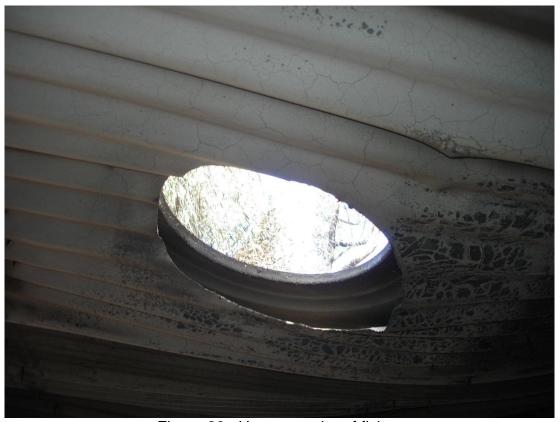
Figure 26: Unscreened roof fixing.

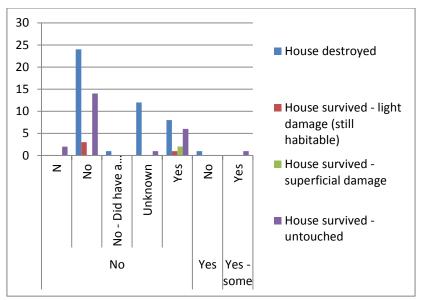
There were a significant number of houses destroyed (24) that did not have wire in their insect screens. It is also noted that eight houses did have wire insect screens, but it was not possible to ascertain the single cause of the house destruction or the entry point of the fire.

Figure 27: Wire not fibreglass in insect screen on doors and window frames.
