REPORT ON – "INVESTIGATION OF THE HOUSE LOSSES IN THE TOODYAY BUSH FIRE 29 DECEMBER 2009"

BUSH FIRE & ENVIRONMENTAL PROTECTION BRANCH

AUTHOR: RALPH SMITH

DATE: 5 AUGUST 2010

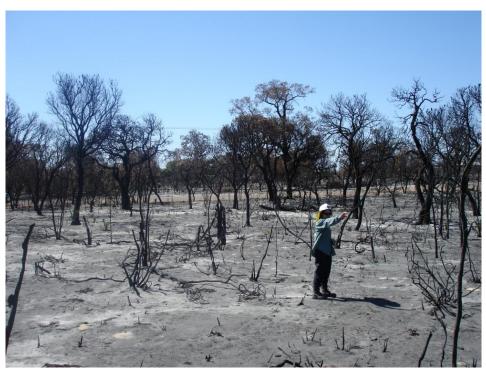
Figure 3 – The impact of the fire on the banksia dominant overstorey areas

The banksia woodland areas appeared to have suffered the most intense fire behaviour with much of the overstorey defoliated and the ground was bare of surface vegetation post the fire.

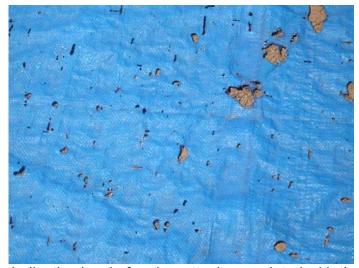
Figure 6 – Indicative level of ember attack associated with the bush fire

As can be observed in figure 5 the tarpaulin (which was placed on the hill near to the communication towers prior to the fire) suffered significant ember attack. This is indicative of the type and quantity of embers likely to have been attacking the homes within the bush fire's path.
