# SAMPLE REPORT

## MAINTENANCE INSPECTION REPORT

Sample Report Address  
Lower Hutt, Wellington  
New Zealand

Inspected by: Kieran Long | Inspection Date: 14 Apr 2022 | Ph: 0212621120

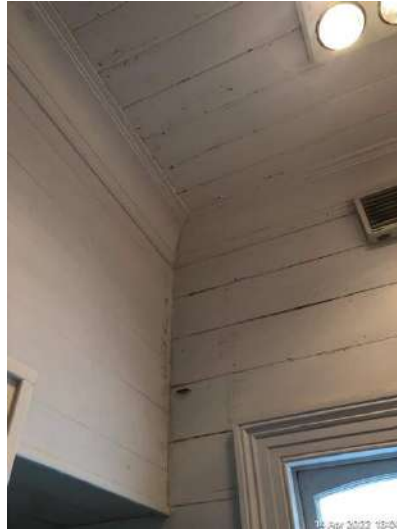
Photo Ref #7: Mould buildup to ensuite wall linings

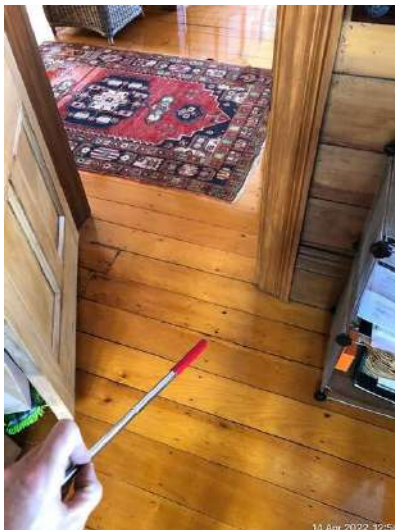
- Loose floorboards were detected at the kitchen doorway. These can easily be secured.

Photo Ref #8: Loose floorboard at kitchen doorway

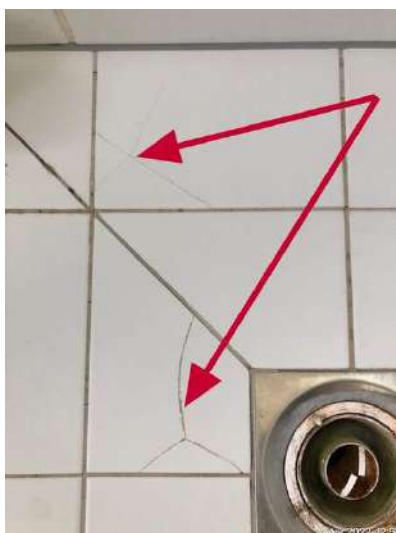
Photo Ref #25: Cracking to floor tiles

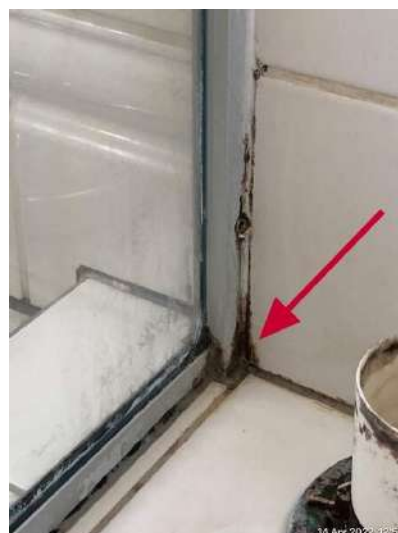
Photo Ref #26: Mould build-up

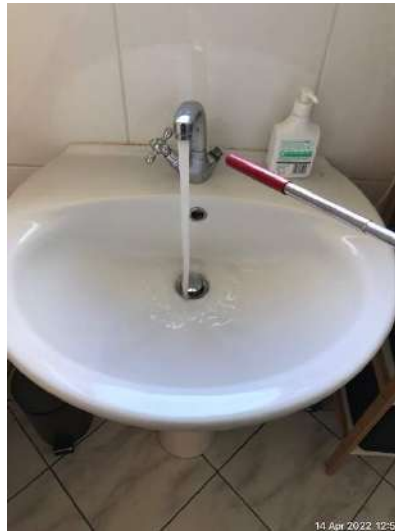
Details:	- The cold tap is missing from the main bathroom vanity. Upgrades would be recommended.
Rating:	Minor Maintenance
Repair Priority:	3 (3 to 12 months)
Trades Required:	Plumber

Photo Ref #33: Cold tap is missing

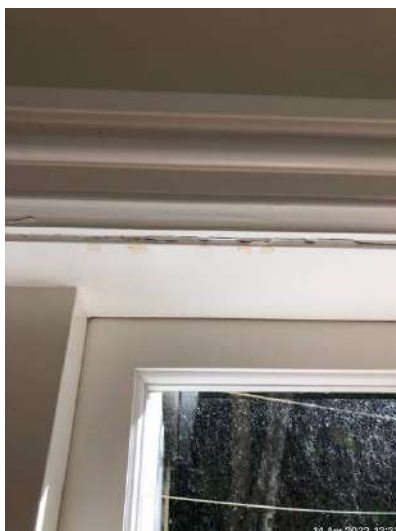
Photo Ref #53: Water staining to kitchen western window upper reveal

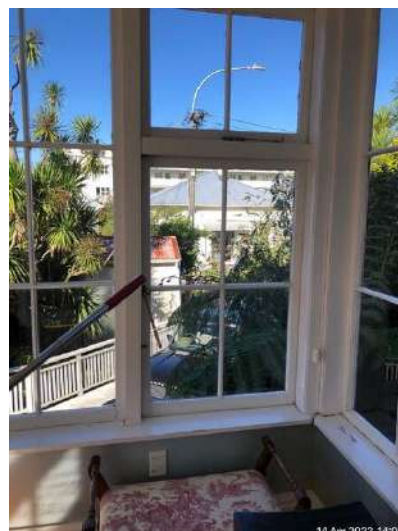
Photo Ref #54: Front sunroom window binding

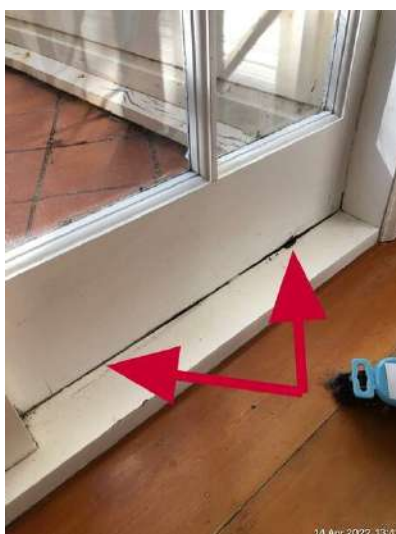
Photo Ref #56: Timber decay detected

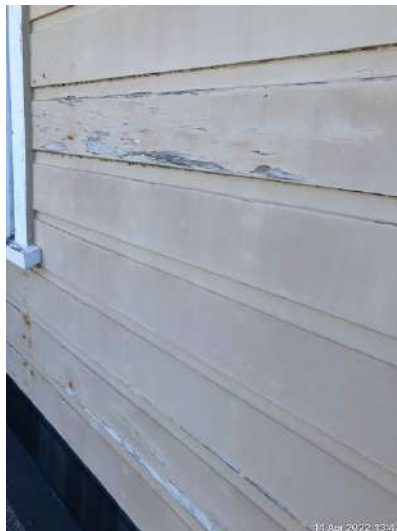
Photo Ref #87: Paint deterioration to weatherboards

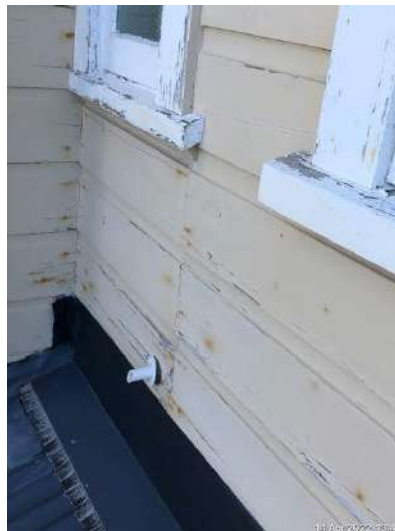
Photo Ref #88: Paint deterioration to weatherboards

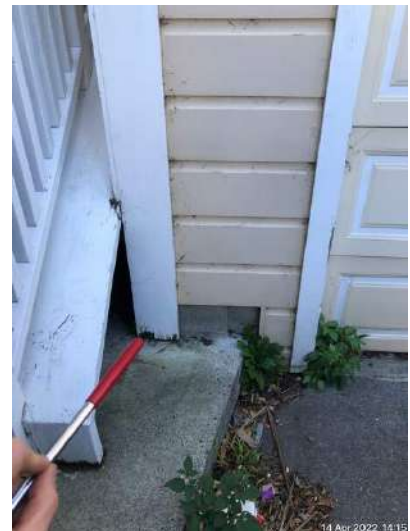
Photo Ref #89: Timber decay to box corner, southeastern corner of garage

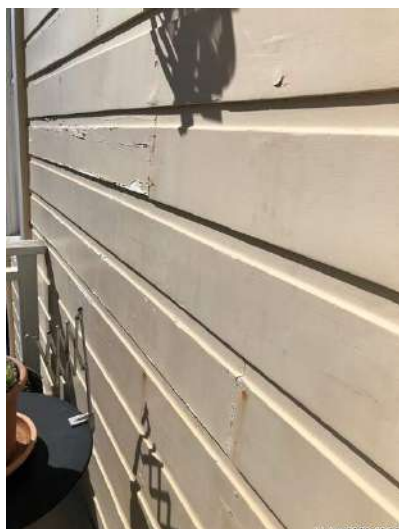
Photo Ref #90: Paint deterioration to weatherboards

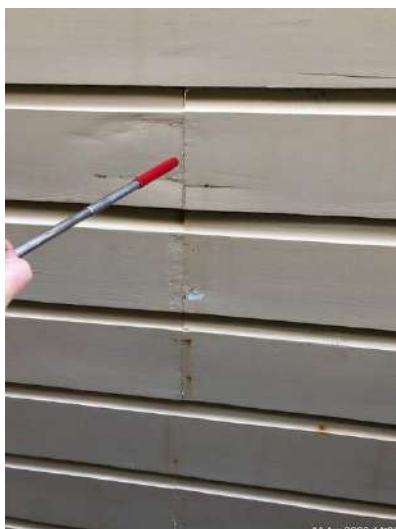
Photo Ref #91: Paint deterioration & timber decay to weatherboards

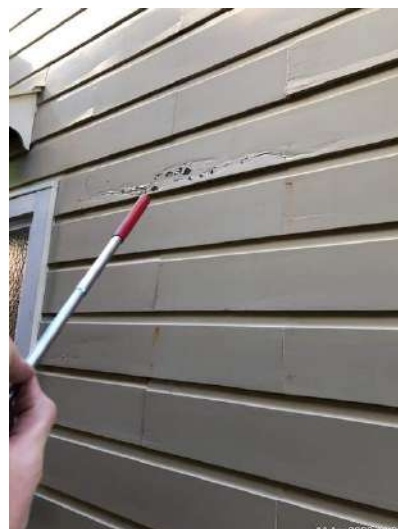
Photo Ref #92: Timber decay to weatherboards on southern face

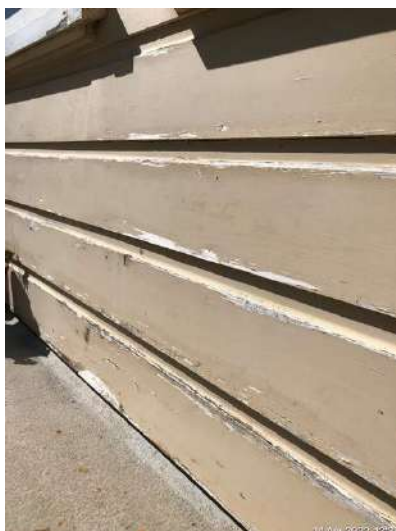
Photo Ref #94: Paint deterioration to weatherboards

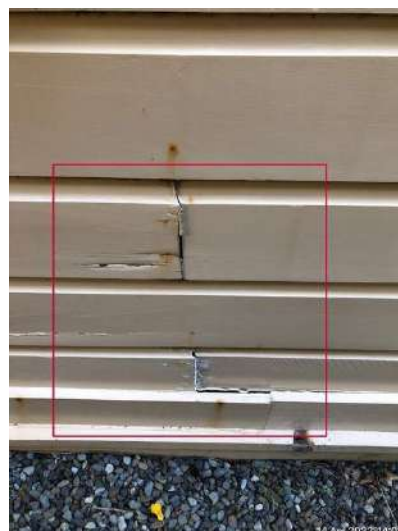
Photo Ref #95: Timber decay to weatherboards on southern face

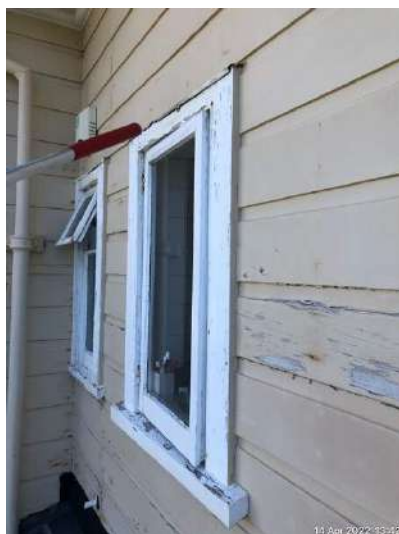
Photo Ref #101: Rusted head flashings

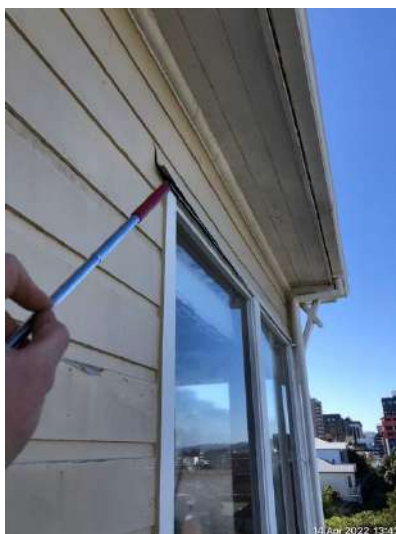
Photo Ref #102: Upstairs lounge eastern window - deterioration and lifting to head flashing

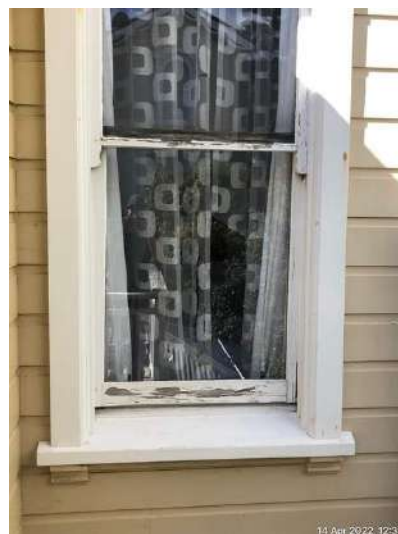
Photo Ref #103: General paint and putty deterioration to window unit

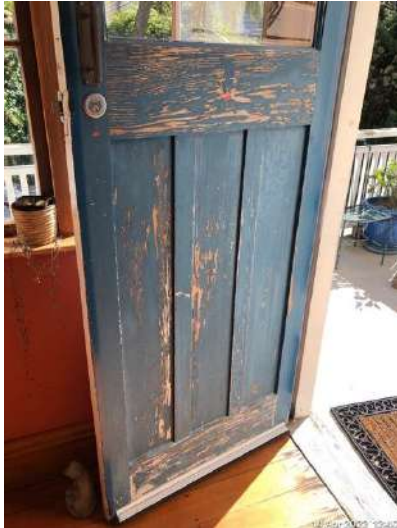
Photo Ref #104: Paint deterioration to doors

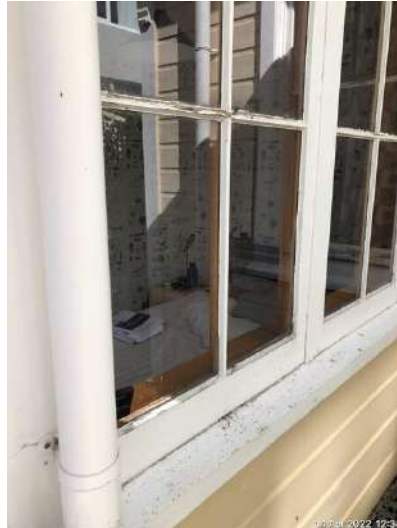
Photo Ref #105: General paint and putty deterioration to window unit

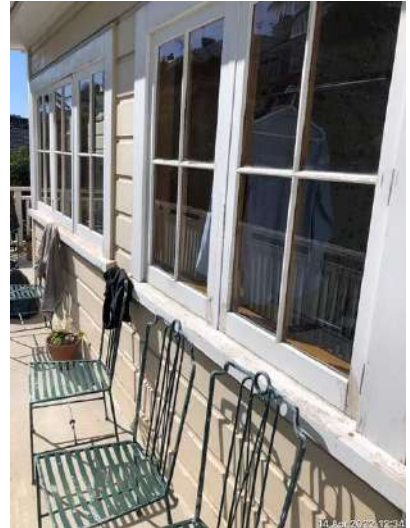
Photo Ref #106: General paint and putty deterioration to window unit

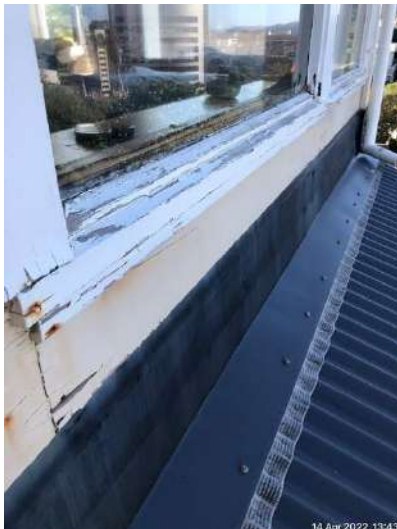
Photo Ref #107: Paint deterioration to window unit

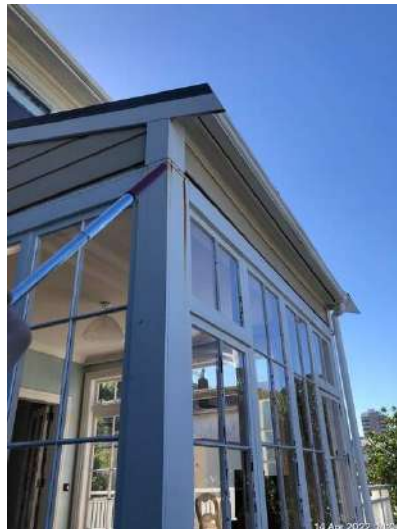
Photo Ref #108: Rust deterioration to sunroom head flashing

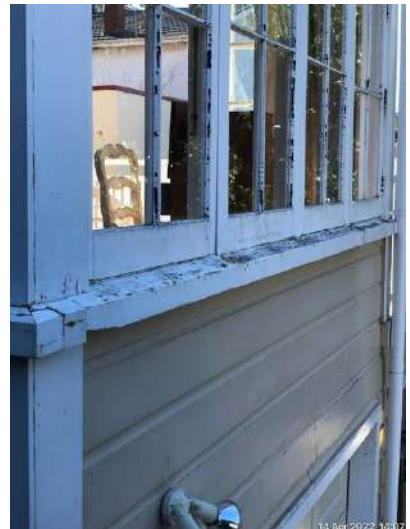
Photo Ref #109: General paint and putty deterioration to window unit

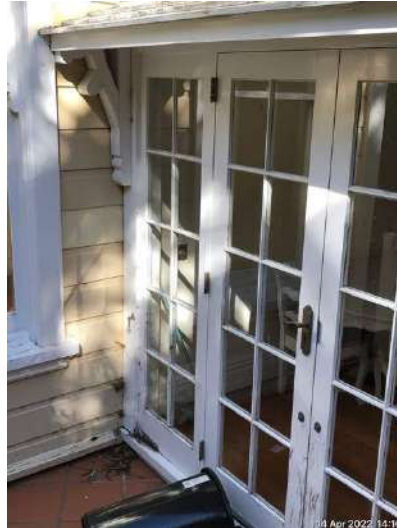
- Timber decay was detected to the downstairs lounge northern door unit and the kitchen northern door unit, replacement of the entire units is recommended.

Photo Ref #111: Timber decay to downstairs kitchen northern door - unit requires replacement.

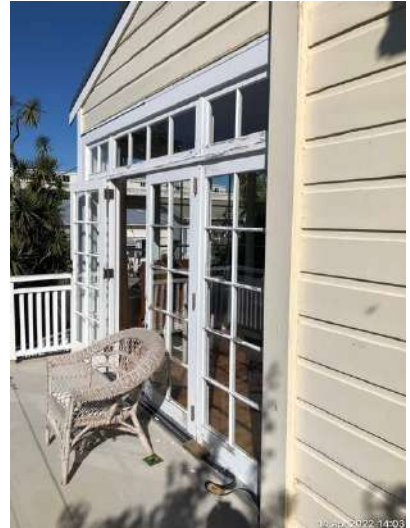
Photo Ref #112: Timber decay to downstairs sunroom northern unit - full unit requires replacement

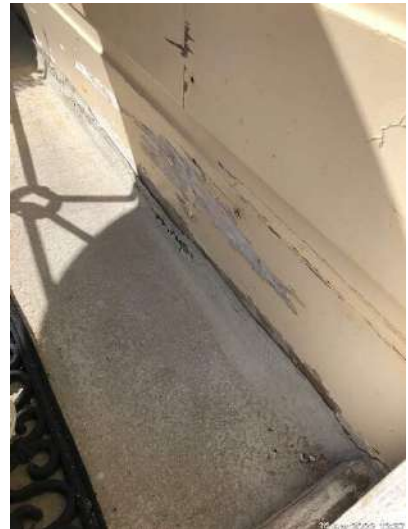
Photo Ref #121: Deterioration to waterproof coating at cladding junction, poor installation causing high risk area

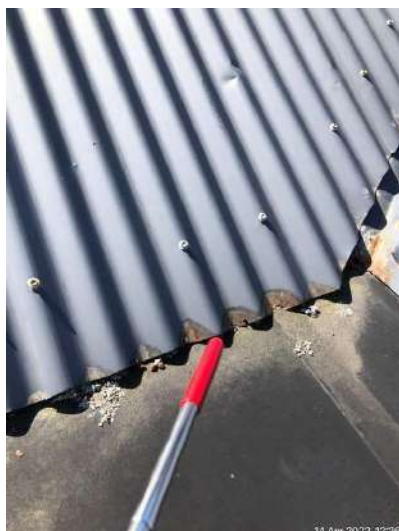
Photo Ref #137: Rust deterioration to bottom of sheets and flashings where in contact with internal gutter

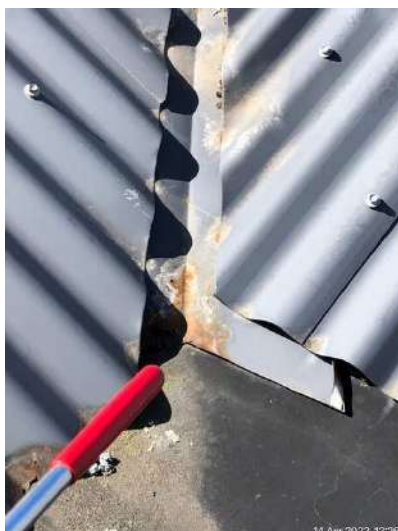
Photo Ref #138: Rust deterioration to bottom of sheets and flashings where in contact with internal gutter

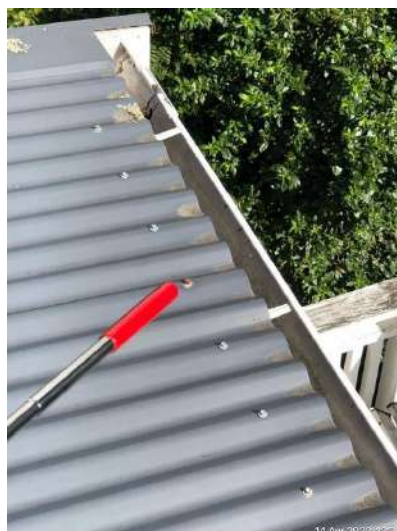
Photo Ref #139: Rusted screw fixings

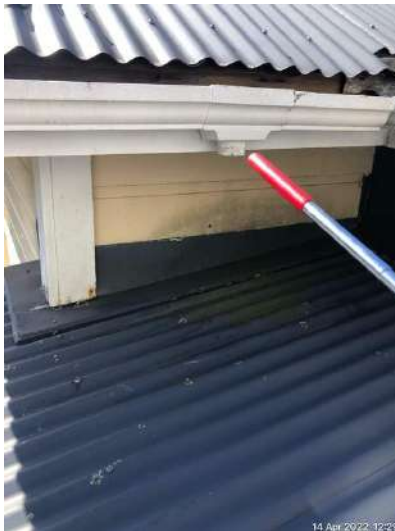
Photo Ref #155: Gutter outlets missing down pipes and spreaders

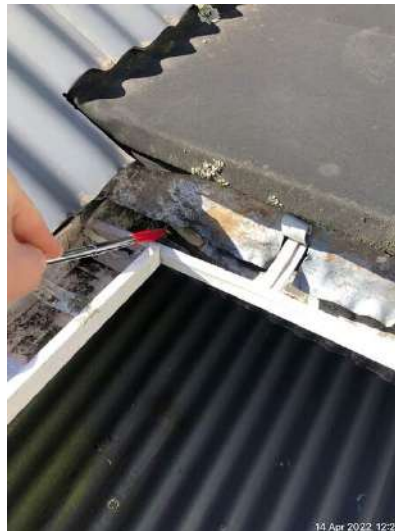
Photo Ref #156: Gutter outlets missing down pipes and spreaders

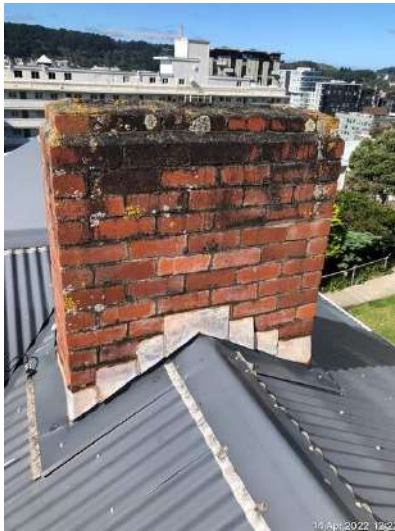
**- Chimney -** Two brick chimneys were in place, movement was detected to the southern chimney in place. Brick chimneys are a recognised hazard in the event of an earthquake, due to the movement detected, we recommend engaging a specialist now to determine if strengthening or removal is recommended

Photo Ref #161: Southern chimney

- Brick chimneys are a recognised hazard in the event of an earthquake, due to the movement detected, we recommend engaging a specialist now to determine if strengthening or removal is recommended.

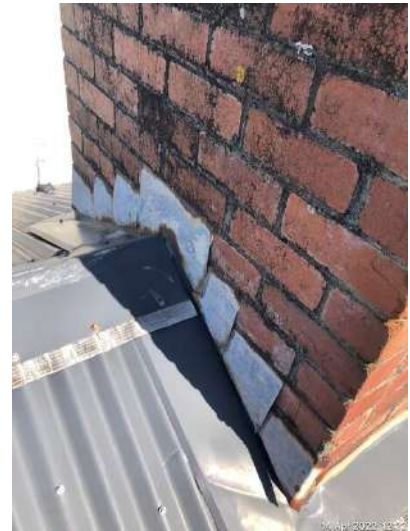
Photo Ref #163: Rust deterioration and gaps at chimney roof penetration flashings

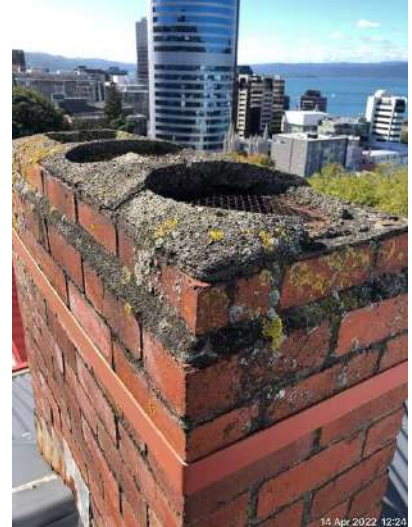
Photo Ref #167: No cap flashing in place

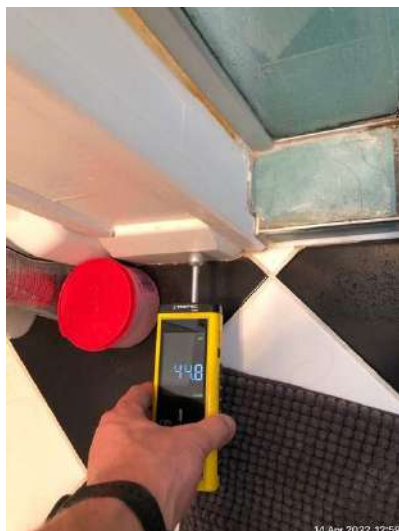
Photo Ref #212: Elevated moisture reading - Ensuite bathroom extractor wall, bottom right hand corner of shower unit

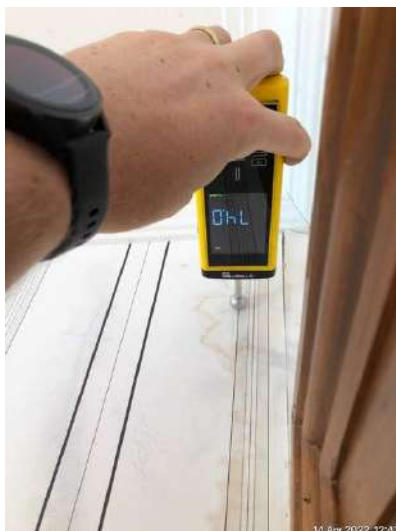
Photo Ref #213: Elevated moisture reading - Hallway northern wall, left of large timber archway.

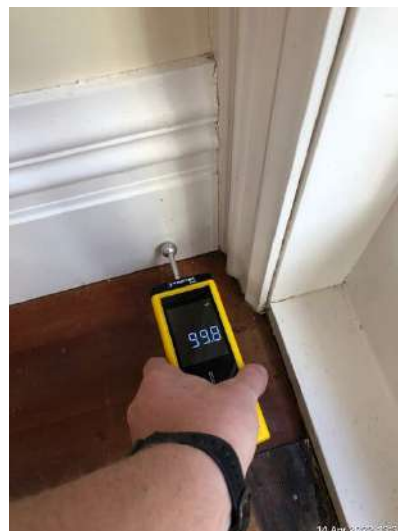
Photo Ref #214: Elevated moisture reading - Kitchen northwestern corner

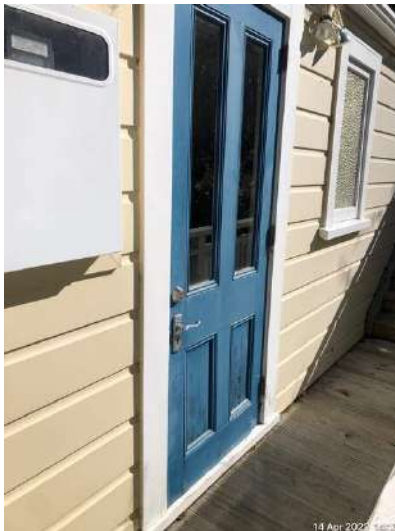
Photo Ref #241: Timber deterioration to side door

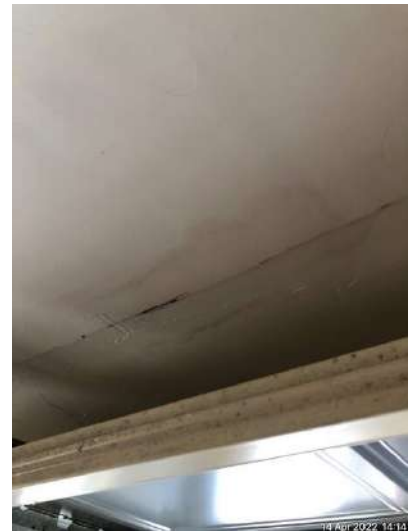
Photo Ref #243: Moisture damage to ceiling lining

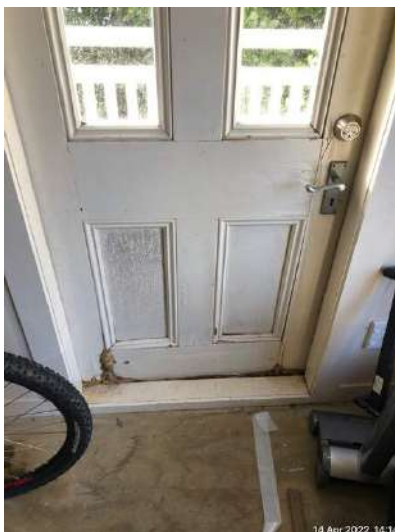
Photo Ref #244: Timber deterioration to side door

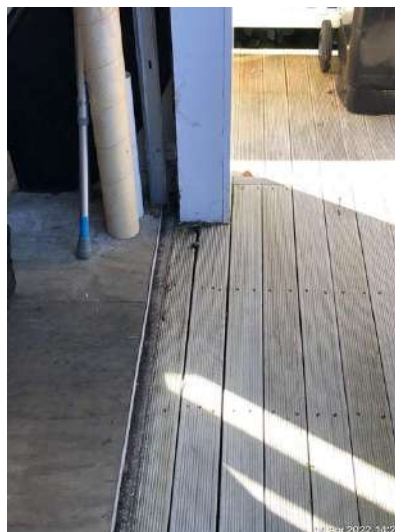
Photo Ref #245: Minor decay to garage door facings

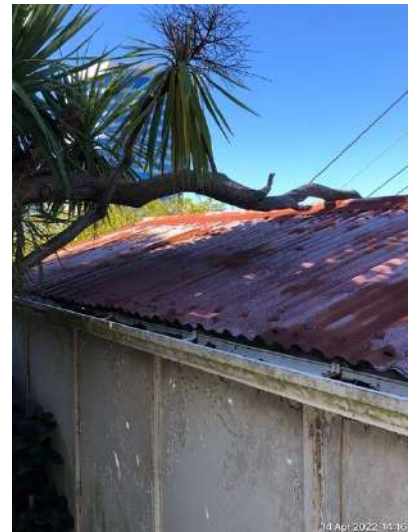
Photo Ref #250: Rust deterioration to roofing, replacement required

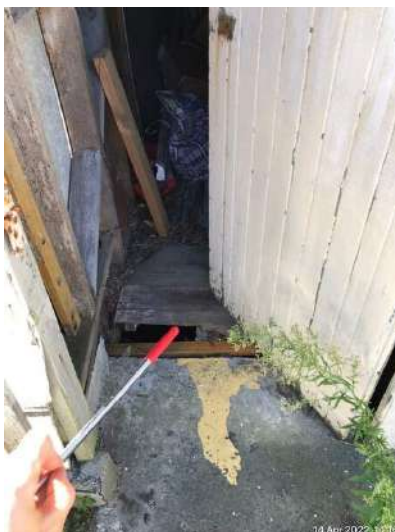
Photo Ref #251: Movement to timber flooring, subfloor frame repairs and strengthening required

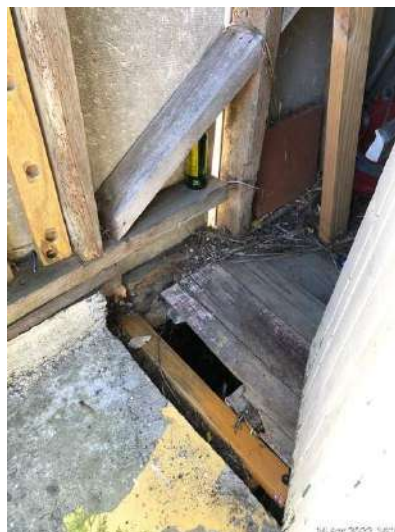
Photo Ref #252: Movement to timber flooring, subfloor frame repairs and strengthening required

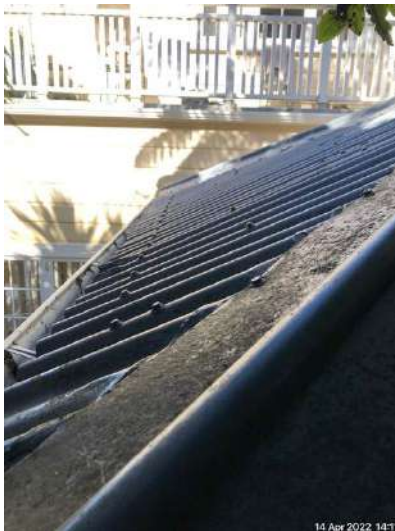
Photo Ref #258: Rust deterioration to roofing

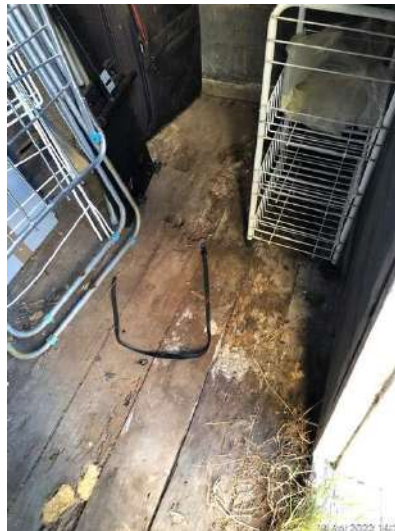
Photo Ref #259: Movement to timber flooring
