PRE-PURCHASE BUILDING INSPECTION REPORT

Sample Address

Inspection Date: 09 Mar 2021

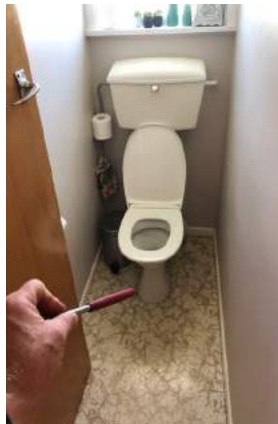
Photo Ref #45 :

✗ No - The pan was inadequately secured to the floor

The pan requires securing to the floor to prevent movement & leakages. Maintenance is required by a tradesman plumber.

Rating: Minor Maintenance

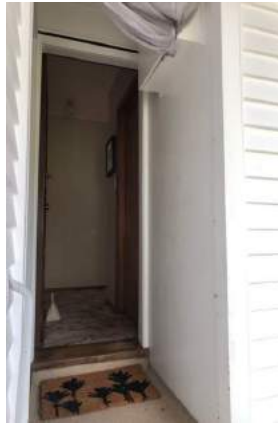
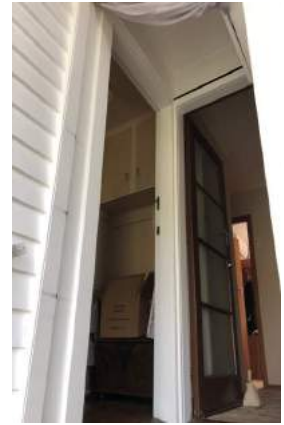
✓ Yes - The fibrous cement sheeting at the back door appeared in good condition for the age of the property.

- Take note this cladding may contain asbestos due to age, however this is unknown without lab testing. I recommend keeping it well painted at all times and testing is recommended prior to any remedial works.

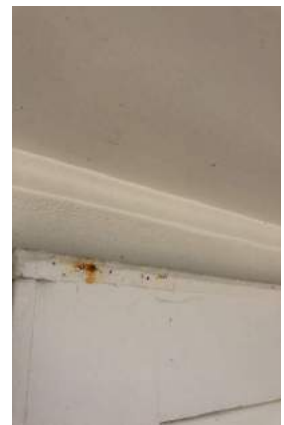
Photo Ref #84 :

✓ Yes - Overall the window and door units appeared well painted and in good condition for their age. However a handful of rusted head flashings were sighted

The rusted head flashings sighted above the windows & doors will require rust treatment repair work to ensure a weathertight barrier and prevent water ingress. This is a simple task for a licensed painter.

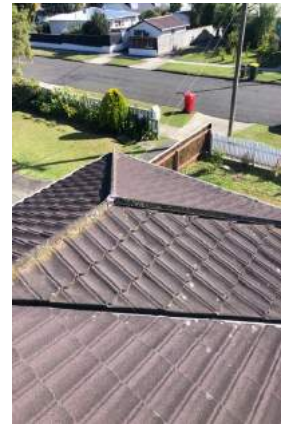
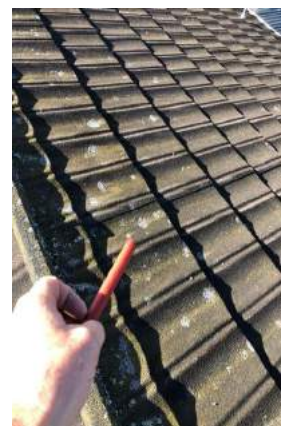
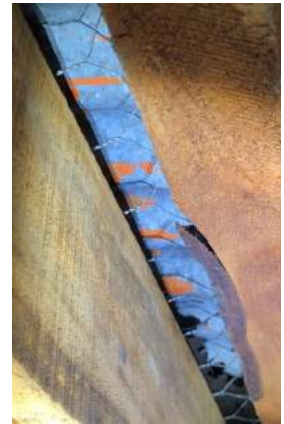
✗ No - Dented and loose tiles were noted

A metal tiled roof was in place. Some deterioration was sighted due to age, the metal tile roof requires minor re coating and painting on the front section of the roof to prevent rusting and also ensure it is watertight. Replacement is required of all dented tiles as this will allow water to sit in the tile and cause rust, further investigation is required by a licensed roofing specialist.

Take note the coating on the metal tiles may contain asbestos due to age however this is unknown without lab testing, I recommend testing takes place prior to any remedial works.

- Take note this metal tiled roof appears too have been installed over the top of the original corrugated iron roof. The condition of the corrugated iron below and how the metal tiled roof is connected to the below roof is unknown without an invasive inspection, also take into consideration should a re roof take place to the metal tiles it is more than likely the corrugated iron will also need replacement.

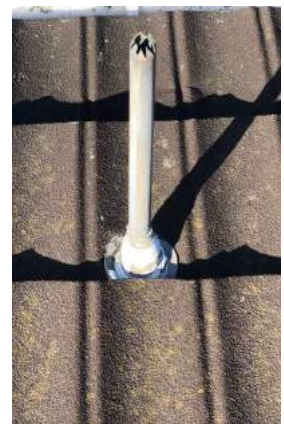
Photo Ref #107 :

✗ No - Seal deterioration detected

I recommend upgrading the vent seals with a water tight seal, this can take place by a licensed plumbing or roofing contractor.

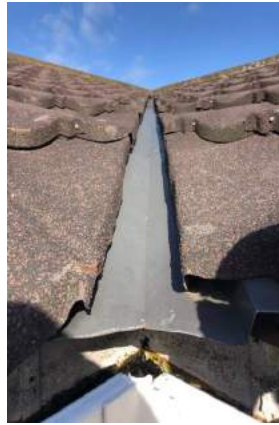
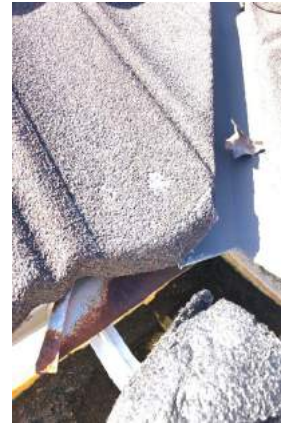
✓ Yes - The valleys appeared functional with no major deterioration or blockages sighted at the time of the inspection.

- Take note the original corrugated iron valley tray is still in place below and rust deterioration was noted.

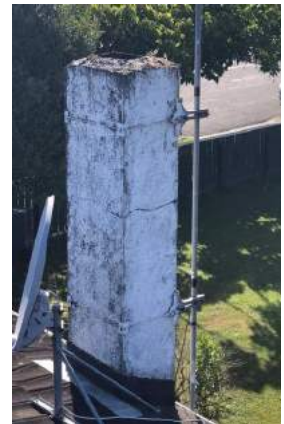
Photo Ref #118 :

✗ No - Chimney cracks were detected

Chimney cracks were sighted, this style of chimney is a safety hazard in the event of an earthquake. I recommend repairing or removing now, seek further advice from a structural engineer.

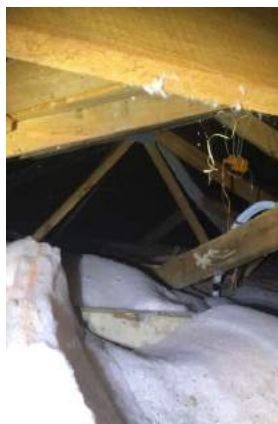
Photo Ref #123 :

✗ No - It appears modification have taken place, I recommend further investigation takes place by checking the plans to see if the modifications have a consent or permit.

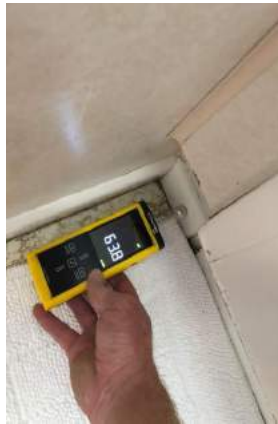
✗ No - Elevated moisture readings were detected in the one located area of the dwelling, further investigation and elimination of the elevated readings noted is recommended.

Photo Ref #173 :
Elevated moisture;
Right of the shower at
skirting height
