# SAMPLE REPORT

## MOISTURE INSPECTION REPORT

for John Smith

Inspection Date: 16 May 2023 |

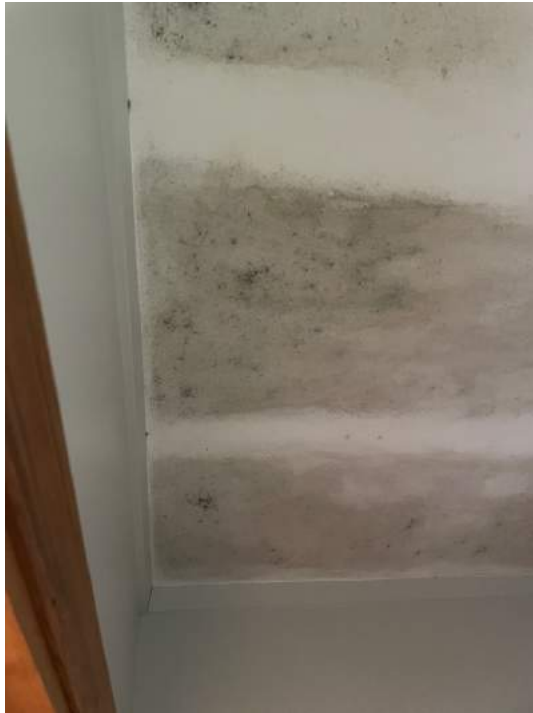
**CheckHome was engaged in assessing the ceilings of two back-to-back wardrobes that have mildew on them.**

Photograph 2: Mould to ceiling linings

- Sufficiently cleaning the mould in place. Recommend contacting ChemDry Barry Timms m. 021491 558
- Once cleaned the ceilings should be repainted and sealed.
- Insulation should be installed in the roof cavity above this area.
- Ensure the doors are not always closed, and windows in the rooms are open. The use of a DampRid Moisture Absorber will also help.

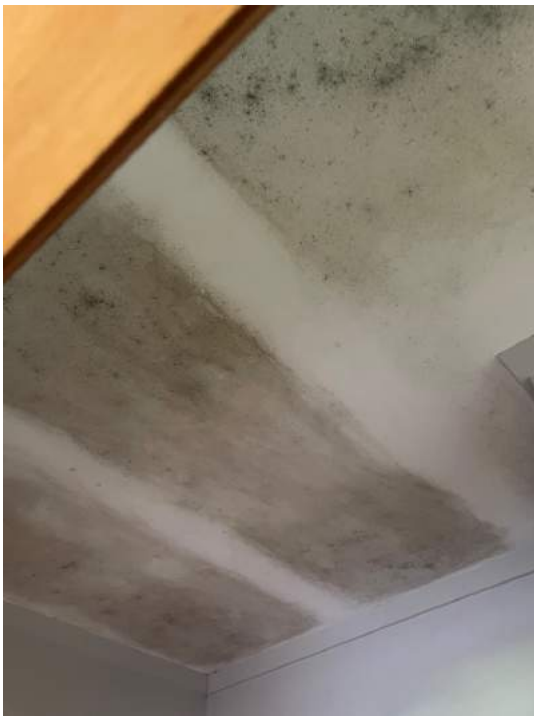
Photograph 3: Mould to ceiling linings

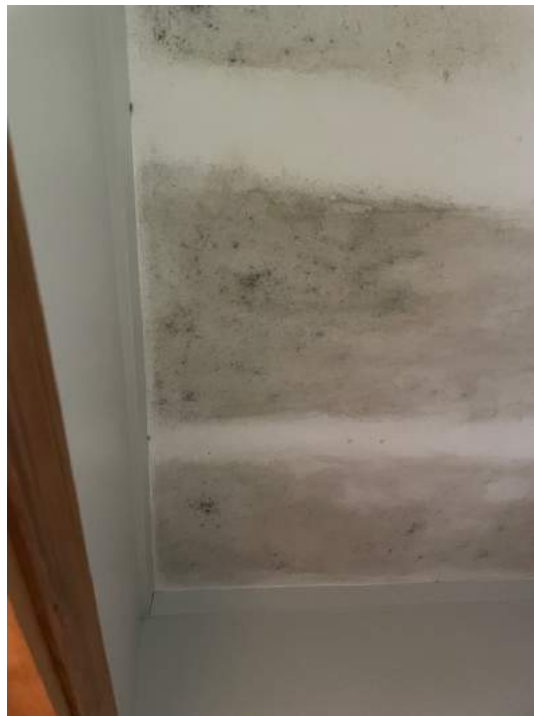
Photograph 4: Mould to ceiling linings

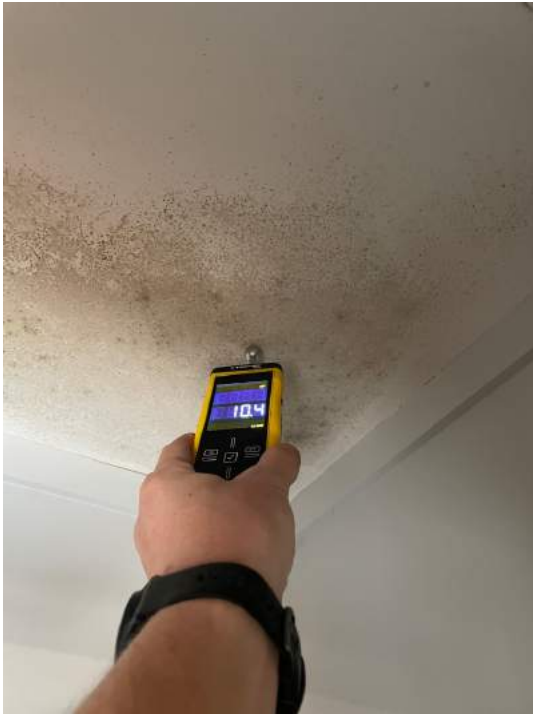
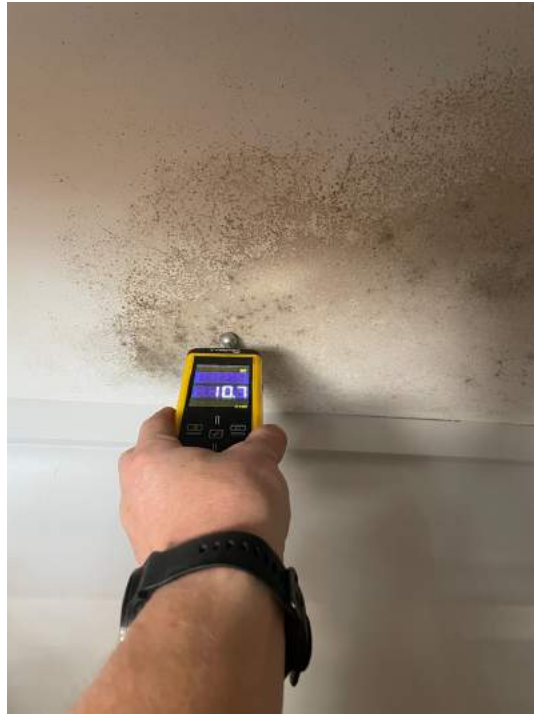
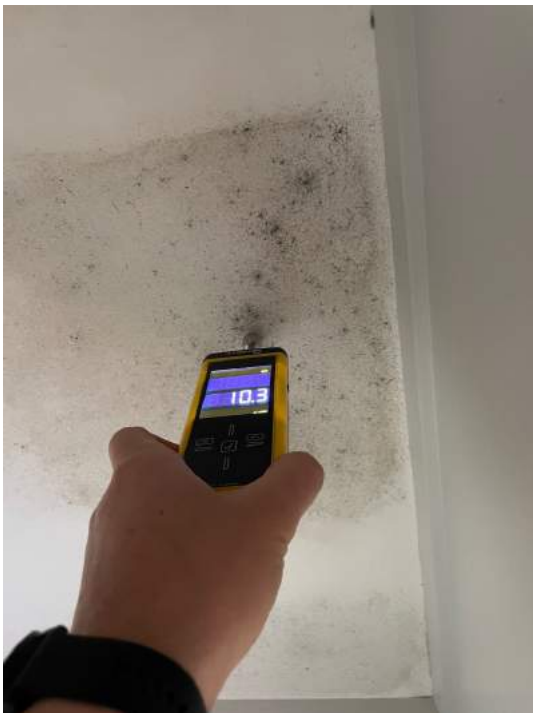
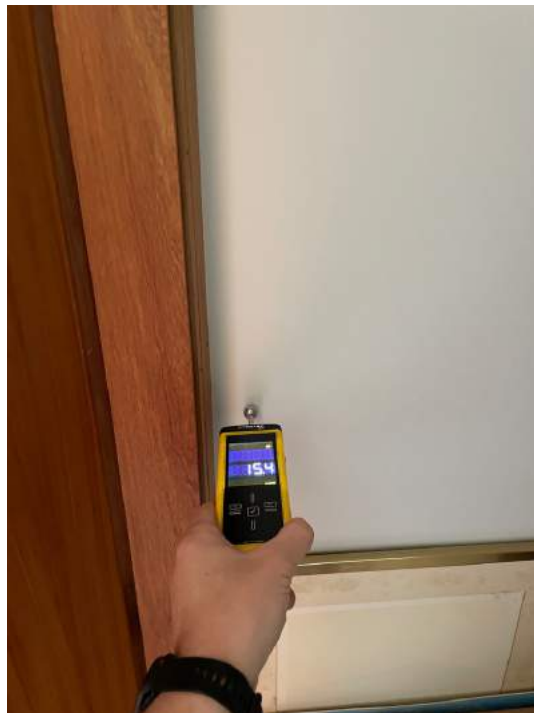
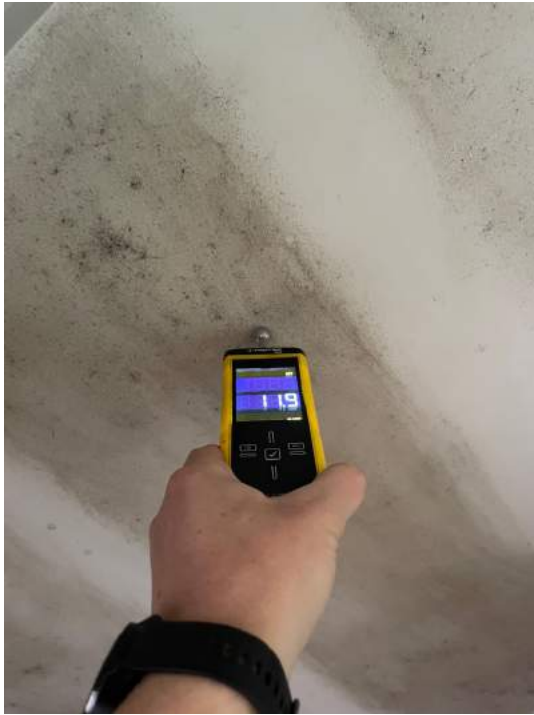
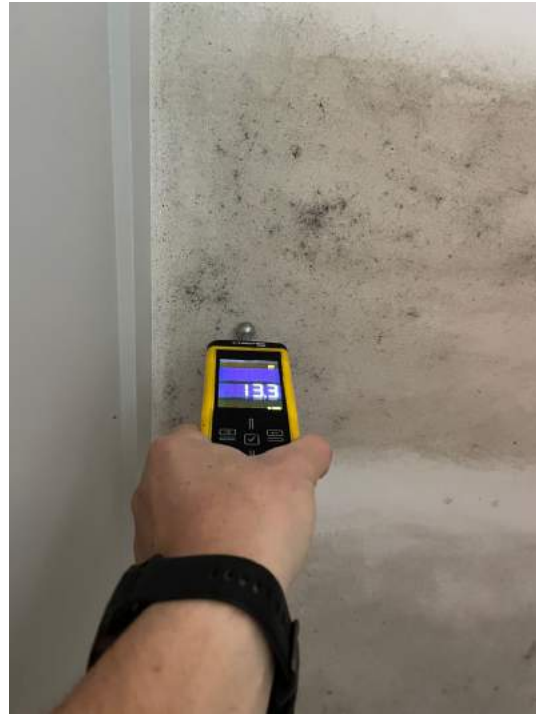
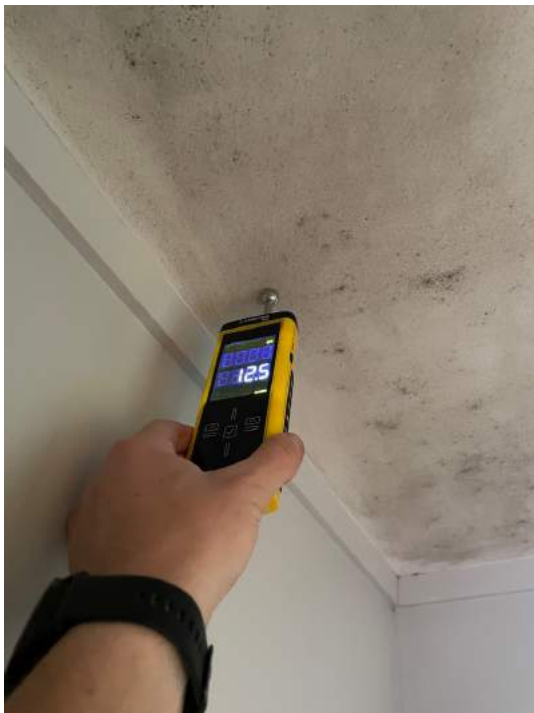
On assessment, no elevated moisture readings were detected to the ceilings or the walls around the affected areas, this shows it does not appear to be due to an external leak. Access was gained to the roof cavity directly above the wardrobes where it shows this area was not insulated.

Photograph 5: Acceptable moisture reading

Photograph 6: Acceptable moisture reading

Photograph 7: Acceptable moisture reading

Photograph 8: Acceptable moisture reading

Photograph 9: Acceptable moisture reading

Photograph 10: Acceptable moisture reading

Photograph 11: Acceptable moisture reading

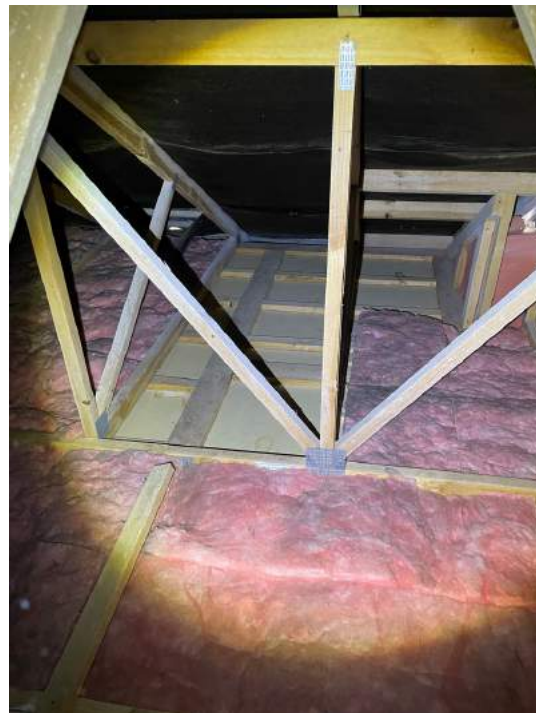
Photograph 12: No insulation above wardrobe

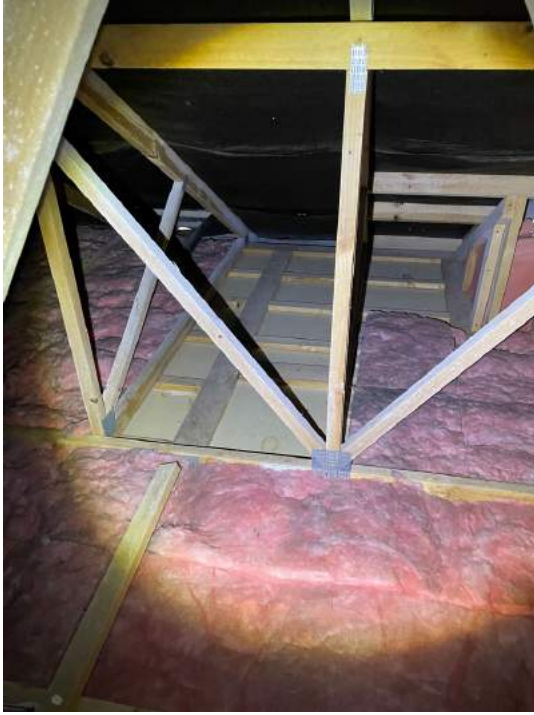
Photograph 13: No insulation above wardrobe

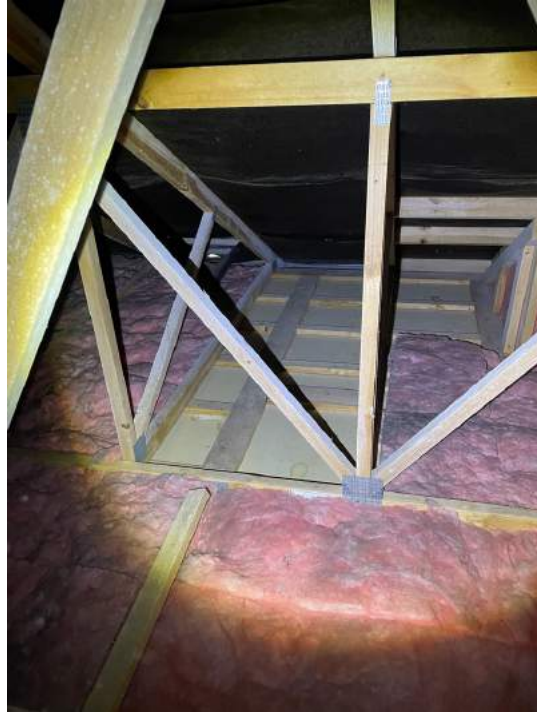
Photograph 14: No insulation above wardrobe
