# SAMPLE HANDOVER REPORT

## BUILDING INSPECTION REPORT

SAMPLE ADDRESS  
Wellington  
New Zealand

Inspected by: Kieran Long | Inspection Date: 31 May 2023 | Ph: 0212621120

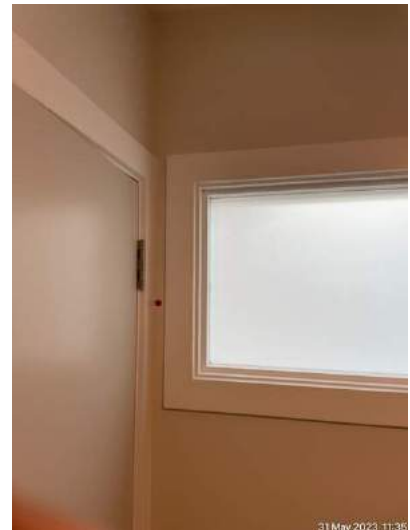
Photo Ref #9: Upstairs spare  
bedroom - plaster/paint  
imperfection

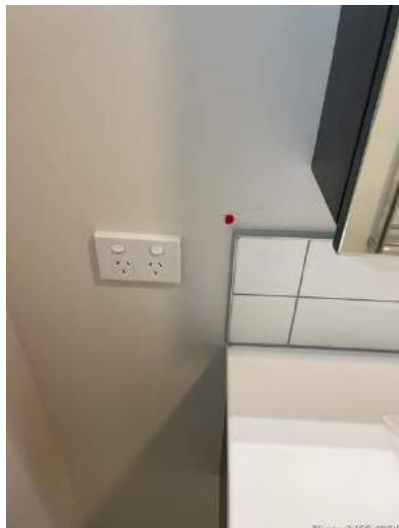
Photo Ref #10: Bathroom  
Upstairs spare bedroom -  
plaster/paint imperfection

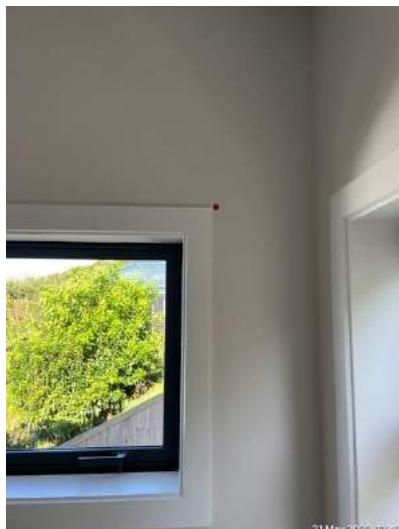
Photo Ref #13: Main bathroom -  
plaster/paint imperfection

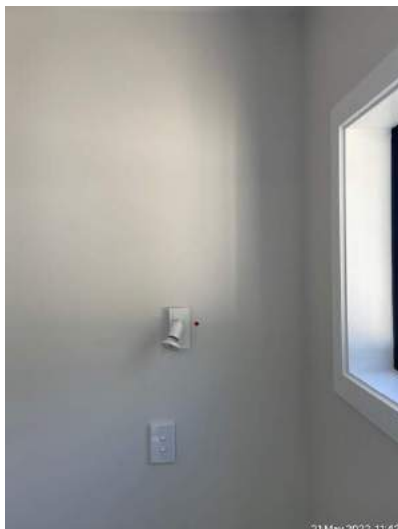
Photo Ref #14: Main bathroom -  
plaster/paint imperfection

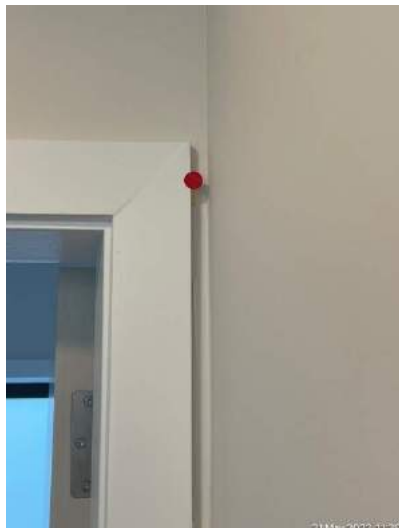
Photo Ref #16: Main bathroom -  
plaster/paint imperfection

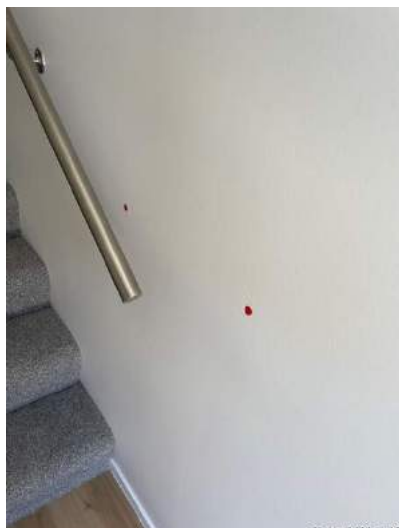
Photo Ref #19: Entrance way - plaster/paint imperfection

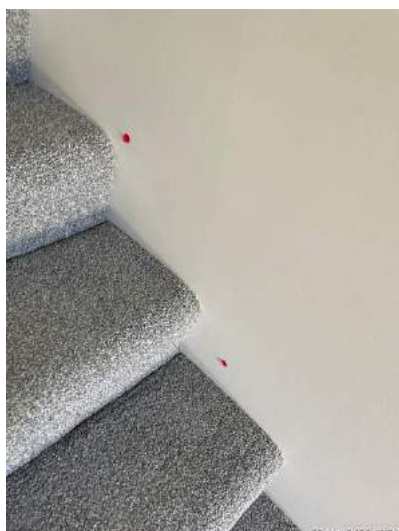
Photo Ref #22: Entrance/Hallway - plaster/paint imperfection

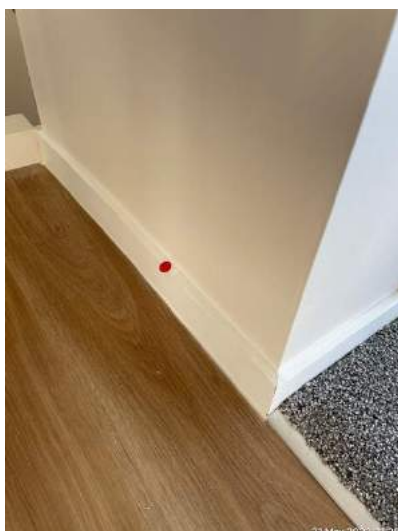
Photo Ref #23: Entrance/Hallway - plaster/paint imperfection

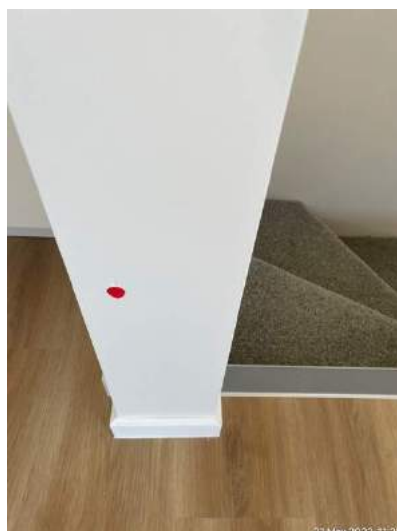
Photo Ref #24: Kitchen wall - plaster/paint imperfection

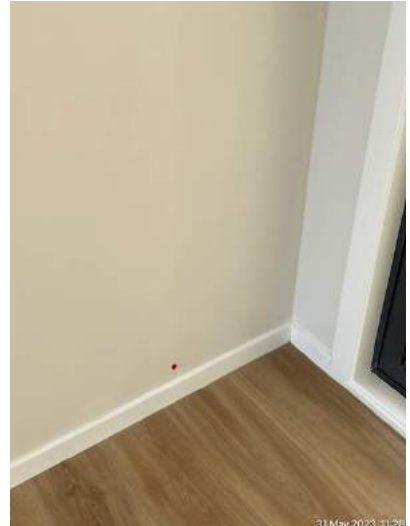
Photo Ref #27: Kitchen wall - plaster/paint imperfection

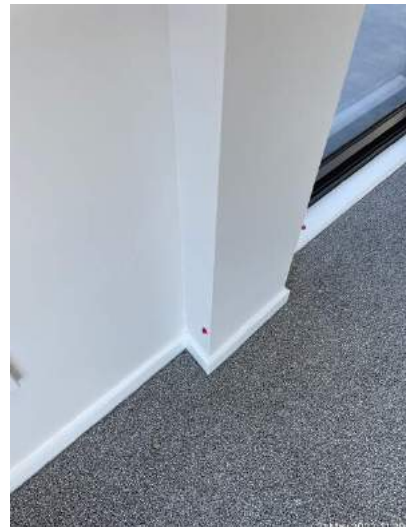
Photo Ref #30: Lounge - plaster/ paint imperfection

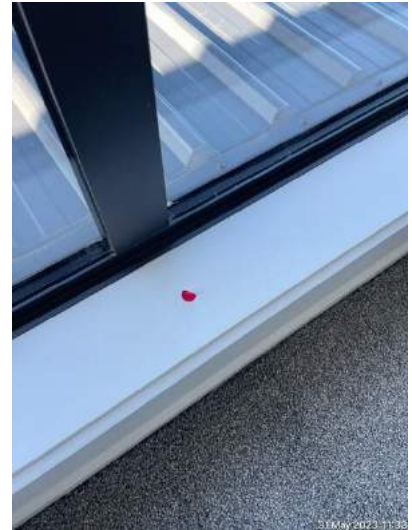
Photo Ref #37: Plaster/paint imperfection

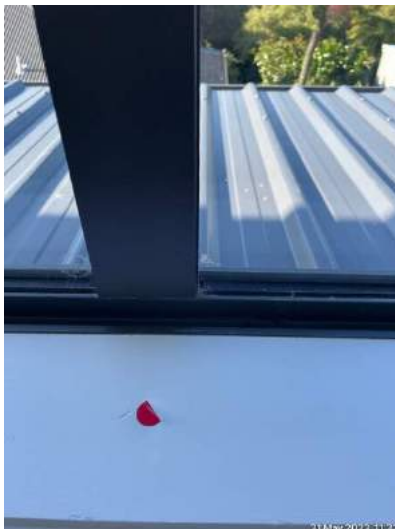
Photo Ref #38: Plaster/paint imperfection

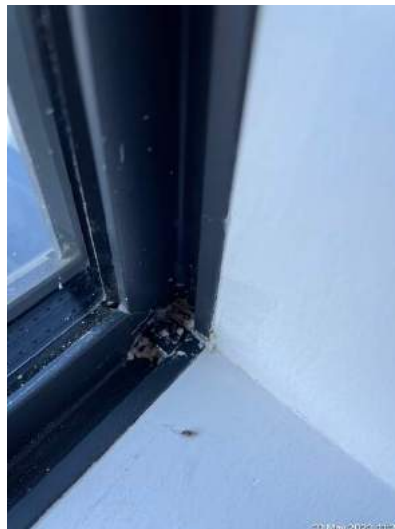
Photo Ref #39: Minor putty defects

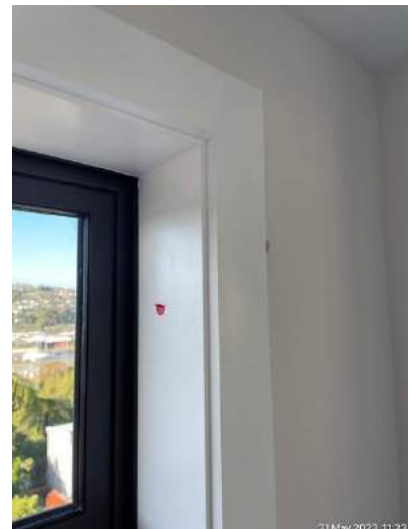
- The window has excess construction dust/dirt around the sill drains. Sill drains are used to allow excess moisture/condensation that can occur to the interior of the window to drain to the exterior. These should be cleared to ensure they can drain freely.

Photo Ref #40: Excess construction dust/dirt around the sill drains

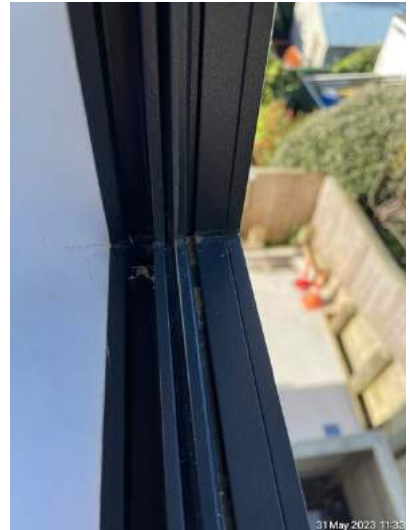
Photo Ref #43: Plaster/paint imperfection

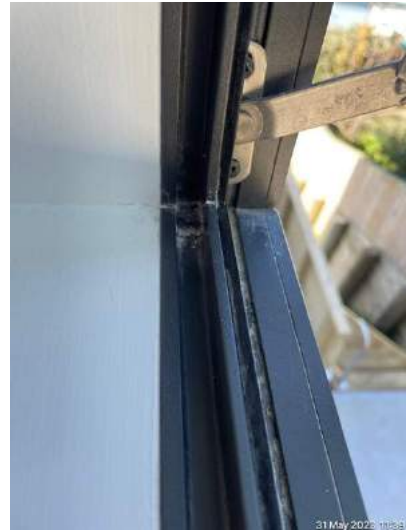
Photo Ref #47: Plaster/paint imperfection

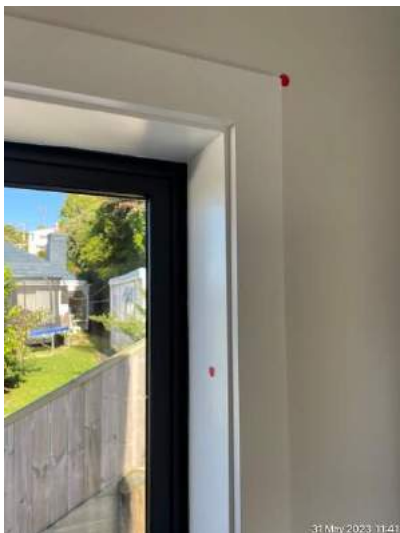
Photo Ref #52: Plaster/paint imperfection

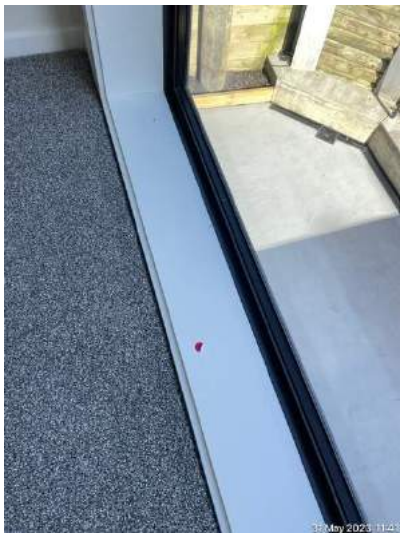
Photo Ref #54: Plaster/paint imperfection

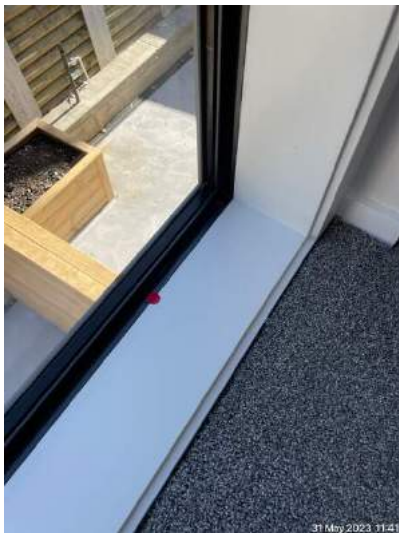
Photo Ref #55: Plaster/paint imperfection

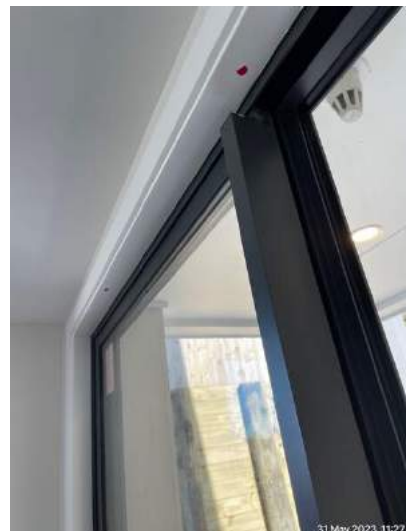
Photo Ref #60: Plaster/paint imperfection

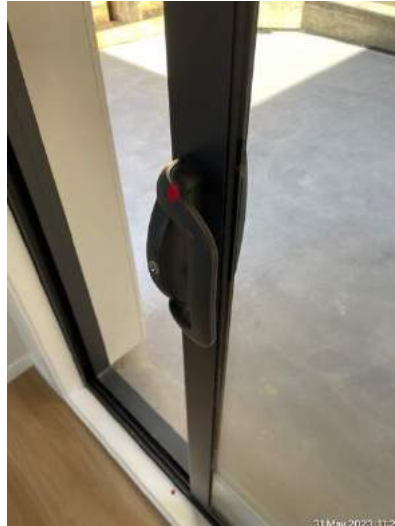
- A loose door handle was detected on the sliding door. This requires securing.

Photo Ref #62: Loose door handle

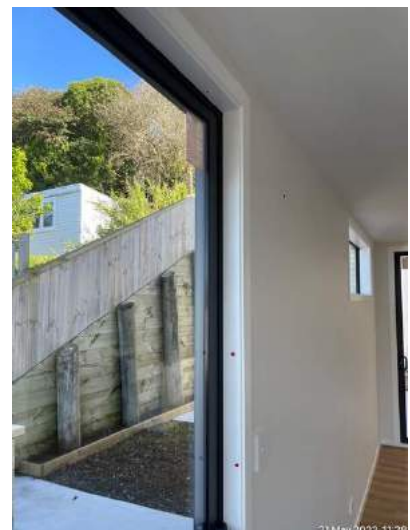
Photo Ref #64: Plaster/paint imperfection

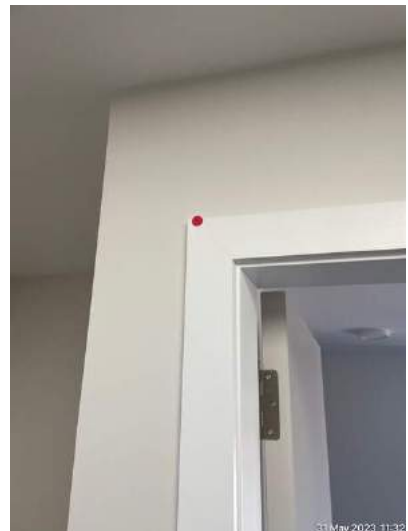
Photo Ref #71: Plaster/paint imperfection

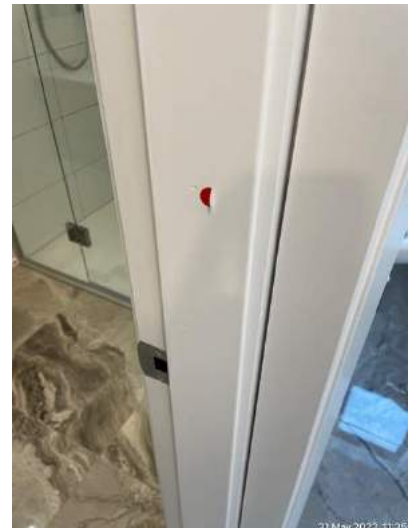
Photo Ref #75: Plaster/paint imperfection

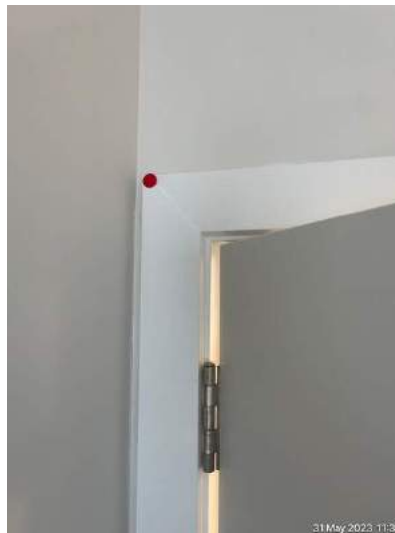
Photo Ref #78: Plaster/paint  
imperfection

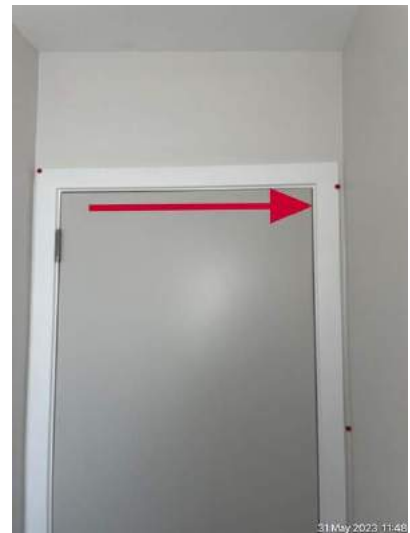
Photo Ref #79: Door binding on  
frame

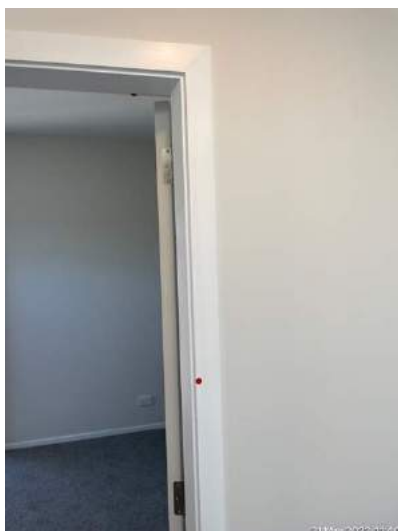
Photo Ref #81: Plaster/paint  
imperfection

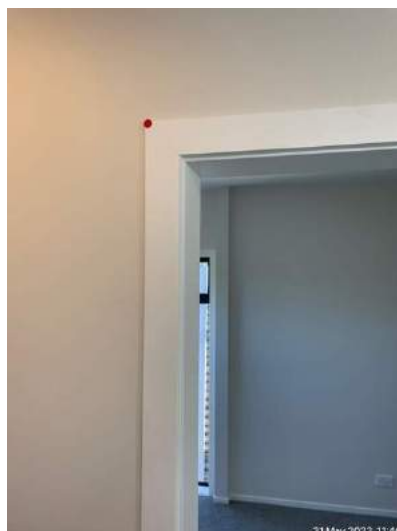
Photo Ref #82: Plaster/paint  
imperfection

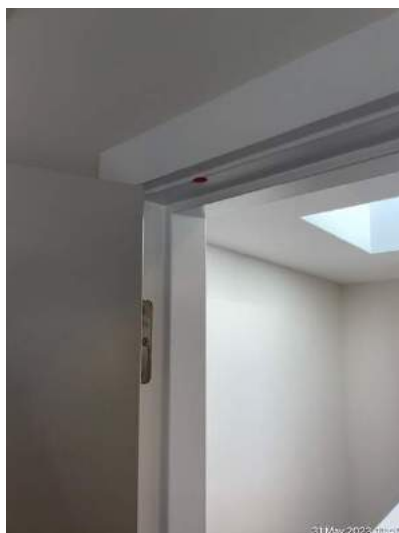
Photo Ref #83: Plaster/paint  
imperfection

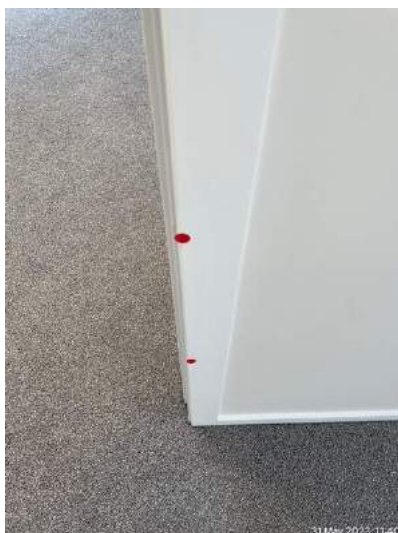
Photo Ref #84: Plaster/paint  
imperfection

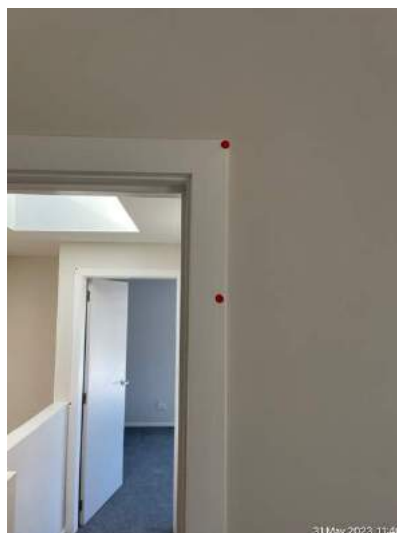
Photo Ref #85: Plaster/paint  
imperfection

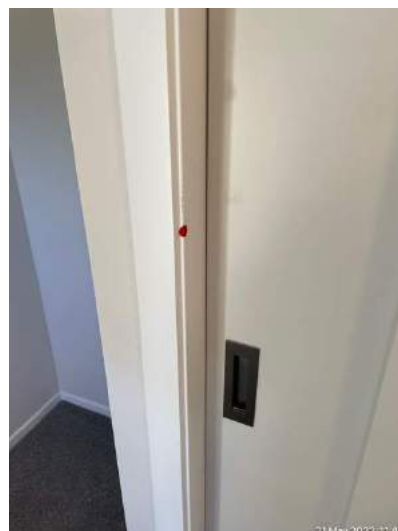
Photo Ref #88: Paint imperfection

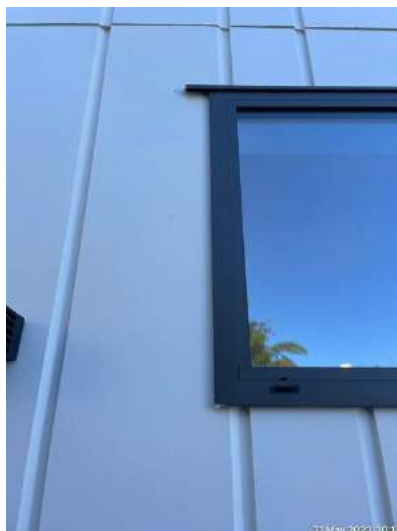
The vertical fibre cement weatherboard/shiplap cladding appeared in reasonable condition. The paint coating was unfinished in some areas. Refer to photographs and details below.

Photo Ref #116: Southern wall - imperfections to paint coating

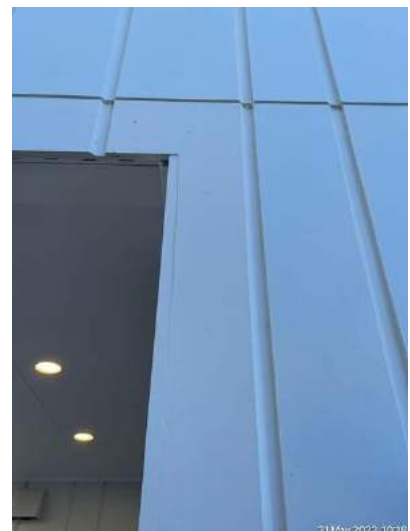
Photo Ref #118: Southern wall - imperfections to paint coating

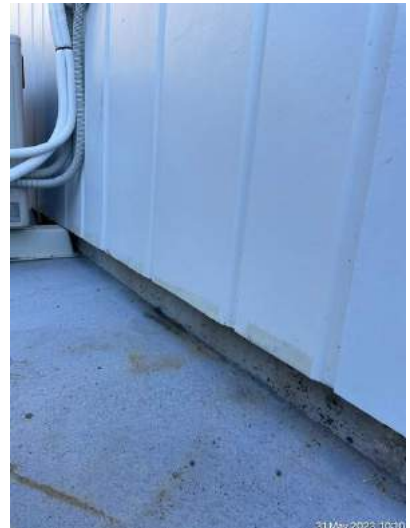
Photo Ref #124: Southern wall - bottom of cladding not painted

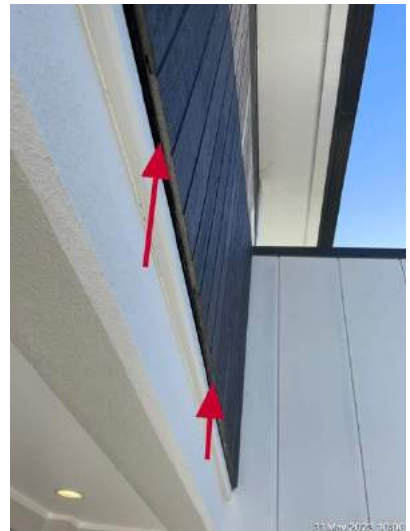
Photo Ref #133: Eastern wall - bottom edge of cladding not painted

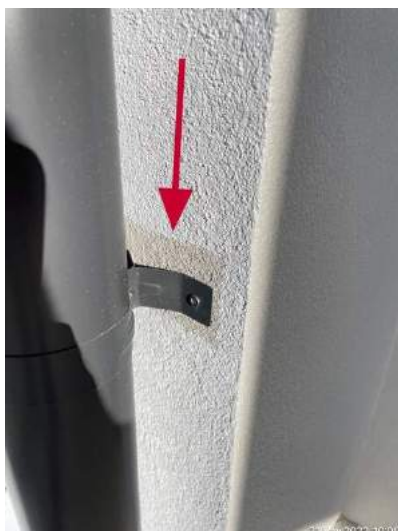
Photo Ref #135: Paint imperfections

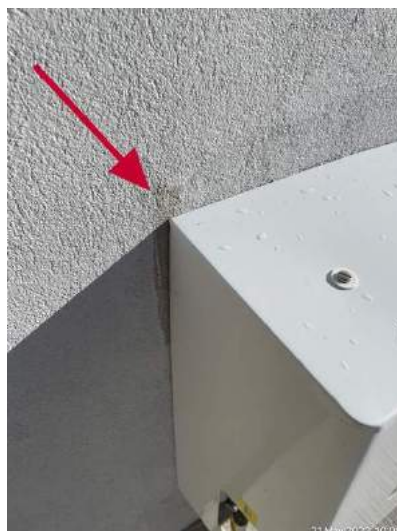
Photo Ref #136: Paint imperfections

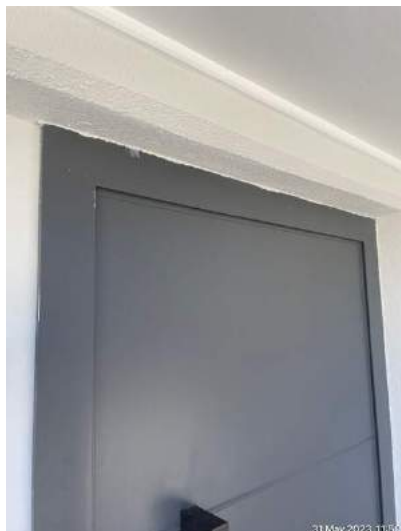
Photo Ref #139: Excess paint to front door frame

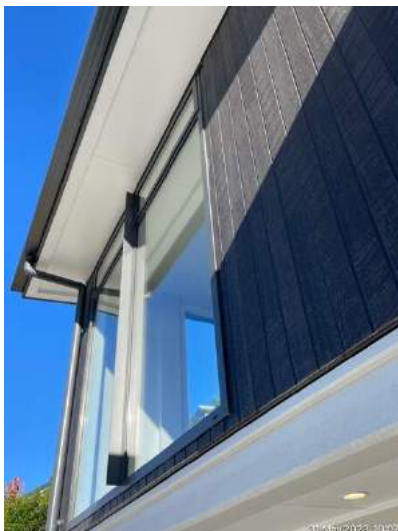
Details:	- Gaps were sighted at the lower window & door to cladding junctions. this could potentially lead to water ingress in the cavity. I recommend referring to the council plans to see if sealant or a scrubber is required.
Rating:	Minor Maintenance

Photo Ref #140: Gaps at joinery to cladding

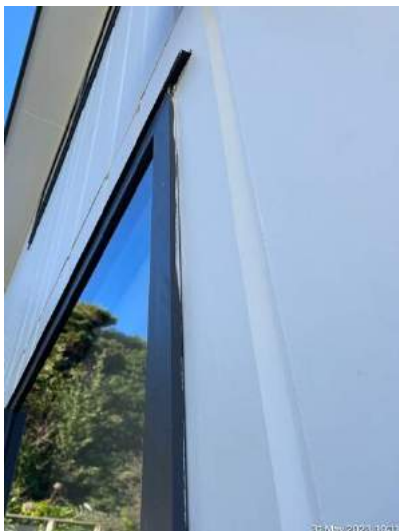
Photo Ref #141: Gaps at joinery to cladding

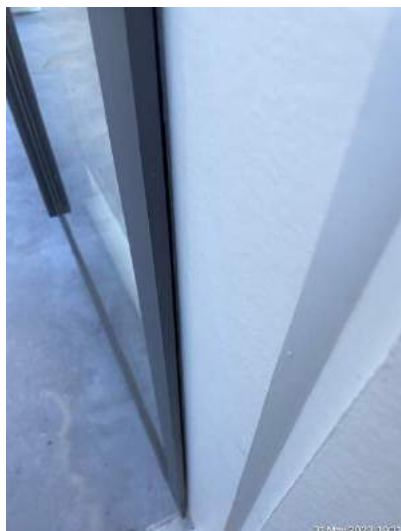
Photo Ref #142: Gaps at joinery to cladding

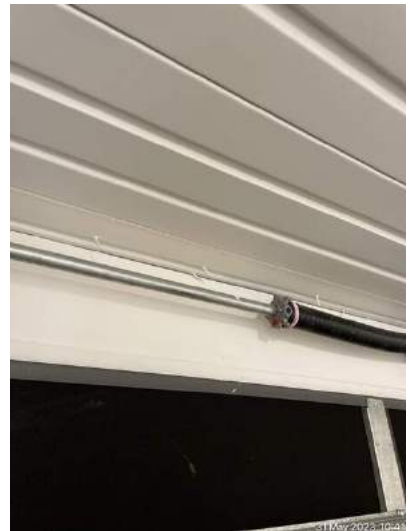
- Exposed nails were sighted coming through the ceiling above the garage door. This could be a hazard. These require removal with a smooth finish.
- Excess paint was in place to the garage concrete floor. This requires cleaning.
- Excess concrete seepage was sighted around the garage masonry block walls.

Photo Ref #154: Exposed nails were sighted coming through the ceiling

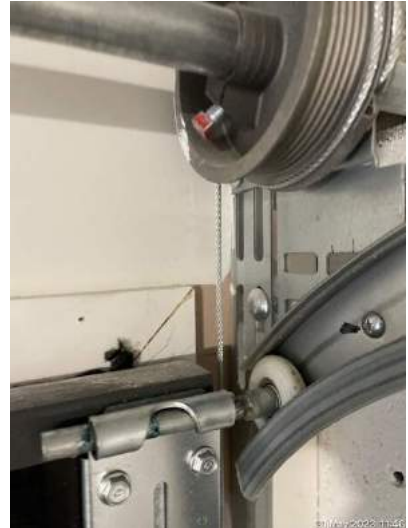
Photo Ref #157: Unpainted areas either side of garage door

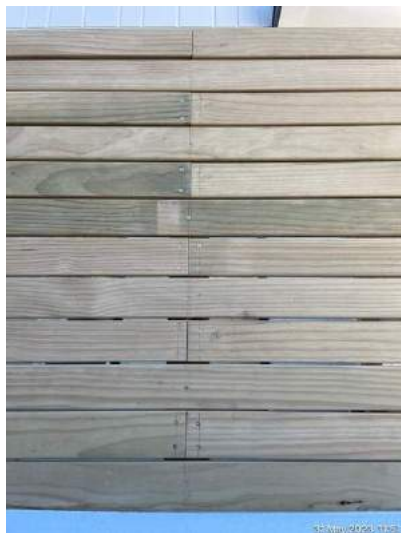
Photo Ref #160: Pencil marks to fencing

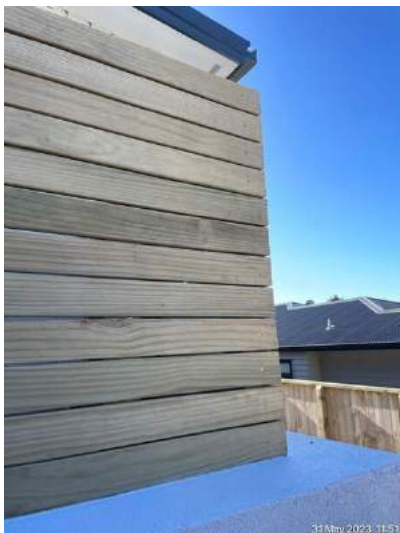
Photo Ref #161: Pencil marks to fencing

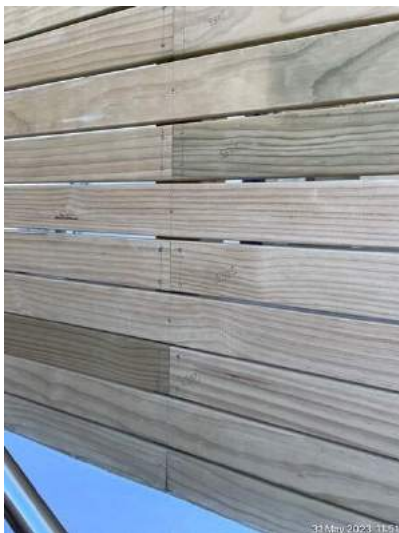
Photo Ref #162: Pencil marks to fencing
