TRANSITION STUDY

Sample Community Association
6987 Landing Drive
Sample City, VA

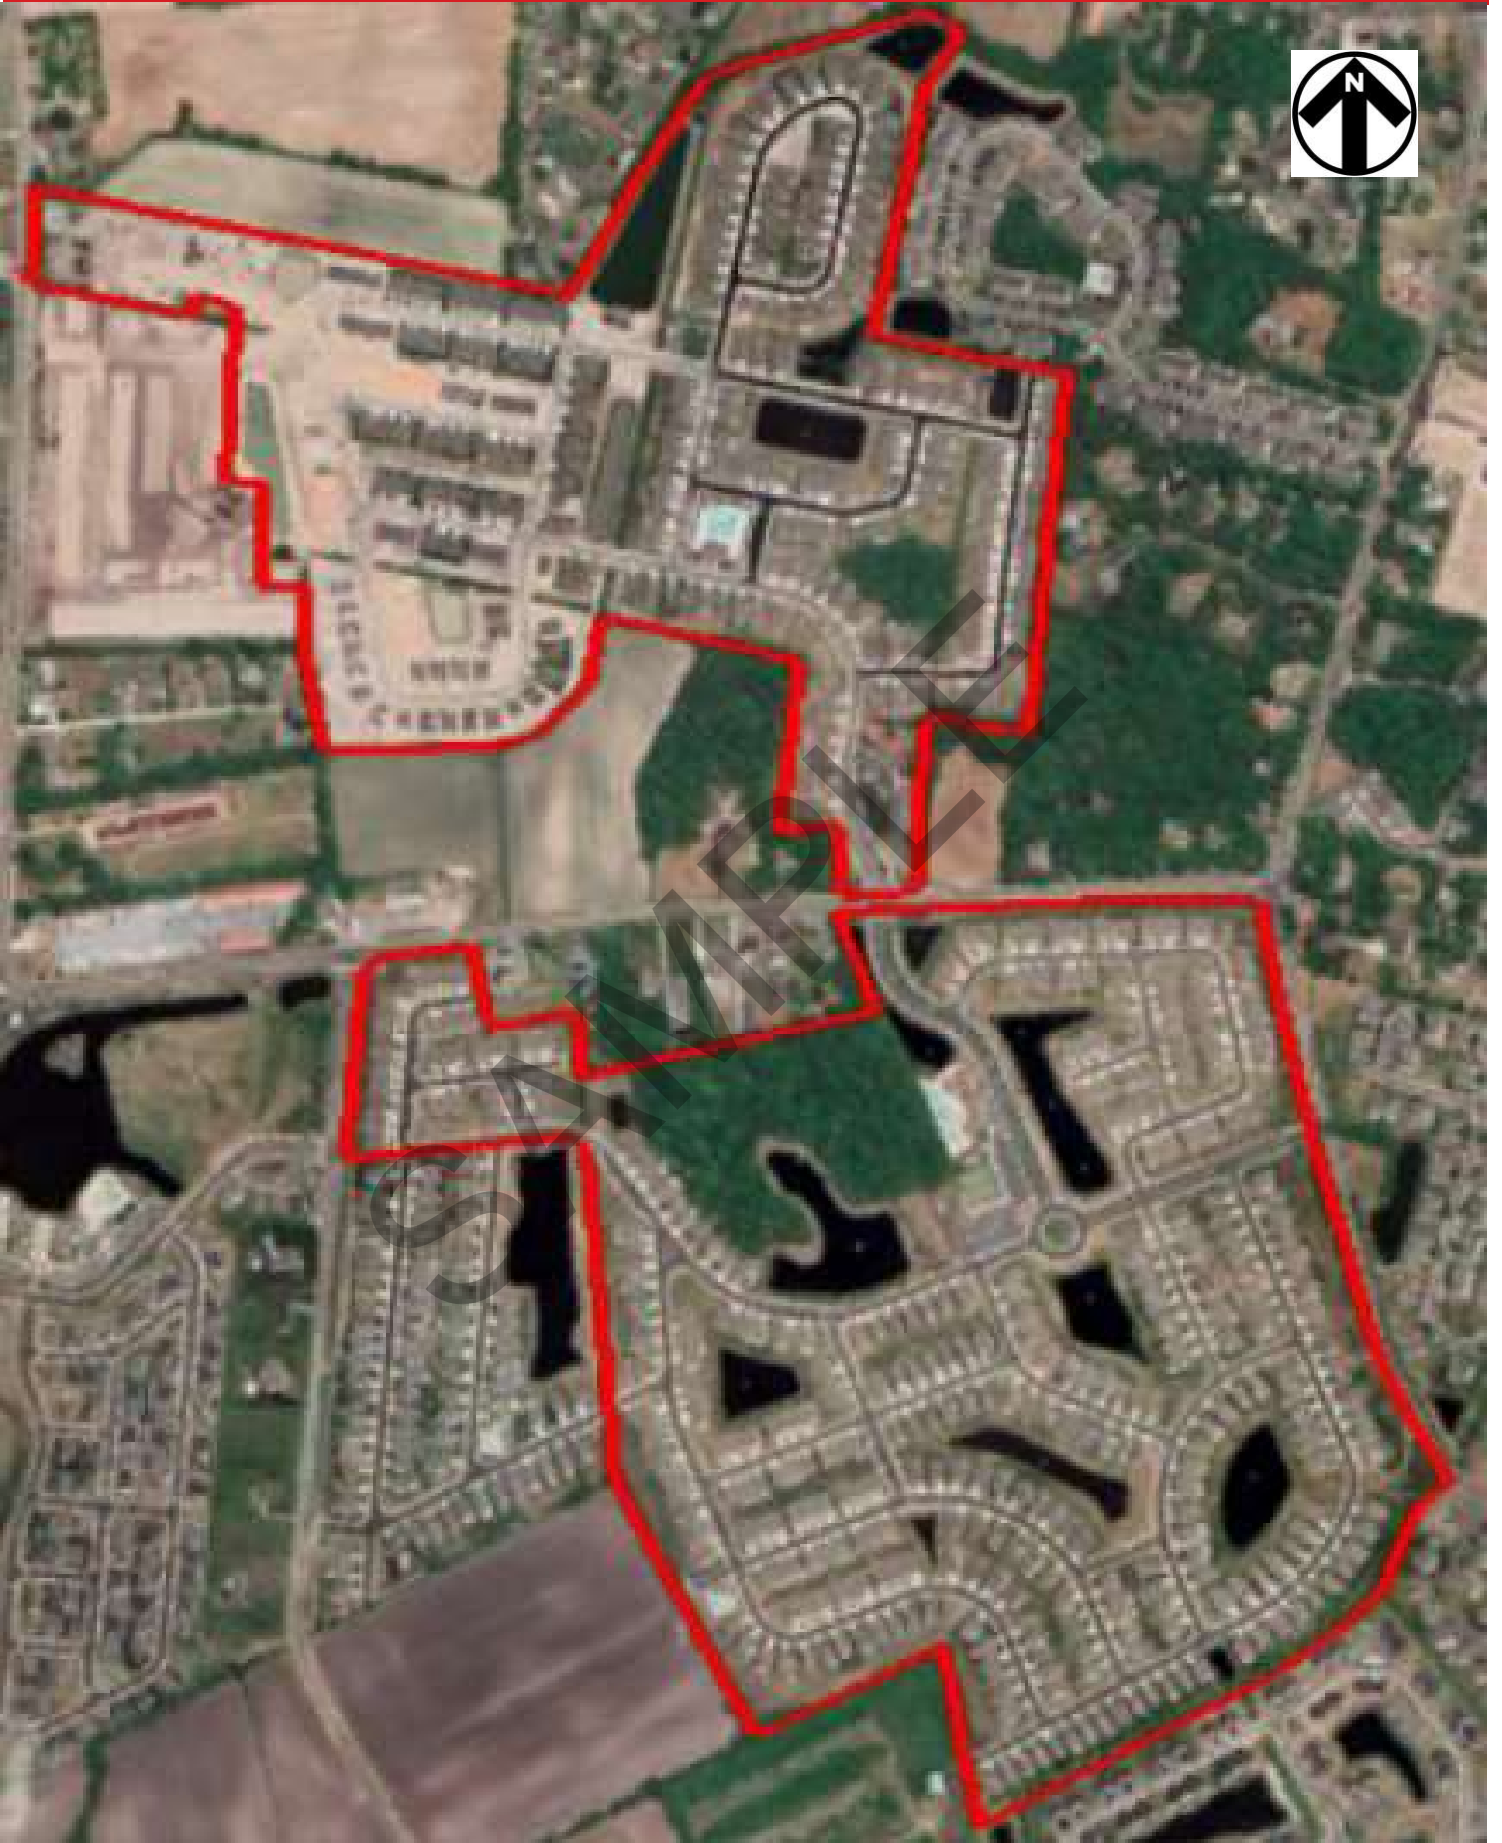
- Assist boards in fulfilling fiduciary responsibilities
- Preserves community appearance
- Preserves capital funds for future projects for routine maintenance, repairs, and replacements
- Eliminates costs associated with unnecessary near-term capital projects borne by community

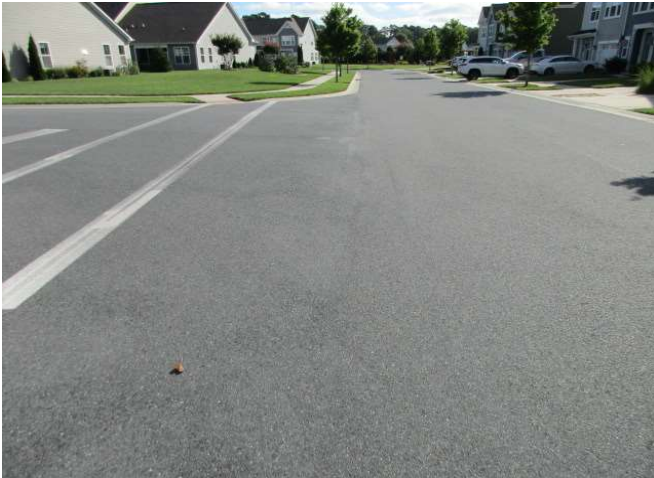
Intersection overview

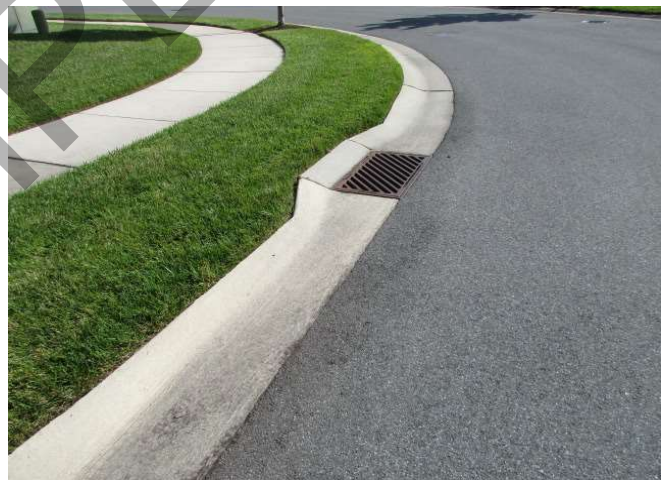
Pavement lower than catch basin entrance

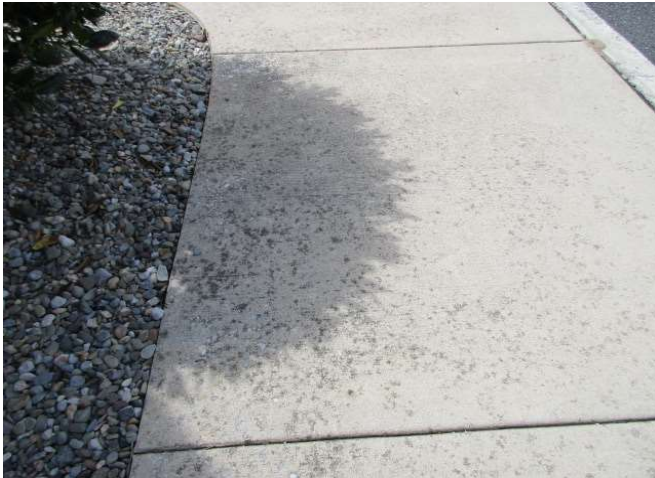
Spalled concrete sidewalk south mailbox kiosk

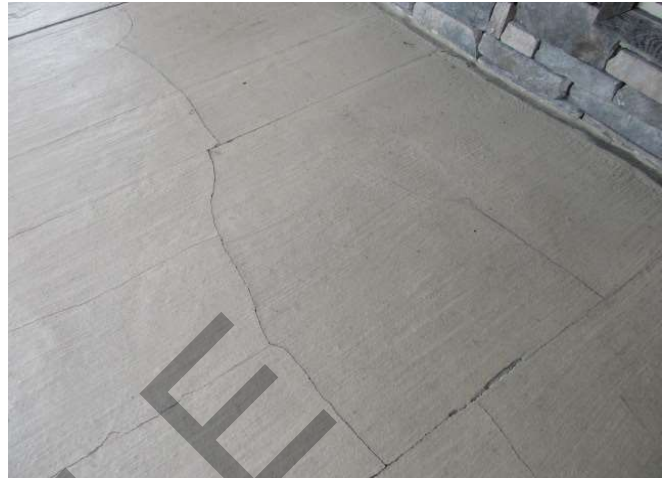
Cracked coating at south mailbox kiosk

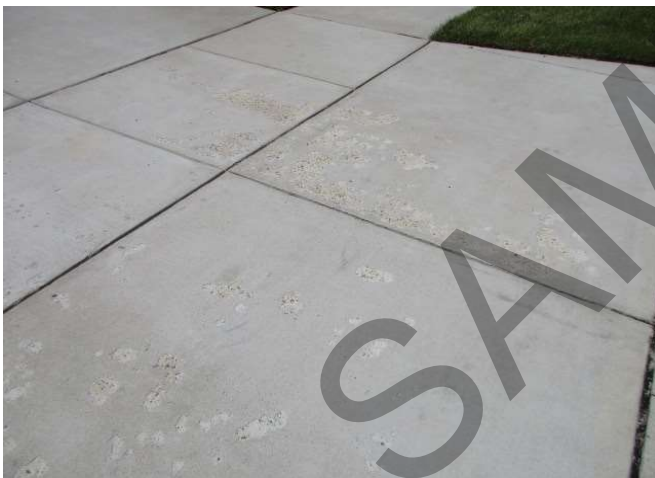
Spalled concrete driveway apron at 18201 Delafort Lane

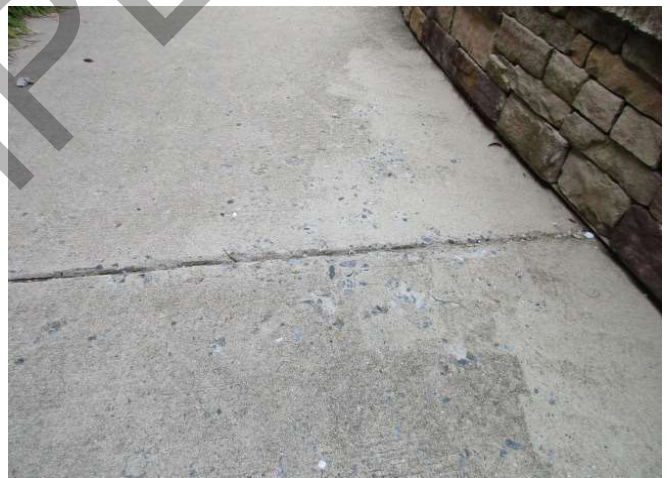
Spalled concrete near BLS clubhouse entrance

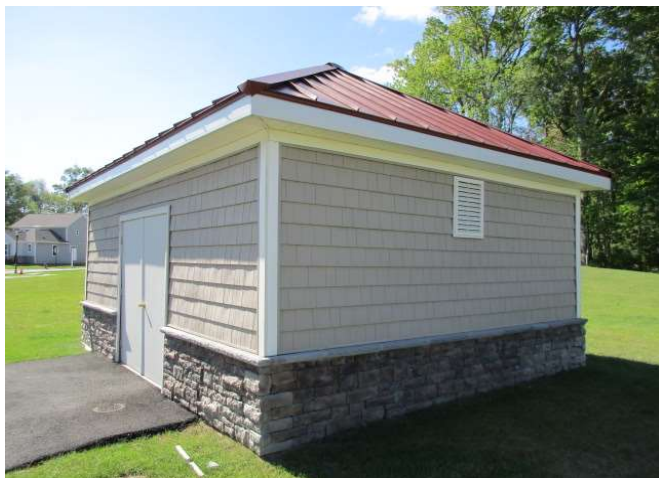
Existing BLN well house

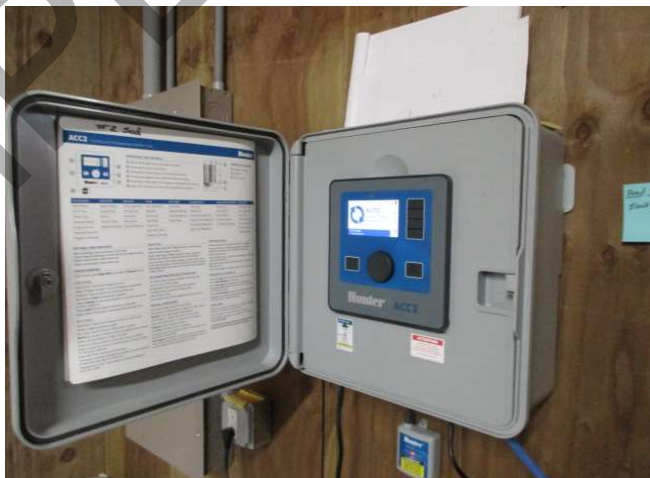
Existing BLN irrigation controller

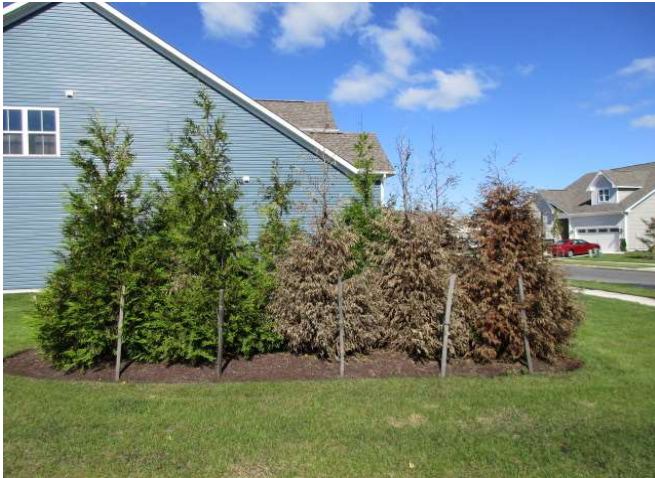
COMPONENT PHOTOGRAPHS

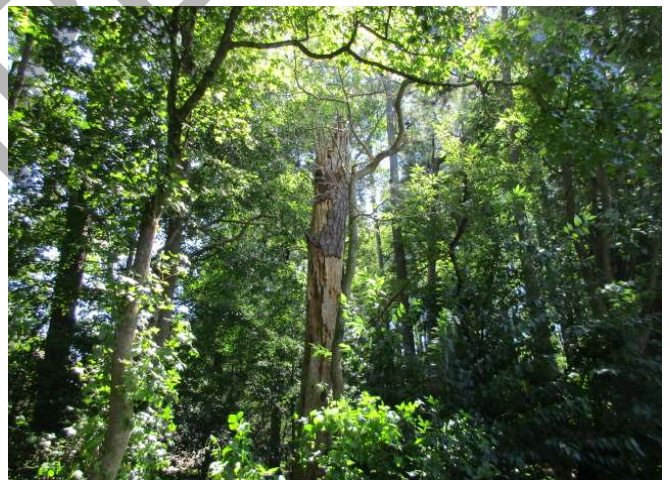
Dead tree in natural area west of BLS clubhouse

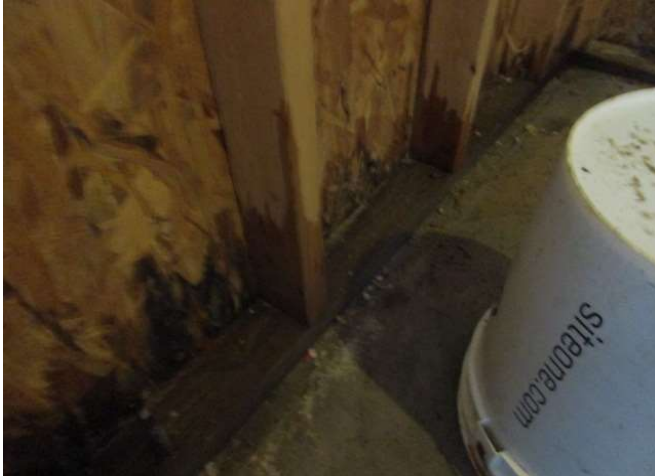
Water damage at BLS clubhouse irrigation well house

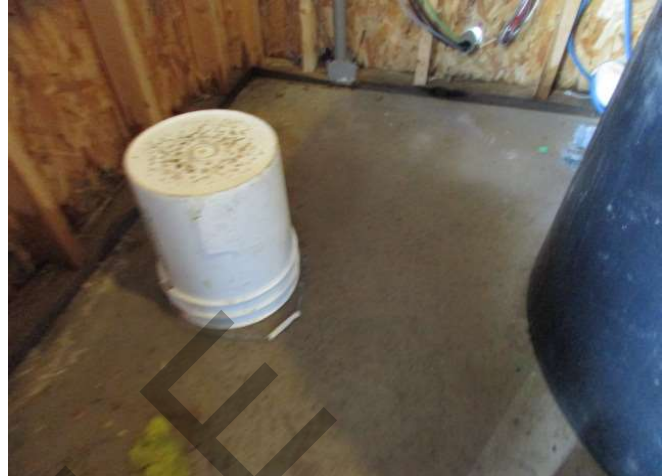
Standing water at BLS clubhouse irrigation well house

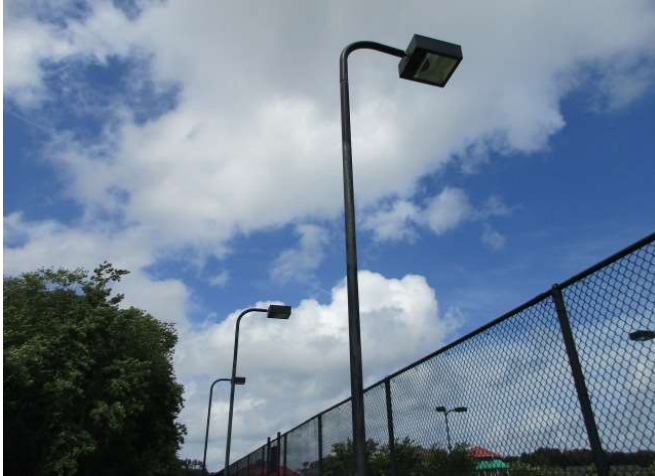
Tennis court light poles

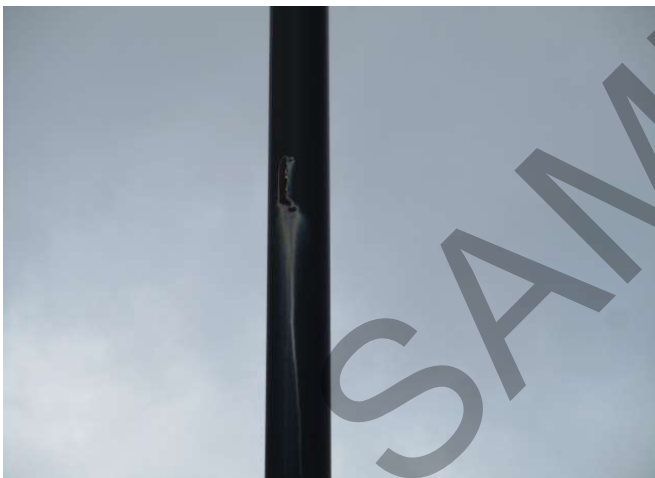
Finish deterioration

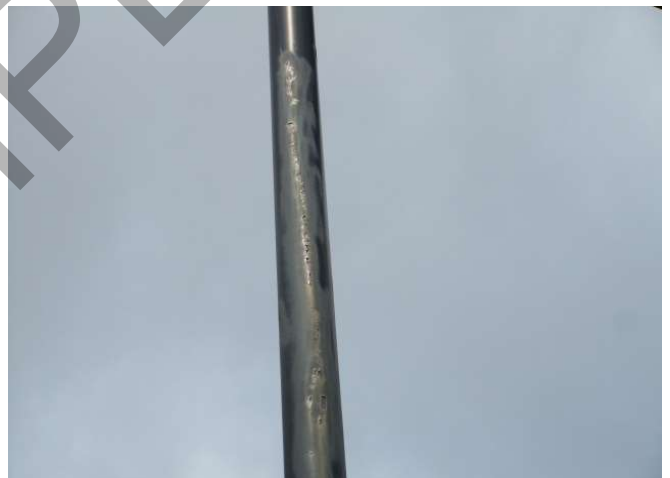
Faded finish at pole

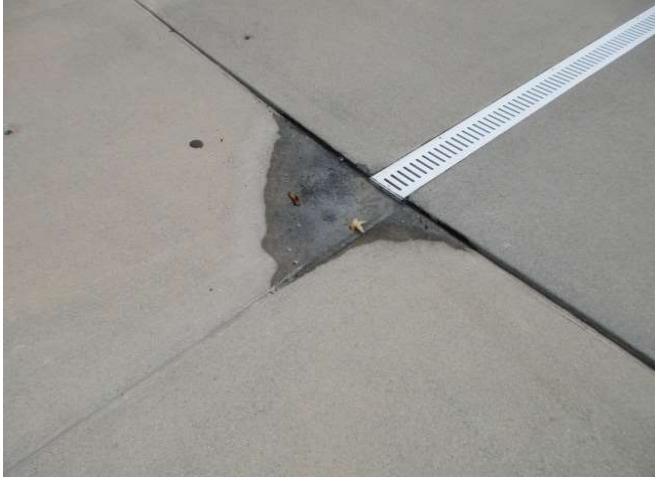
Concrete settlement at BLS pool deck

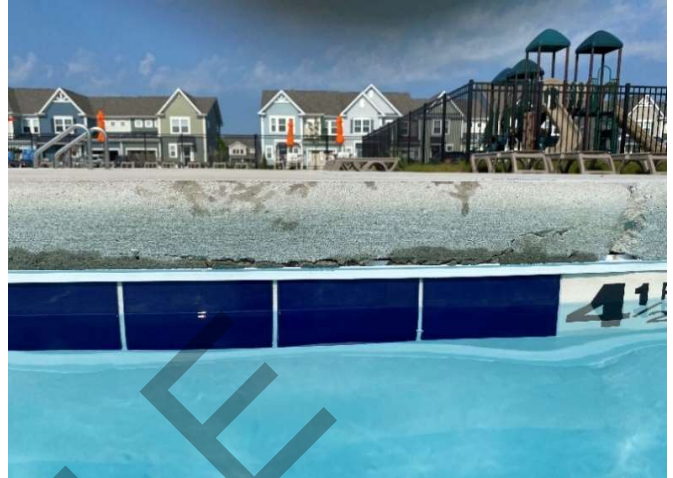
Coping deterioration at BLN - photo provided by client

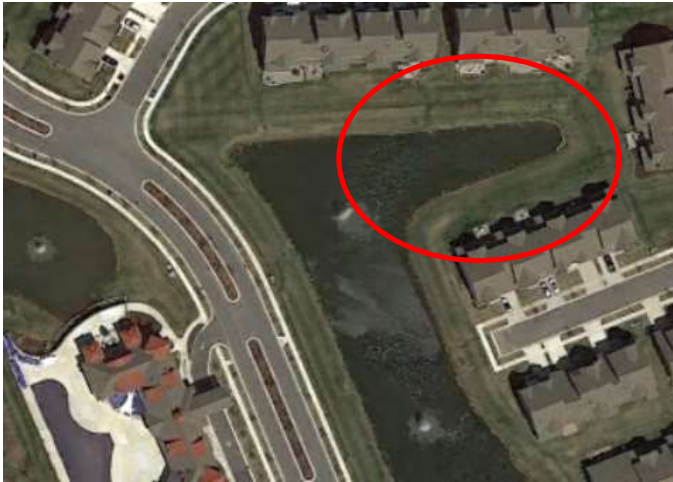
Pond #3 with narrow area at east side

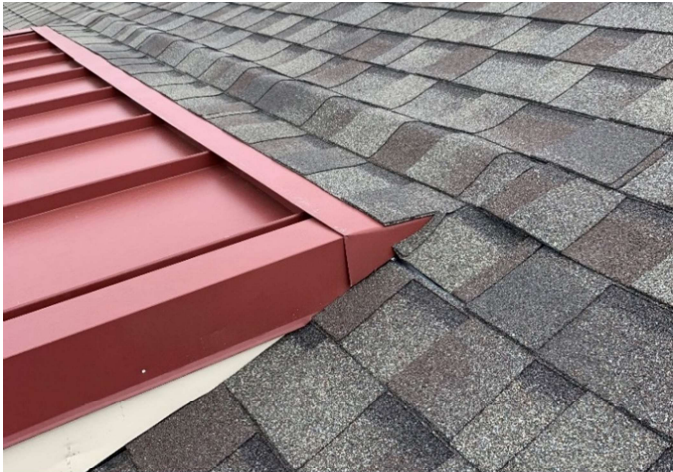
"Hump" over metal/shingle interface - photo provided by client

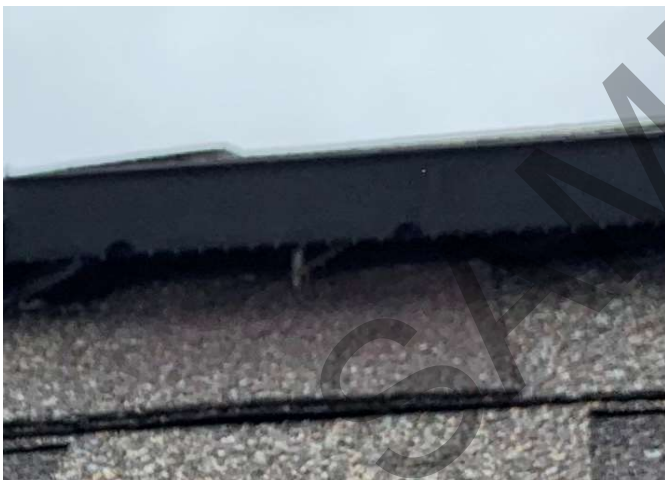
Loose ridge vent - photo provided by client

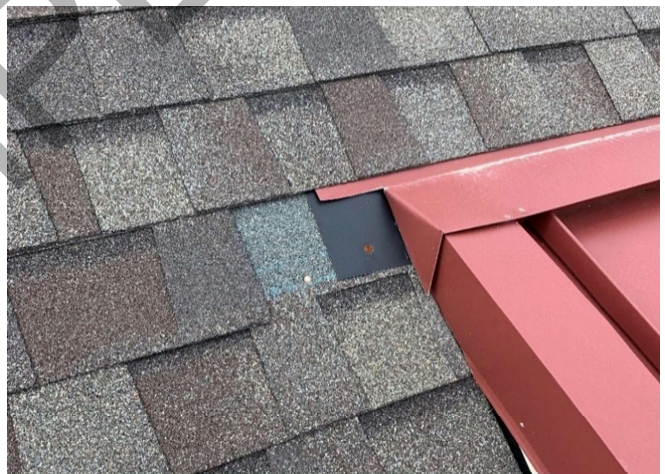
Missing shingle - photo provided by client

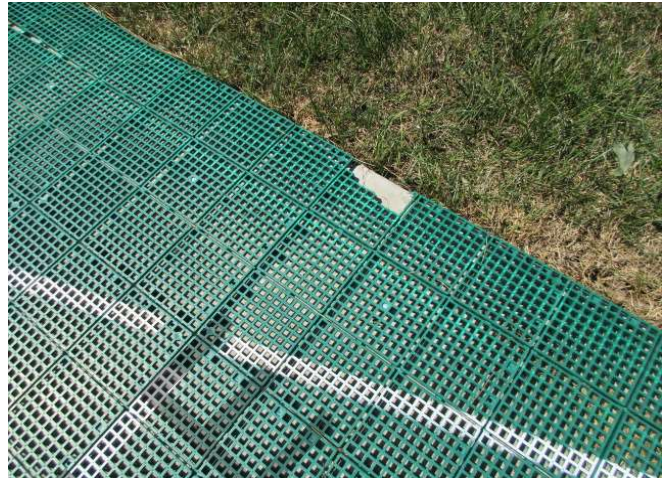
Damaged poly surface

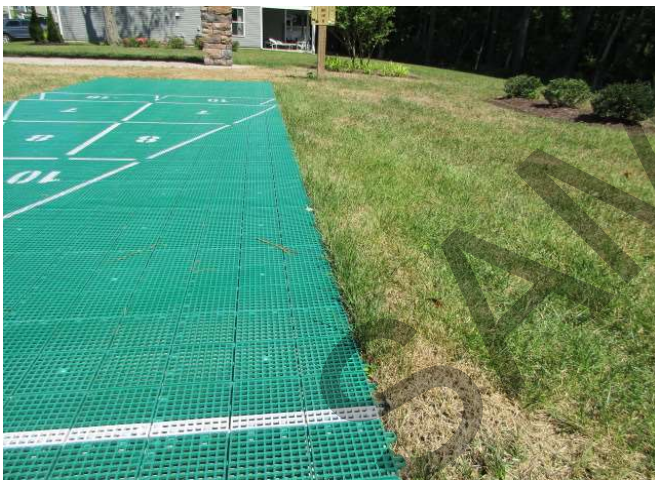
Landscape growth adjacent to court

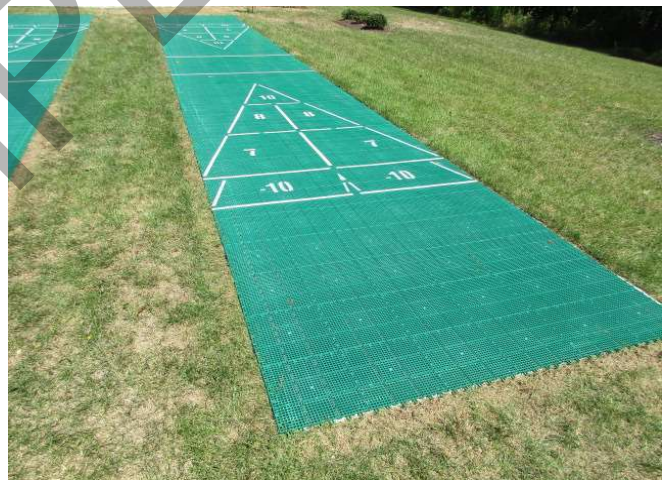
Lack of border around poly surface

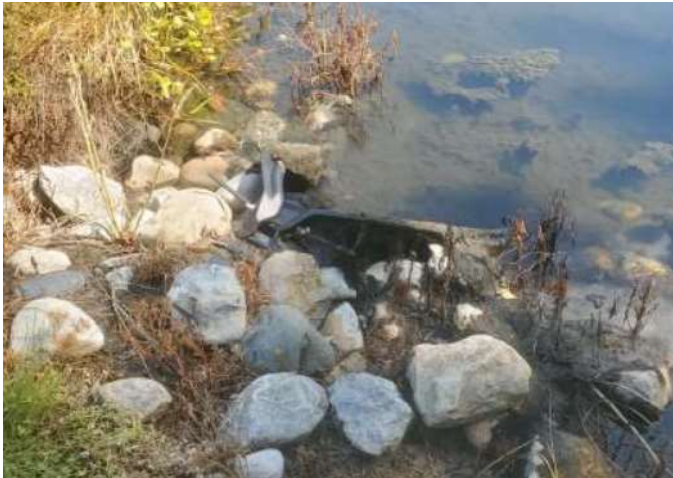
Lack of geotextile fabric at Pond #2 - photo from Envirotech report

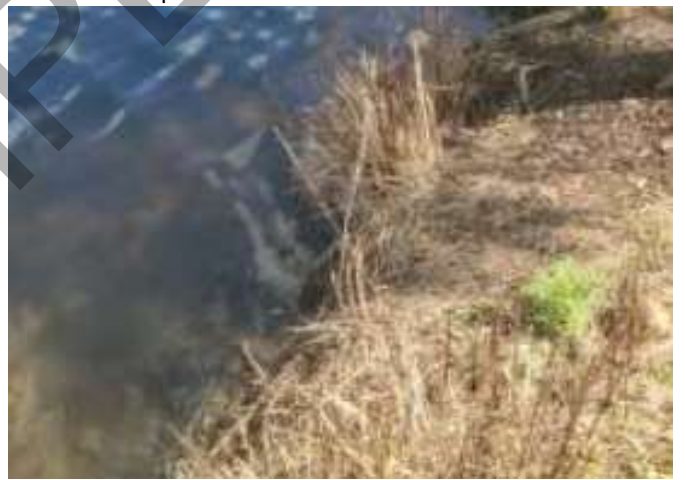
Erosion at Pond #4 behind lots #96-99 - photo from Envirotech report

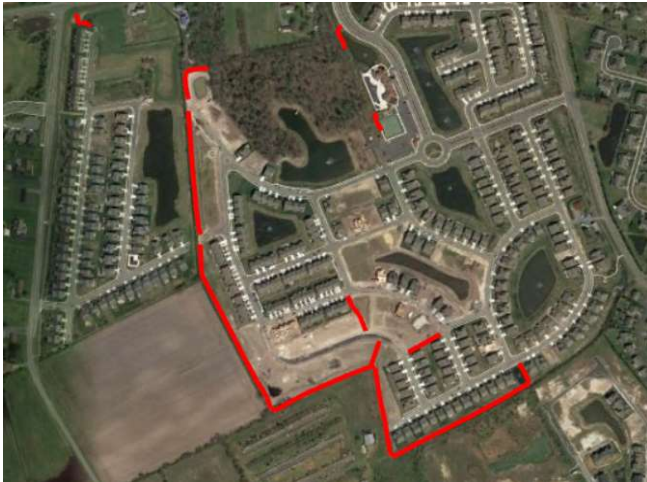
Approximate locations of cinder walking path

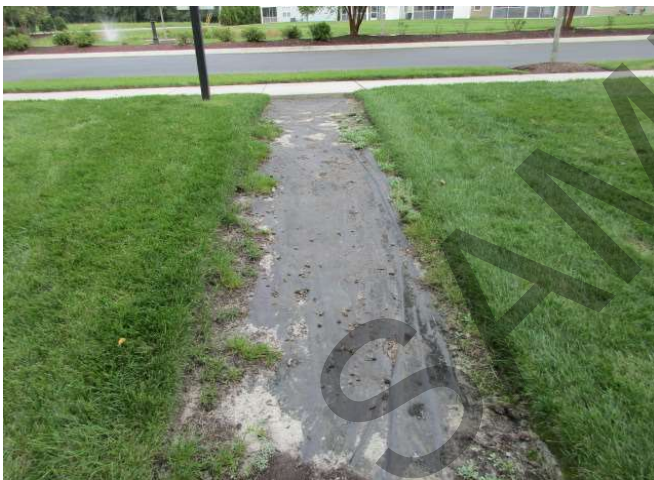
Missing walking surface

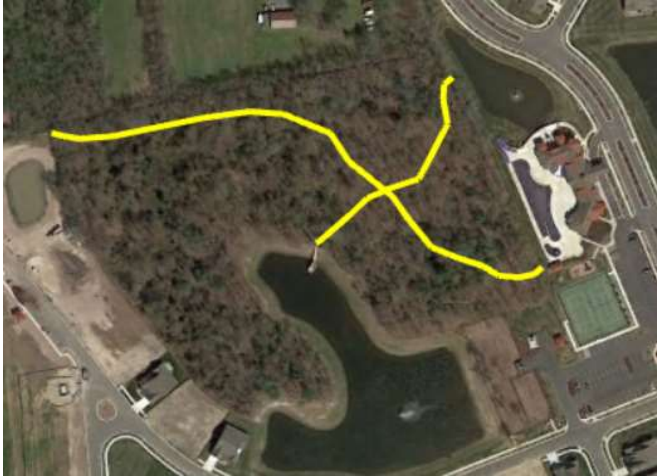
Approximate locations of wood chip walking paths

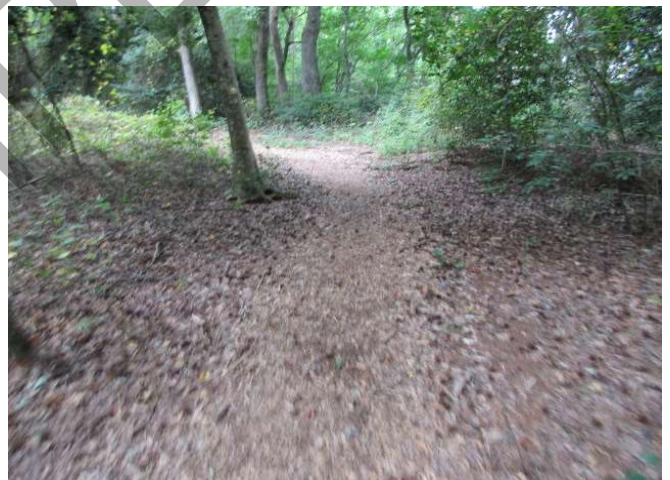
Thin wood chip coverage

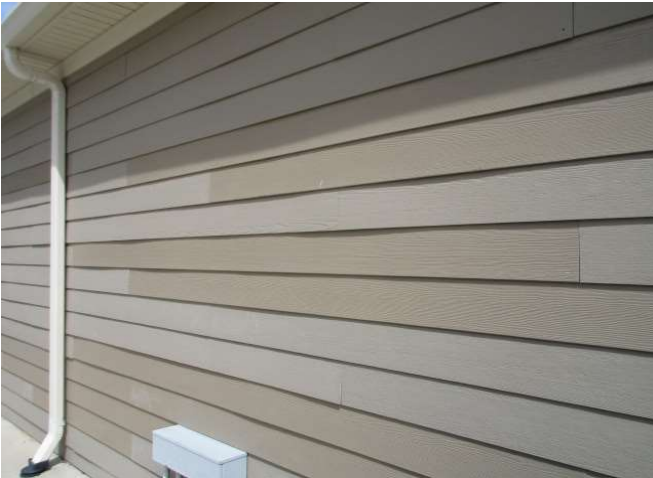
Non-matching siding at BLS clubhouse south elevation

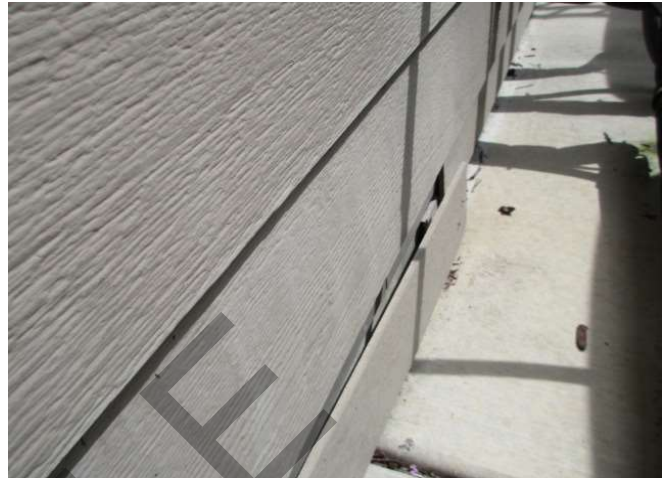
Loose siding at south elevation

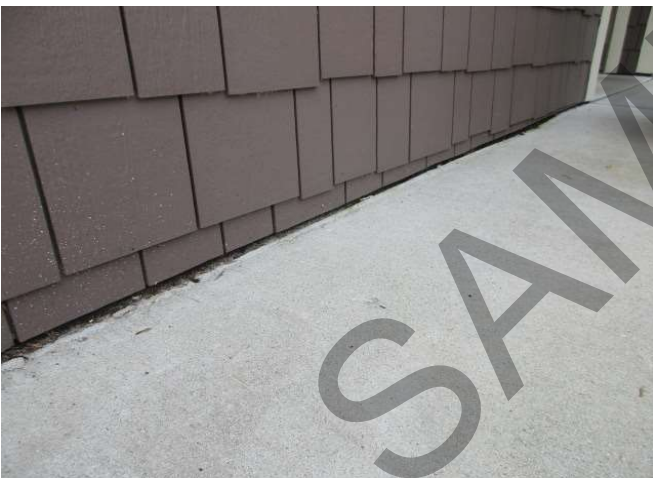
Insufficient spacing between concrete and siding

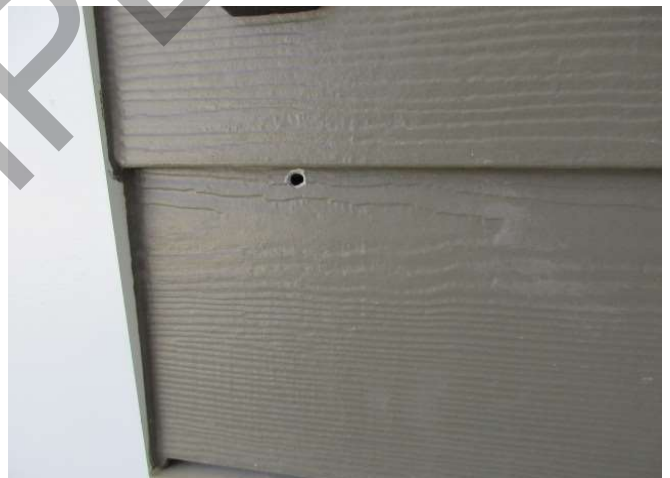
Hole in siding at BLN clubhouse near north door

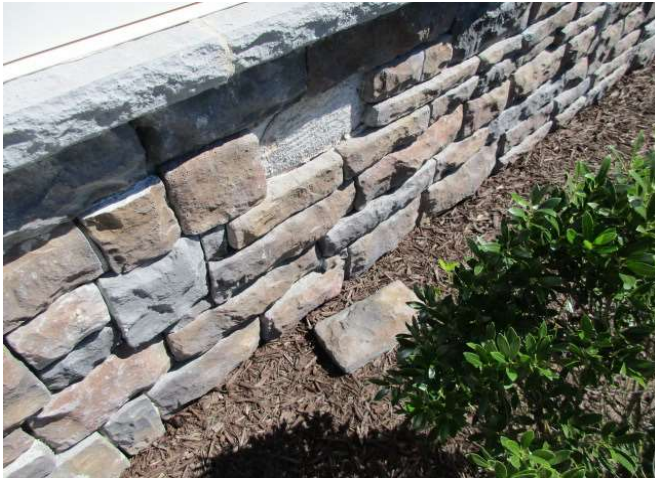
Loose stone at BLN clubhouse

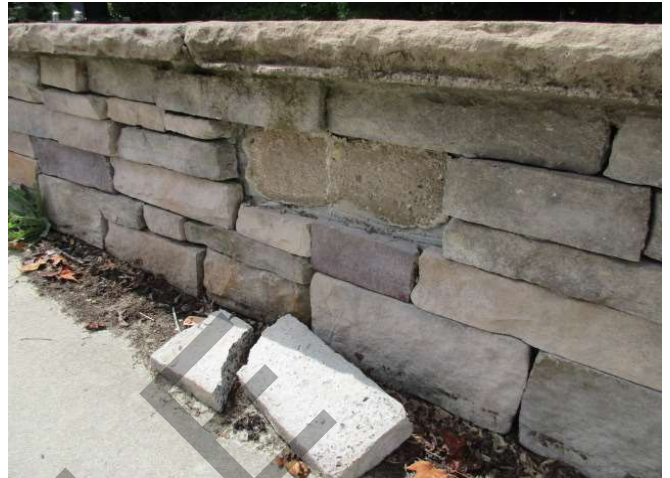
Damaged stone at BLS clubhouse knee wall

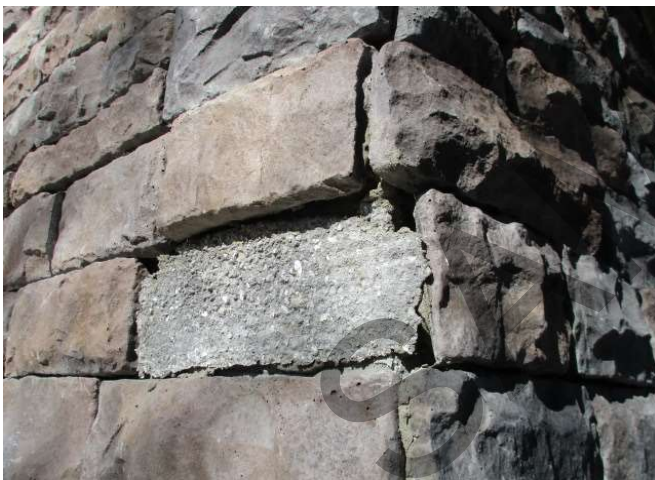
Missing stone at BLN mailbox kiosk wall

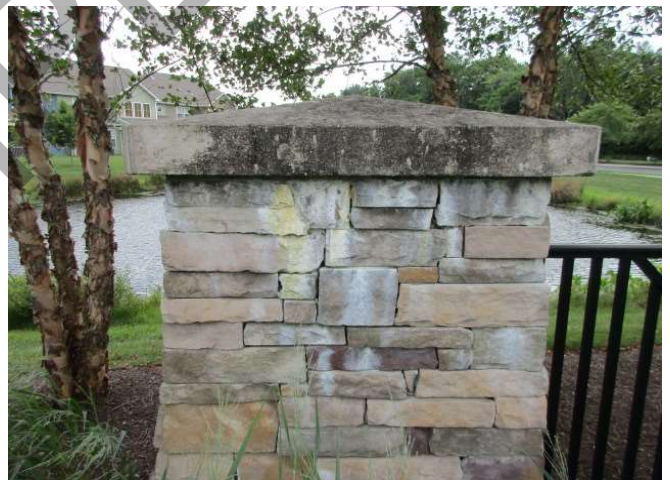
Efflorescence at entrance monument

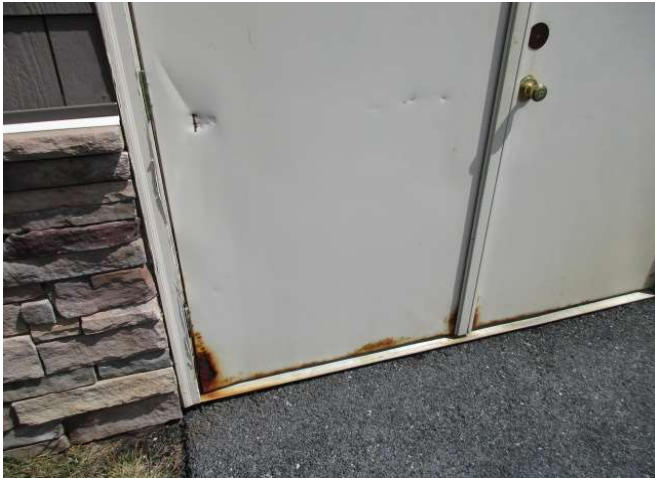
Damaged and rusted door at BLS clubhouse well house, likely from impact with the masonry sill

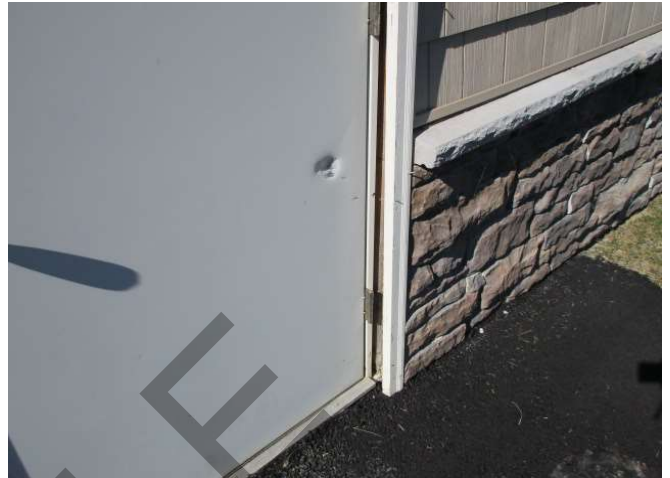
Damaged door at BLN well house, likely from impact with the masonry sill

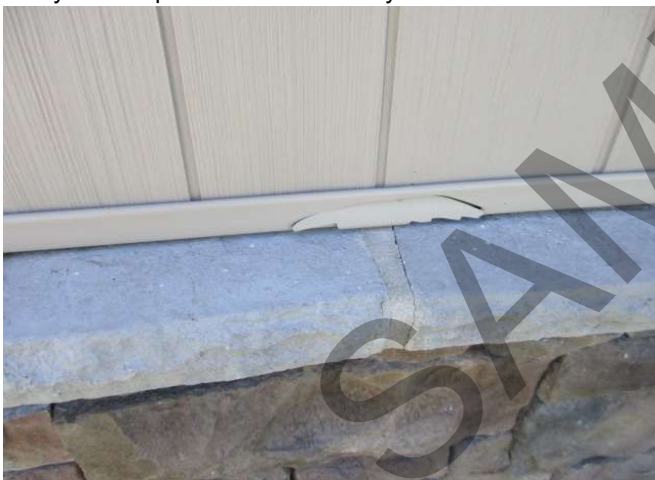
Cracked vinyl trim at BLN well house

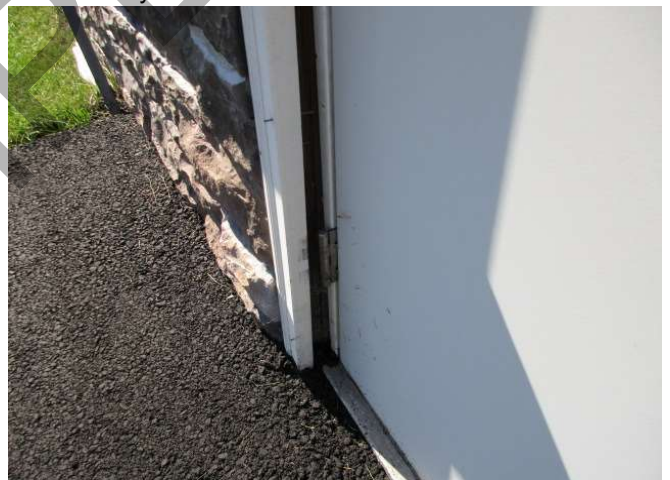
Loose door trim at BLN well house

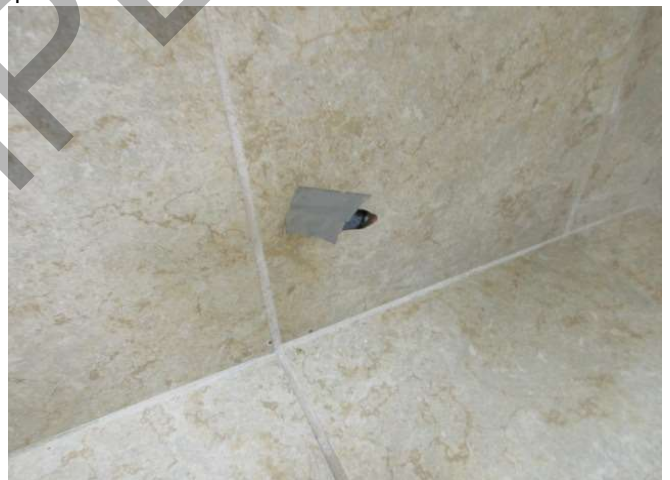
Hole at Bellevue rest room tile

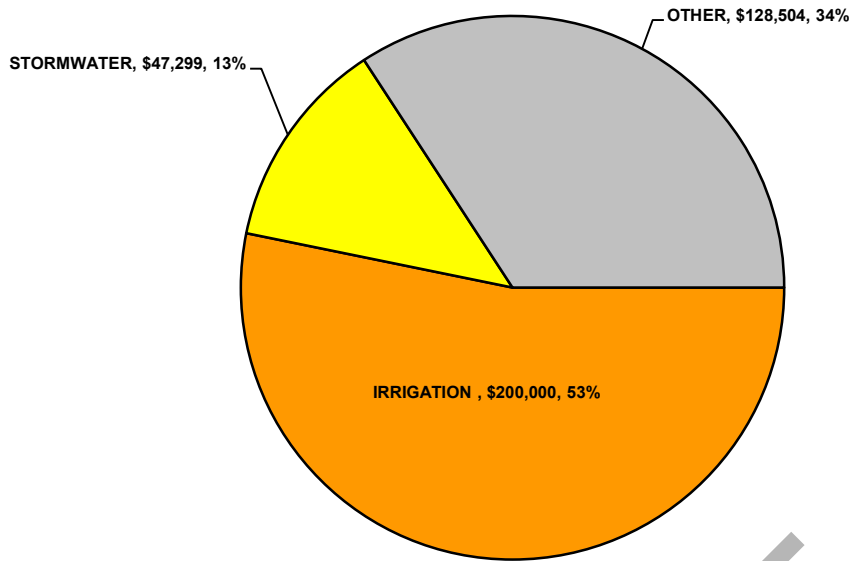
Graph Illustrates Total Costs By Property Class

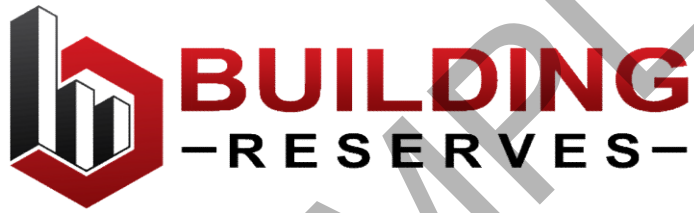
WWW.BUILDINGRESERVES.COM
