LIFE CYCLE ANALYSIS REPORT

**EAGLE RIDGE HOME OWNERS ASSOCIATION
538 HEFFERNAN DRIVE, EDMONTON, AB**

NOVEMBER 2017

WADE ENGINEERING LTD.

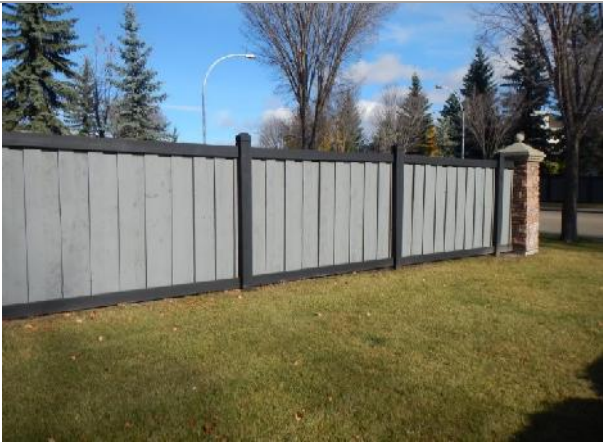
Photograph 1		Photograph 2			
Painted wood fencing – Zone 1		Painted wood fencing – Zone 6

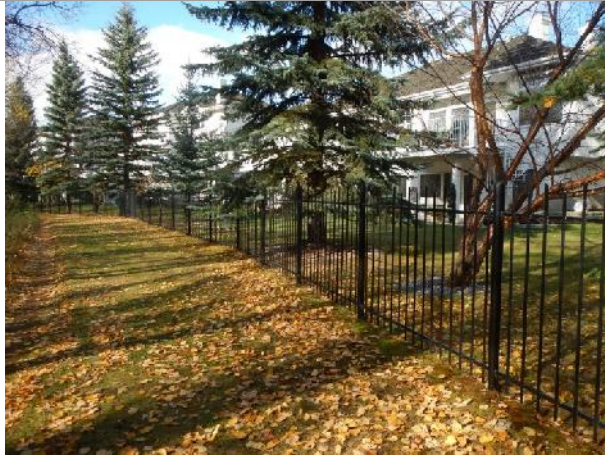
Photograph 3

Painted metal fencing – Zone 7

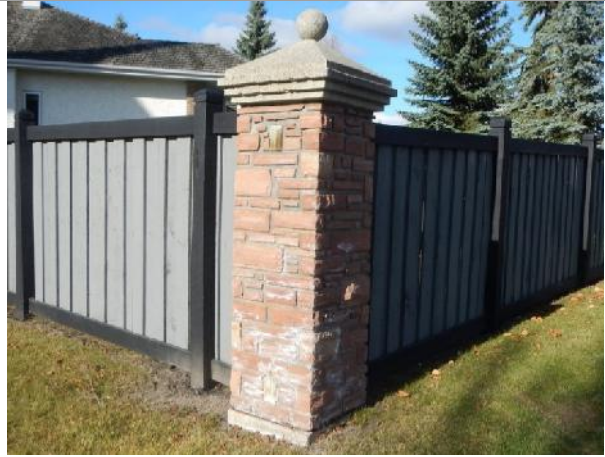
Photograph 4

Stone veneer columns

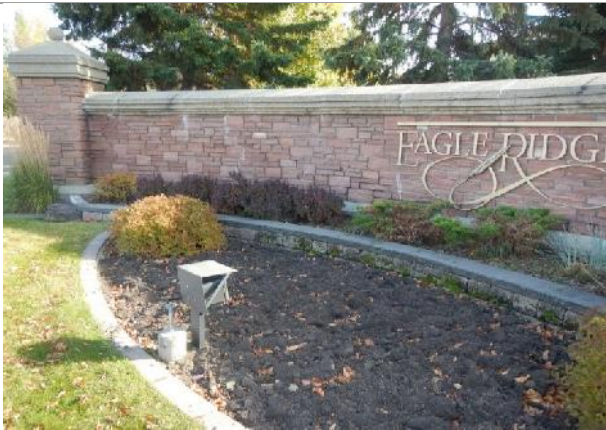
Photograph 7

Lighting at property entrance signage

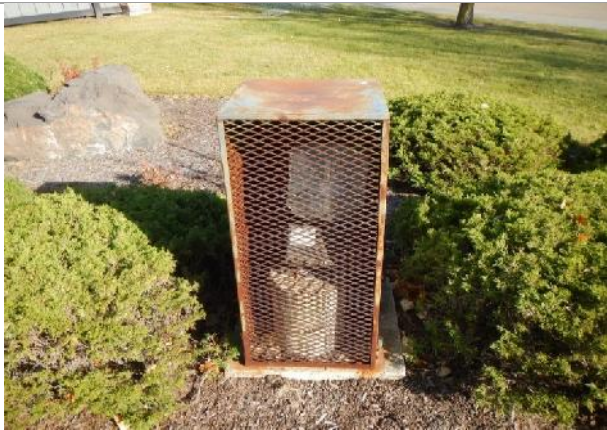
Photograph 8

Flood lighting for monument

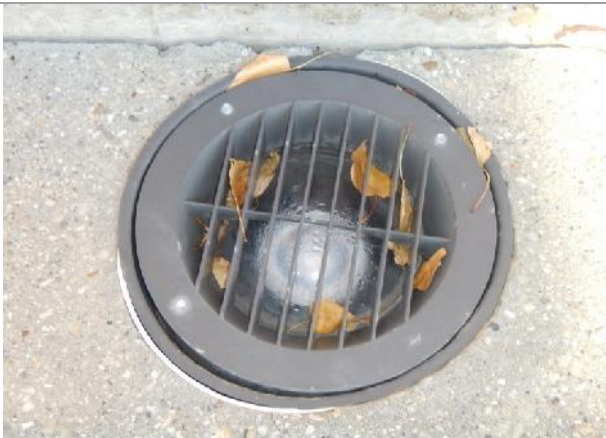
Photograph 9

Base light (floor mounted) for monument

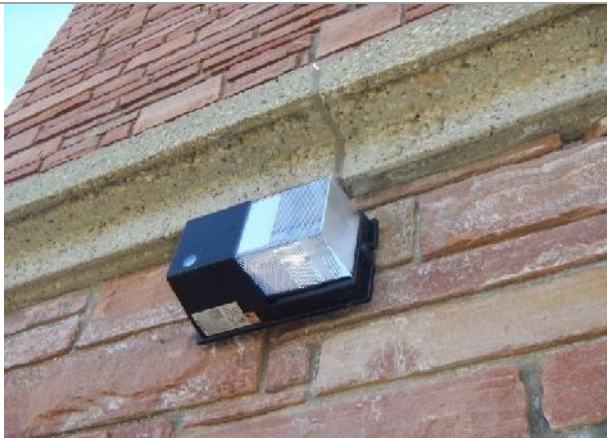
Photograph 10

- No concerns were noted with the lighting.
- Exterior wall mounted lighting on the monument (west side) was replaced over the recent years.

Replaced wall mounted back light on monument

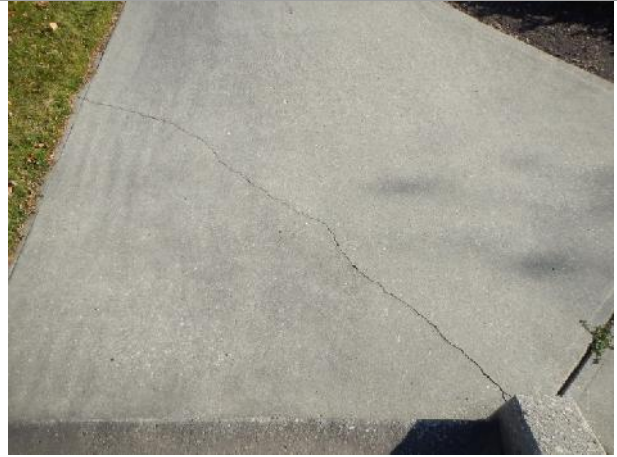
Photograph 23

- Minor cracking was noted at few locations on the poured concrete walkways.

Minor cracking on poured concrete walkway

- Seal cracks on poured concrete walkways as necessary.

- ❖ Do not use salt for de-icing, as it can cause spalling and premature deterioration of concrete components.
- ❖ An application of a penetrating sealer will help protect the surface from spalling and freeze/ thaw damage.
- ❖ Seal cracks wider than 3/16th of an inch to minimize progressive damage from freeze/thaw.

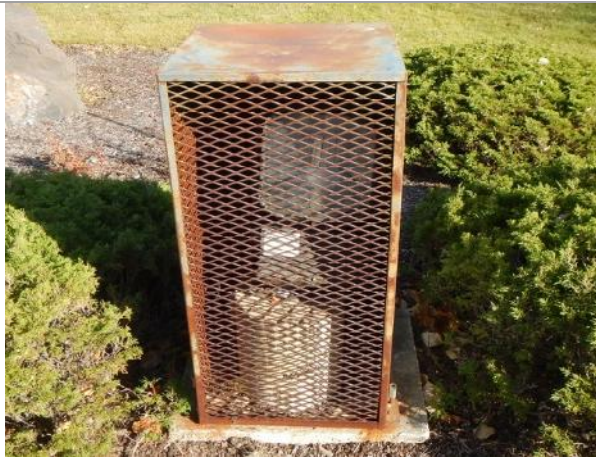
Photograph 24

- Corrosion was evident on the surface of flood lighting cage. Paint metal cage with corrosion inhibitive paint.
- Minor crack and unsealed wall penetration was noted at one located of monument wall. Seal wall penetrations to avoid any potential water entry into wall components.

Corrosion on surface of metal cage

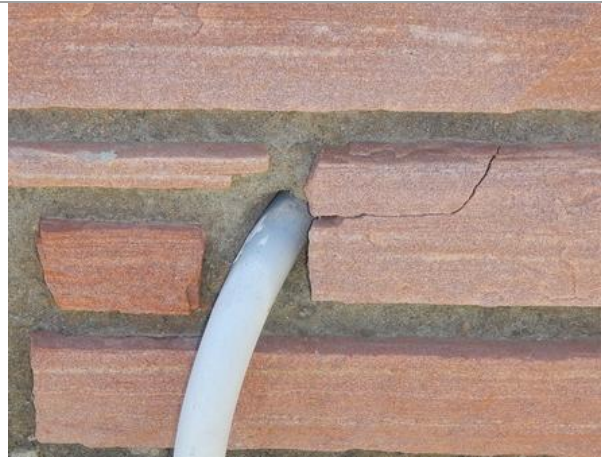
Photograph 25

Unsealed wall penetration
