**UNITED TESTING
SERVICES**

CPSC REPORT NO. 20180519-A9E35-2147387862
Recall Number 12-117
UL 147 Compliance Failure Submission
February 14, 2019

Hand-Held Torch Failure and Injury Study

**Related Brands Including: BernzOmatic, Medina,
Worthington, Sears, Ace, and Lenox**

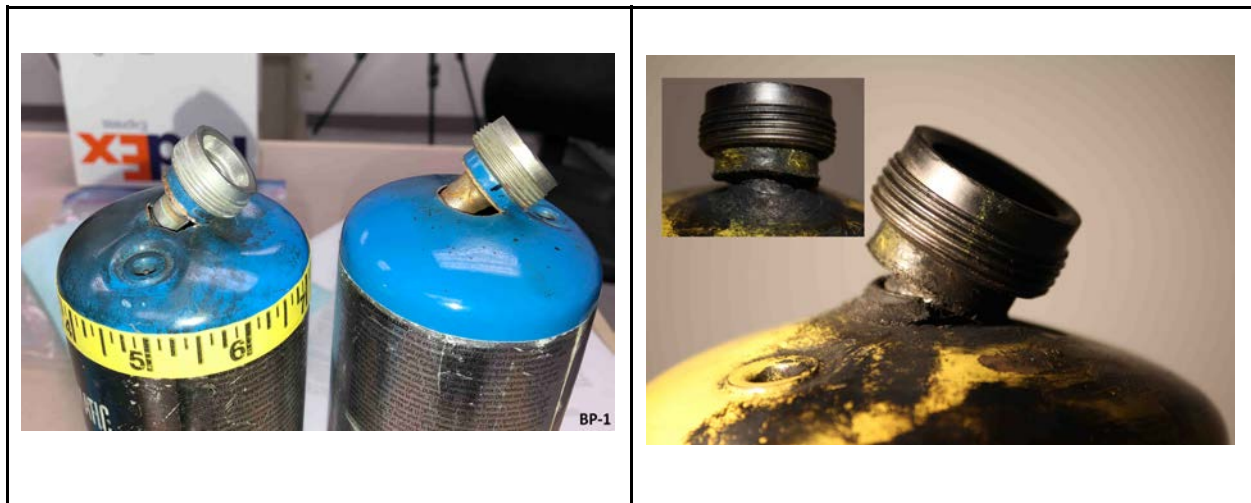
During the various entity changes it was noted that propane-filled cylinders were failing at the neck area just below the threads to which the torch attachments affix.

This area is referred to as the “brazed bushing” and are governed under [49 CFR 178.65](#). The failures were apparently noted approximately in 1979, leading to creation of a failure report by one [Mr. Roger L. Maxon](#), an internal quality control upper management employee at Newell. A safety feature was invented and designed by Newell’s employee, [Mr. John M. Nelson](#), an engineer in the product engineering department. Mr. Nelson’s safety feature was called a “[Fracture groove](#),” which was

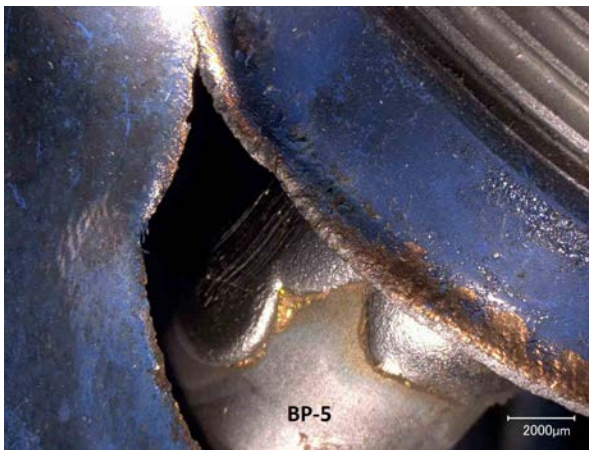
Peralta cylinder failure

The Peralta and Bailey cylinders evidenced failures at the neck in the area of the brazed joint and were nearly identical.

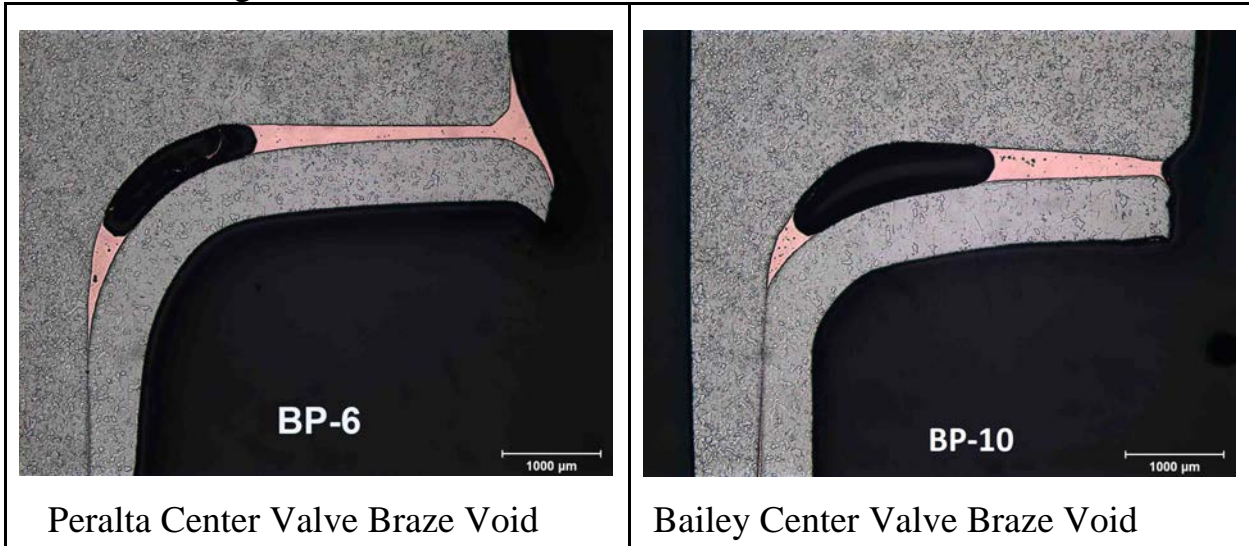
The x-ray images revealed that the Peralta and Bailey cylinders contained identical impermissible voids in the brazing compound at the center bushing just below the device mounting threads.

The x-ray samples were taken from the center valve cross-sections of the Bailey and Peralta cylinders.

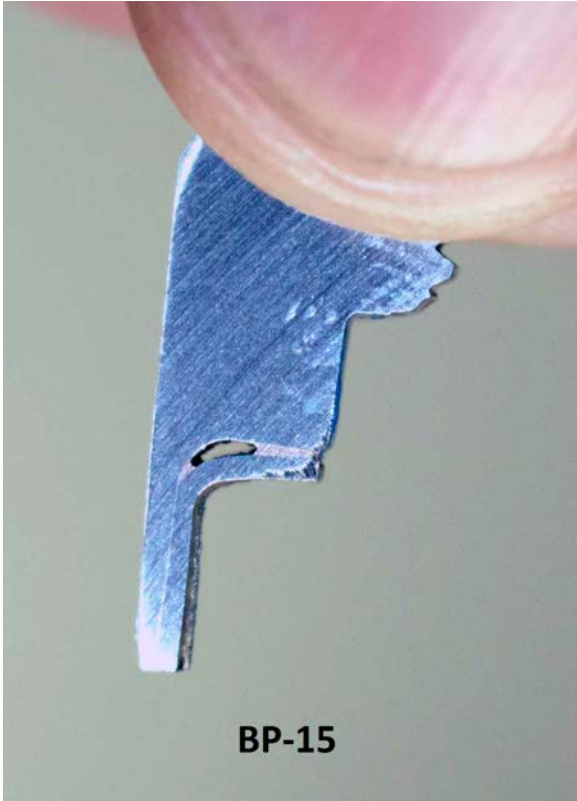
BP-15

Bailey cylinder valve section

The impermissible voids noted on the Bailey and Peralta cylinders evidence a compliance failure with [DOT 39](#) and [UL 147](#), and are generally identical to voids noted by an expert witness metallurgist [Dr. Robert Anderson in his study of another injury case in the year 2008](#).

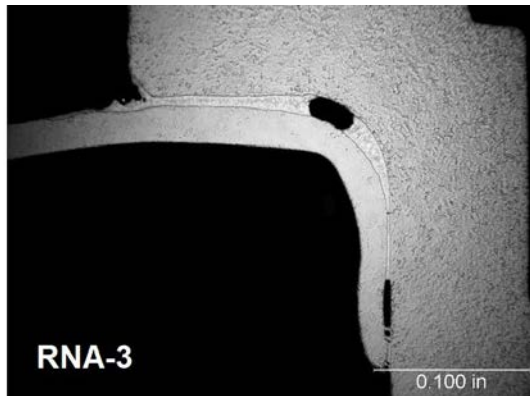
RNA-3

Expert Anderson’s cross-section photo evidence an identical manufacturing defect on another NRT cylinder in relation to [Plaintiff] v. Worthington, et al., 07-cv-2107-MMA.

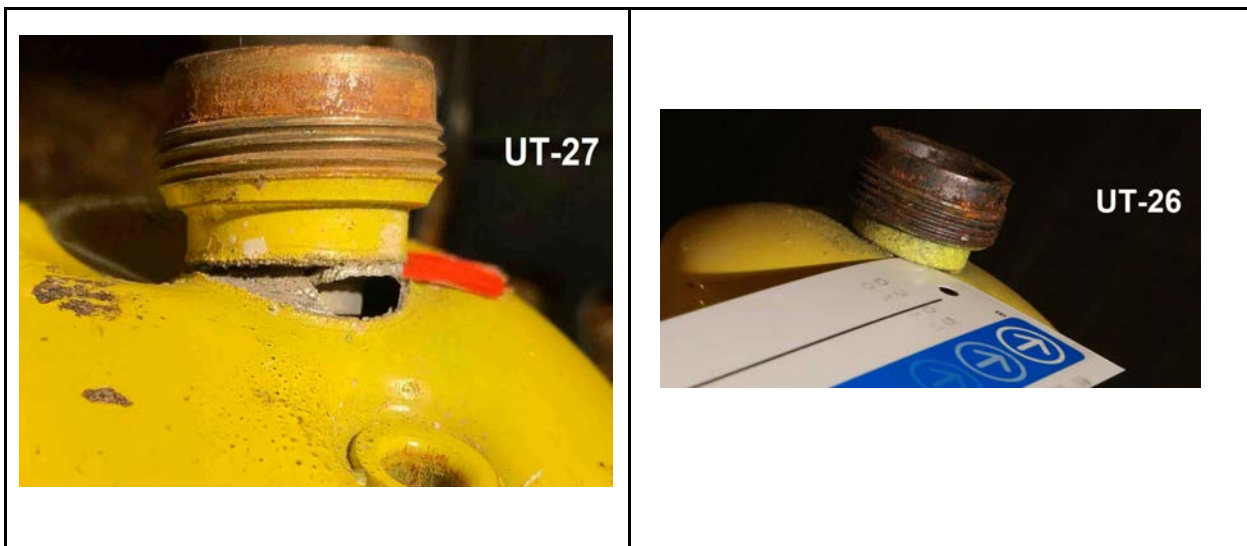
The Bailey and Peralta cylinders also failed to comply with [DOT 39](#) requirements, evidencing manufacturing defects which resulted in failure of the parent steel in the center valve brazed joint area. It is axiomatic in the welding industry that reduced weld surface area will result in increase in stress to the parent metal because the forces are focused only at the point of fusion of the weld or braze to the parent metal. The void shifts stress to the point of contact where the tear in the steel occurs:

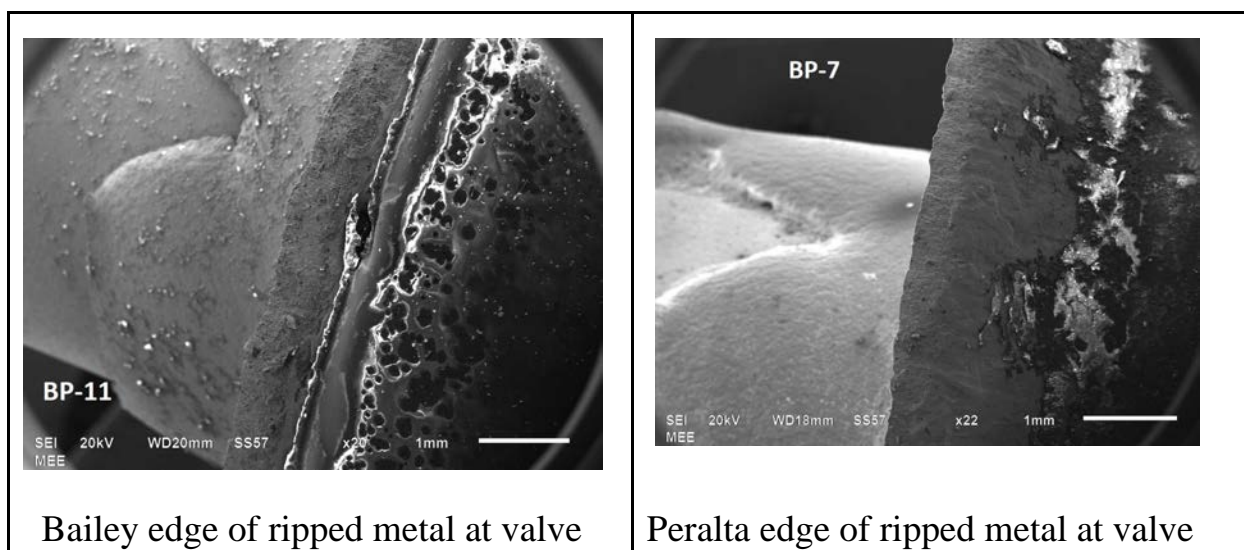
The [SEM](#) images also show that the Bailey cylinder had additional manufacturing defects evidenced by comparison to the Peralta Cylinder [SEM](#) images.

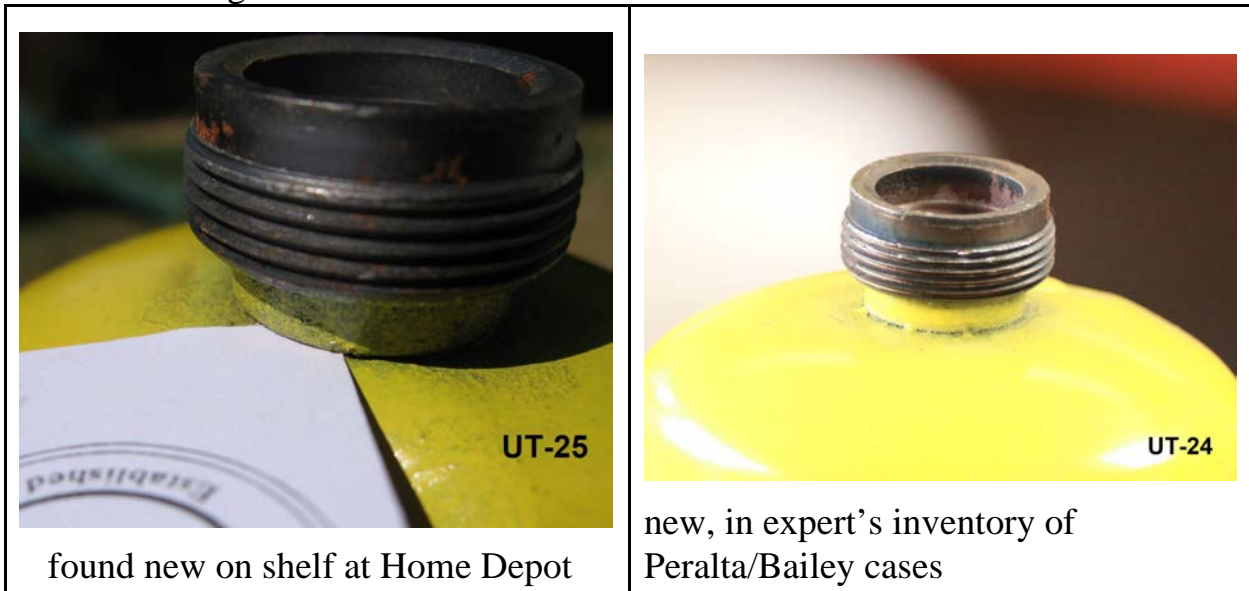
The defects noted above and in the many cases filed with the Courts exist on the NRT cylinders containing both types of fuel, often times with voids visible to the eye without the magnification.

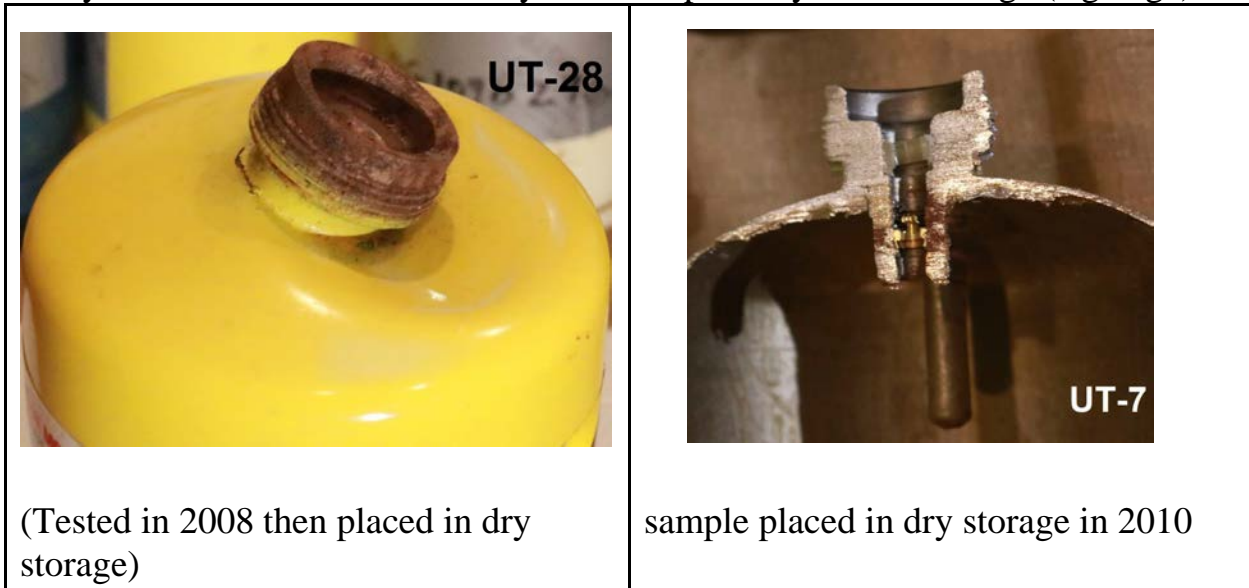
Heavy rust was also observed on cylinders kept in dry indoor storage (a garage).

[UL 147](#) and [DOT 39](#) require reasonably adequate rust and corrosion protection. Quality control is lacking in this area as well.

6. Comply with [UL 147 sections 7.3 and 7.4](#) for protection against rust and corrosion (Marmont fatality).
7. Redesign the [Fracture groove](#) features of the TS4000 torch attachments to fracture under less force akin to the force required to fracture the newer UL2317 design, meeting the requirements of [UL 147 section 12.2](#).

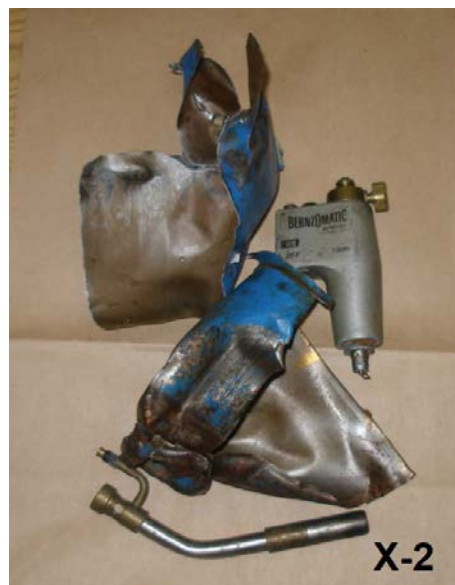
The Marmont cylinder PRV was tested and vented at approximately 650 PSIG, whereas the cylinder was designed to withstand 900 PSIG. Unsurprisingly the steel ripped a full 360° at the braised joint, and the center valve with the torch attachment separated entirely off the cylinder. The failure resulted in the death of Ms. Marmont.

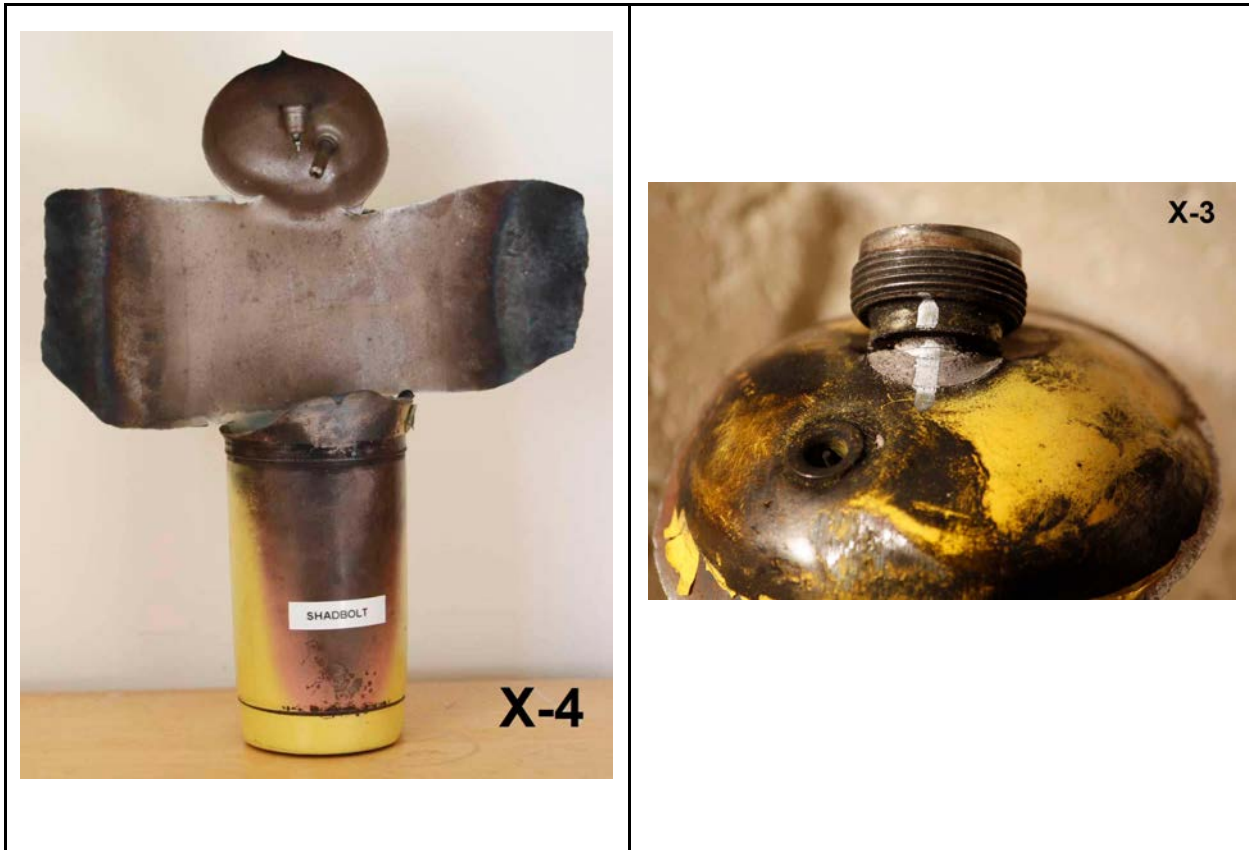
Shadbolt

Mr. Shadbolt's cylinder had the same initial defect as did Mr. Peralta's in that after he lit the torch a flame emitted from the neck of the cylinder, causing him to drop the assembly. The drop was from about 3 feet. The assembly landed on the top of the torch, causing the brazed joint to breach further, and the flames ignited towels on the floor. The flames heated the breached cylinder, which still had pressurized fuel content. The PRV did not vent. Instead, the cylinder ripped wide open as shown.

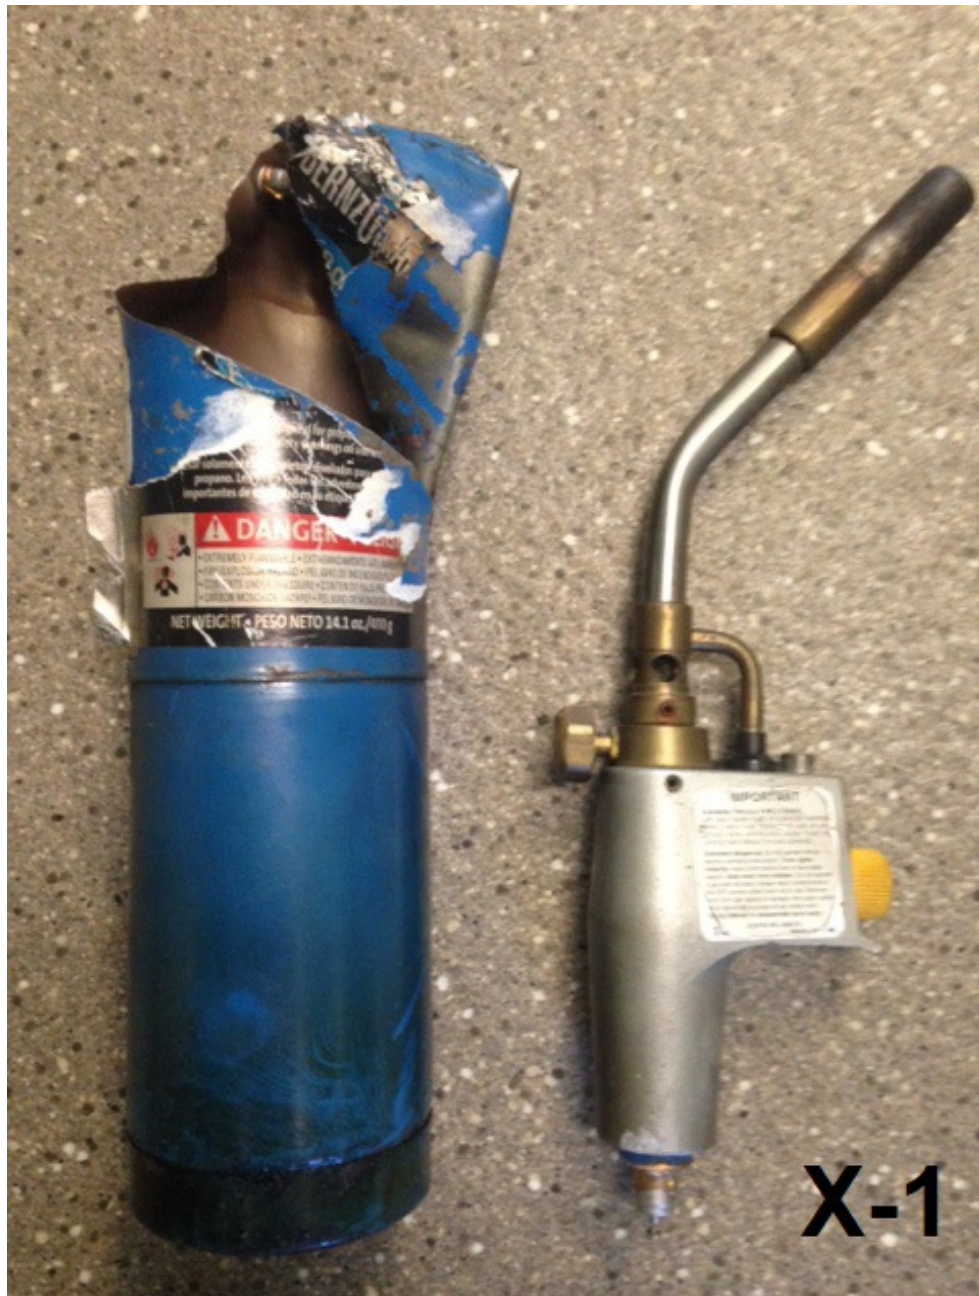
Mr. Avery's cylinder was sitting on a deck and exposed to heat caused by leaves burning under the deck. The PRV did not vent. Unsurprisingly the steel ripped a full 360° at the brazed joint, and the center valve with the torch attachment separated entirely off the cylinder, as did the Marmont cylinder.

Failure of the NRT cylinders when exposed to heat and flame occurs due to the PRV failures observed on the [HSE report](#), evidencing an additional manufacturing defect. This defect invariably results in over-pressurization, with the pressure finding its way to the vulnerable center valve brazed joint area of the cylinder.

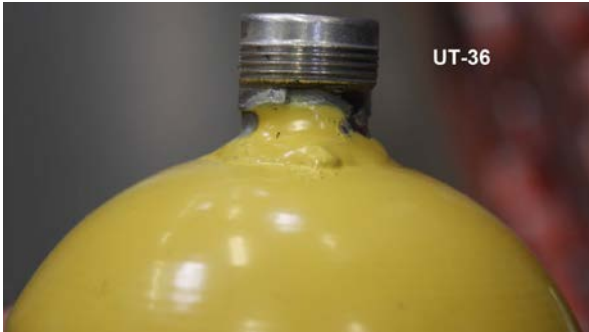
4. The manufacturer on occasion “fixed” poorly brazed joints, as observed by cylinders found on the shelf at Home Depot, and discerned by comparing the welded cylinders to poorly brazed cylinders also found on the shelf at Home Depot.

welded cylinder found as photographed on the shelf at Home Depot

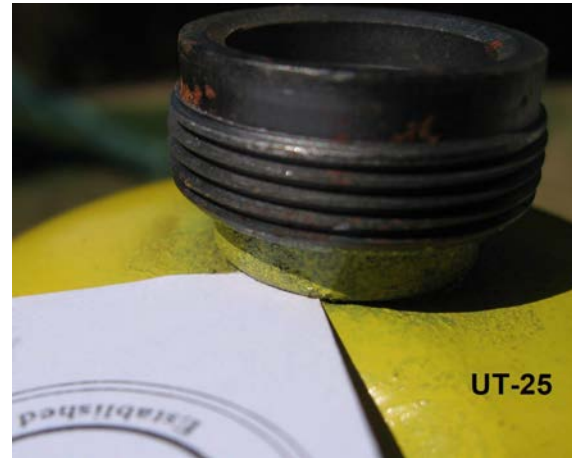
Poorly brazed joint as found on the shelf at Home Depot.

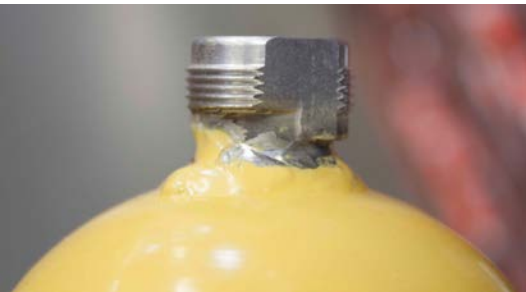
Bernzomatic/Worthington Map/Pro cylinder found on shelf at Home Depot, El Cerrito, CA, as shown, on February 12, 2012, evidences weld repair then sale as a new cylinder.
