**UNITED TESTING
SERVICES**

**NHTSA NO. 326272
SECOND GENERATION FORD EXPEDITION 4X4
FUEL TANK PLACEMENT DESIGN DEFECT INVESTIGATION
September 14, 2020
Revision 1**

SUBJECT VEHICLE: 2004 FORD EXPEDITION 4X4

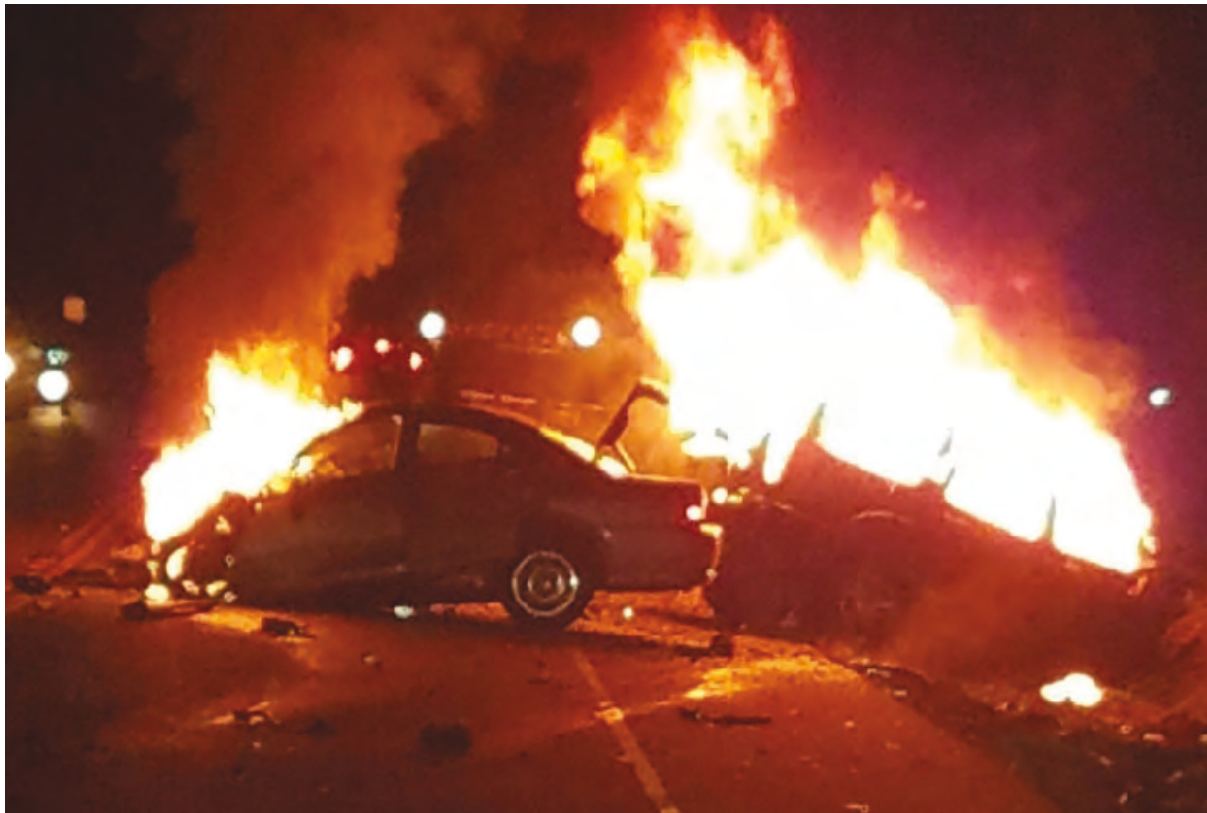
Mr. Arriaga, a 20 year old male, was driving his 2004 Ford Expedition at the time, when it collided head-on with a 2001 Lincoln LS 4-door sedan. The Lincoln was driven by Mr. Forrest Kidwell, a 34 year old man. He had a passenger, Mr. Destry Glick, who was 26 years old at the time. The two vehicles immediately caught on fire as shown.

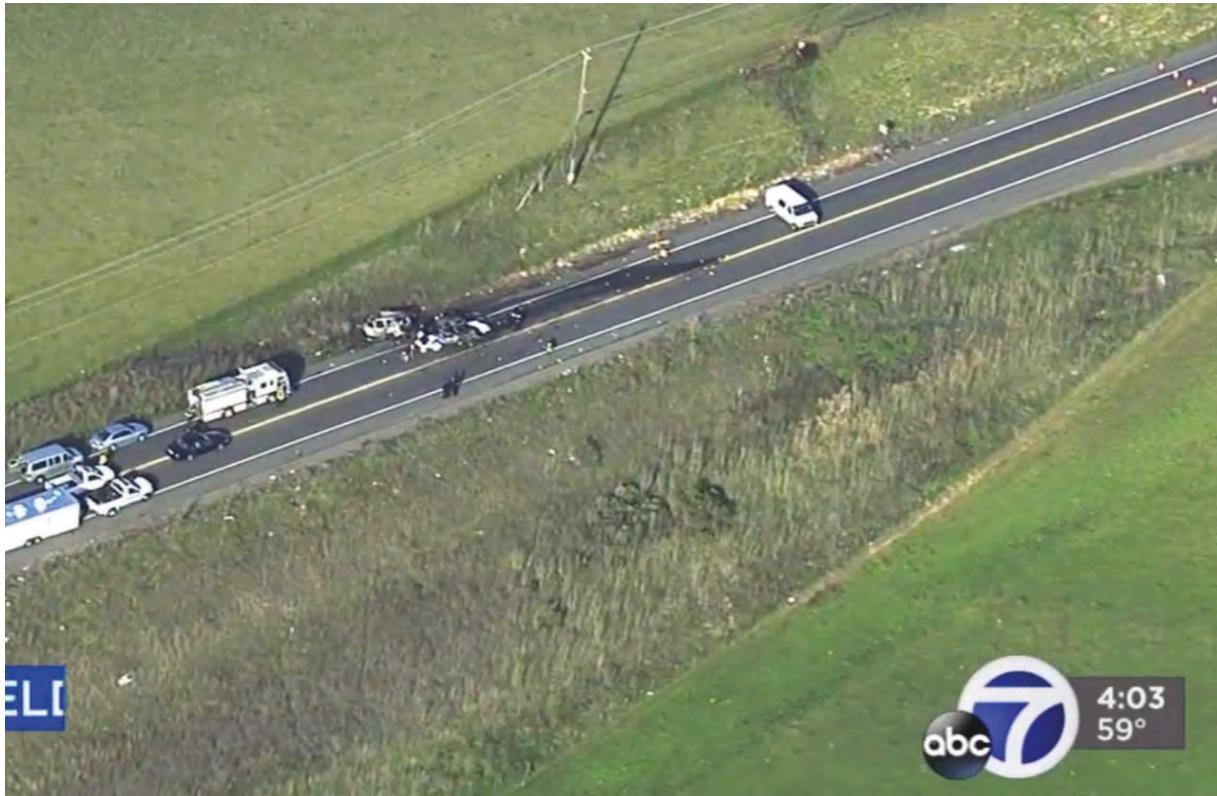
The Expedition was in it's southbound lane, and came to rest on the same southbound lane, in the right embankment, evidencing a hard right maneuver by Mr. Arriaga at the last minute to avoid the accident. The Lincoln also came to rest, but not in it's northbound lane. Instead, it came to rest in its entirety in the southbound lane, which was the lane of travel of Mr. Arriaga's vehicle. This is a news helicopter image of the

two vehicles at their respective points of rest, noting that the Expedition is the vehicle in the embankment:

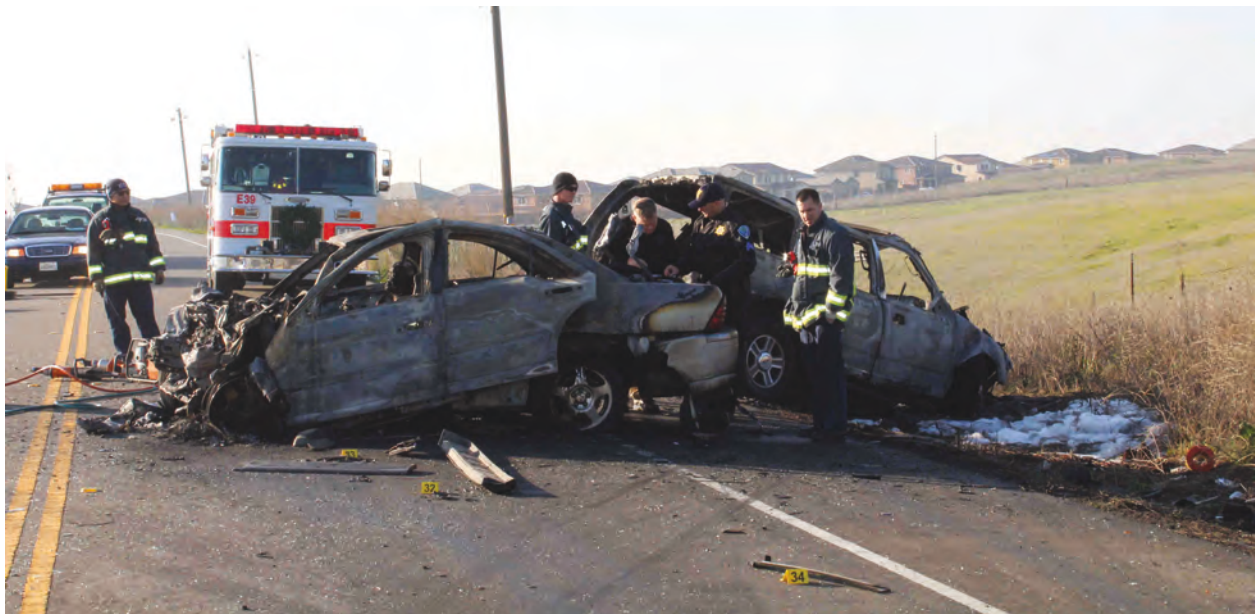
In the morning the Multi Accident Investigation Team (MAIT) took this photograph showing the respective points of rest of the two vehicles:

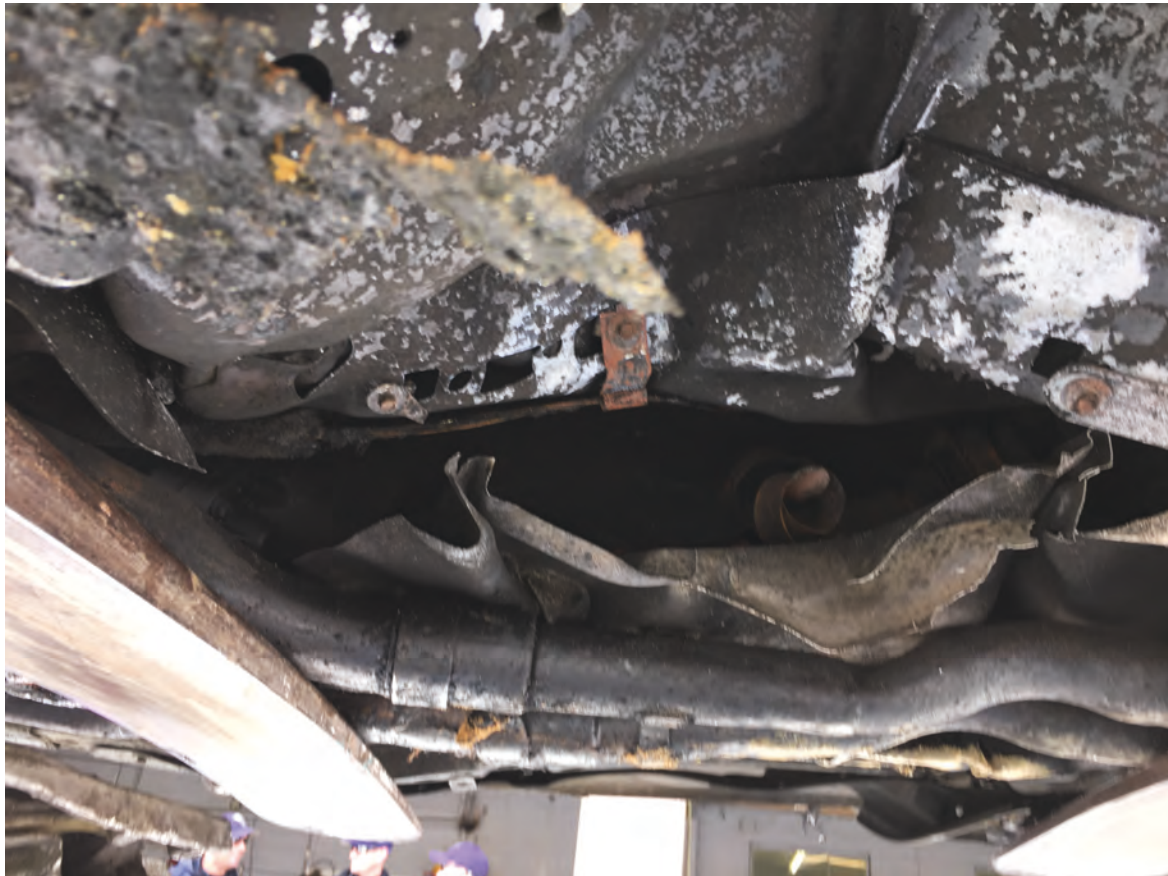
The transmission pan of the Lincoln had ripped wide open, causing the red transmission fluid to disperse southbound in the trajectory of travel of the Lincoln. The Lincoln's transmission pan was inspected and found to have breached wide open:

Photo of Lincoln transmission pan resting on exhaust pipes.

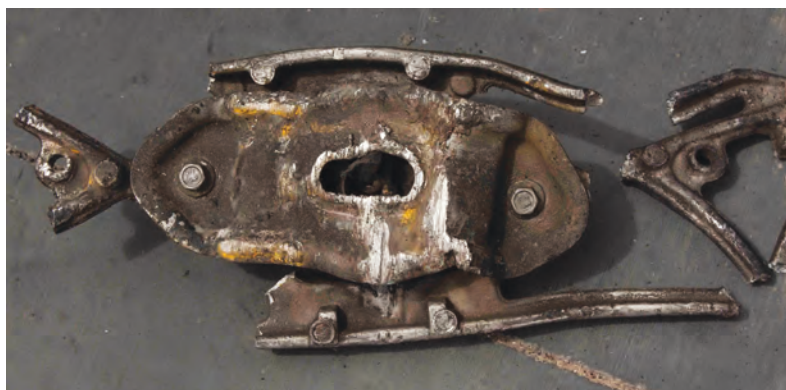
The transmission mount of the Lincoln, which was located dead-center on the vehicle, was observed to have had yellow paint transfer from the double yellow line that separated the lanes:

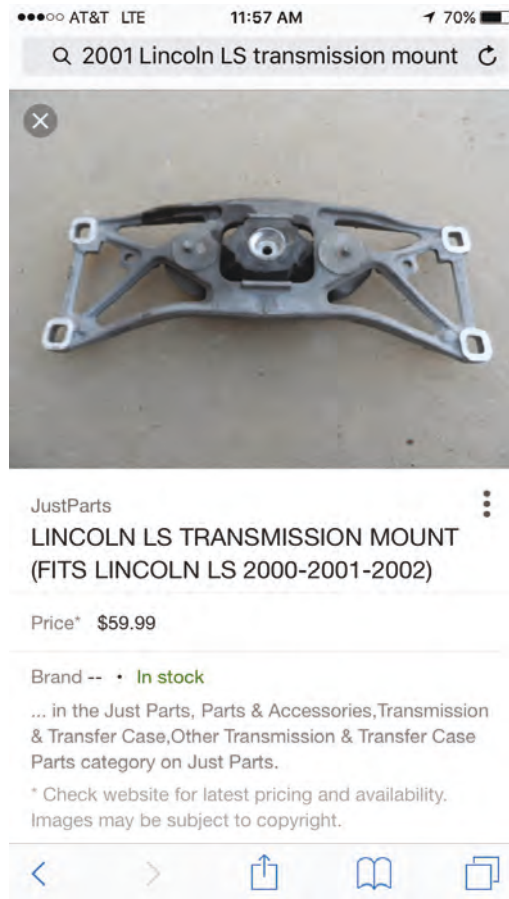
The transmission mount was verified as having come off of the Lincoln:

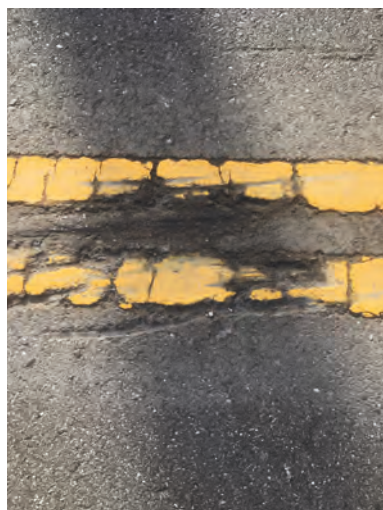
The double yellow line showed the point of contact and paint transfer onto the transmission mount:

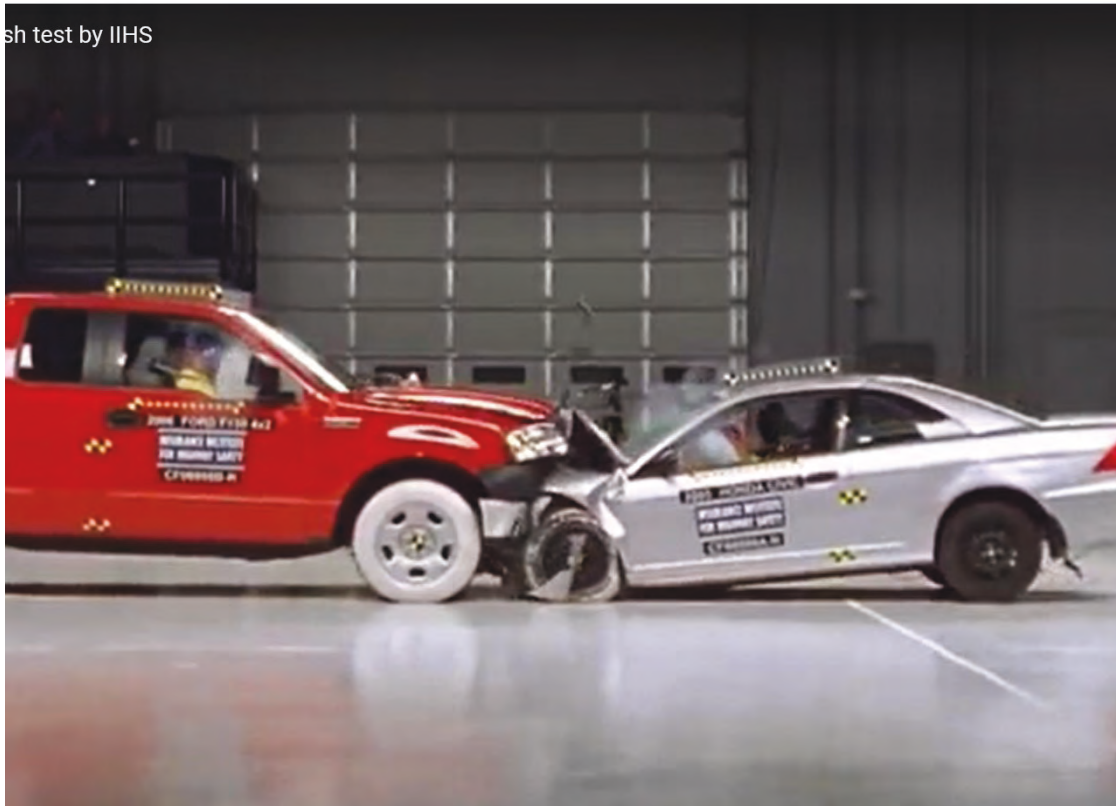
By investigating multiple like-kind head-on collision footage, it was observed that typically the smaller vehicle, i.e. the sedan, would be pushed downward by the larger vehicle, i.e. the Ford, causing the transmission mount to make contact with the pavement:

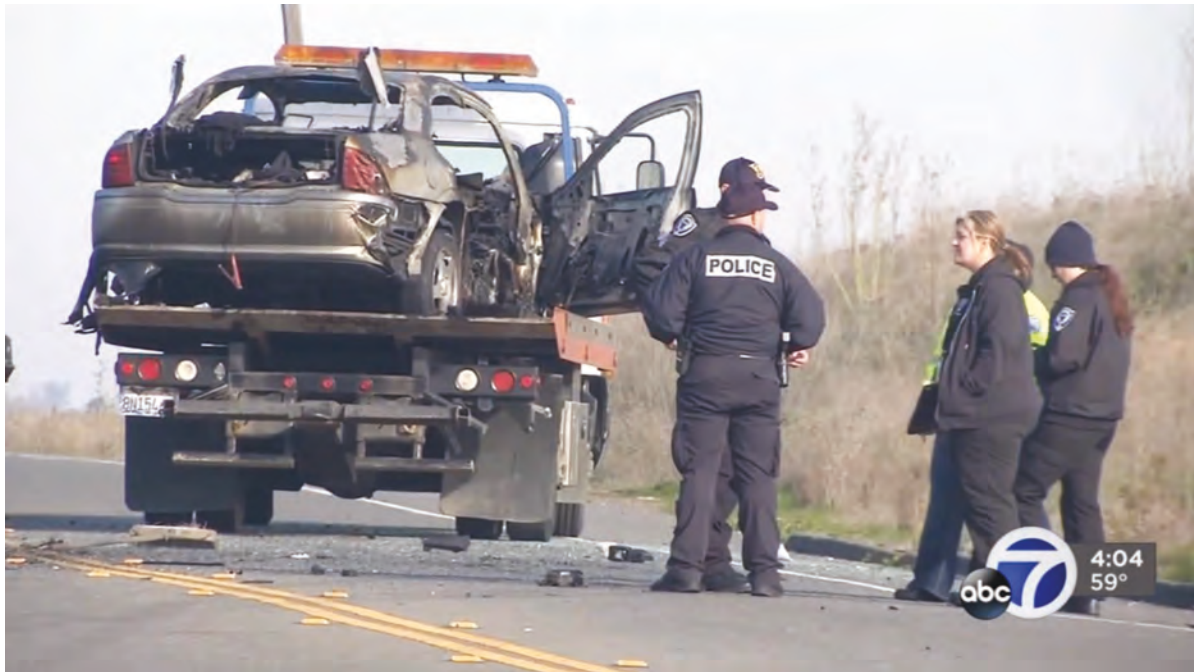
The news footage shows the Lincoln had jumper cables hanging out of the trunk:

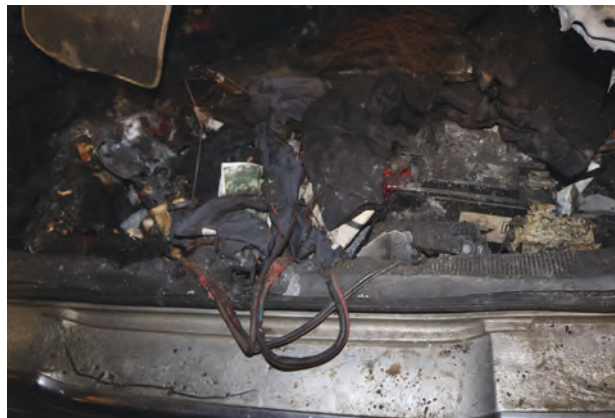
During our inspection we noted the same jumper cables:

The person who sold the Lincoln to Mr. Kidwell, one Mr. London, reported that the vehicle had electrical problems and warning lights stayed on. We therefore conclude that the Lincoln likely lost electrical power (lighting) and either came to a stop, or was stopped by Mr. Kidwell because he was not able to see the roadway once his lights went out. It therefore appears the reason the accident occurred was because the Lincoln's headlights went out, the roadway was pitch-black, and Mr. Kidwell likely stopped his vehicle because he was not able to see his orientation in relation to the roadway. Mr. Arriaga's eyewitness account that he saw "something" on the roadway and did not see lights, and swerved to the right to avoid it, is consistent. Mechanical (electrical) failure in the Lincoln is therefore the likely cause of this accident.

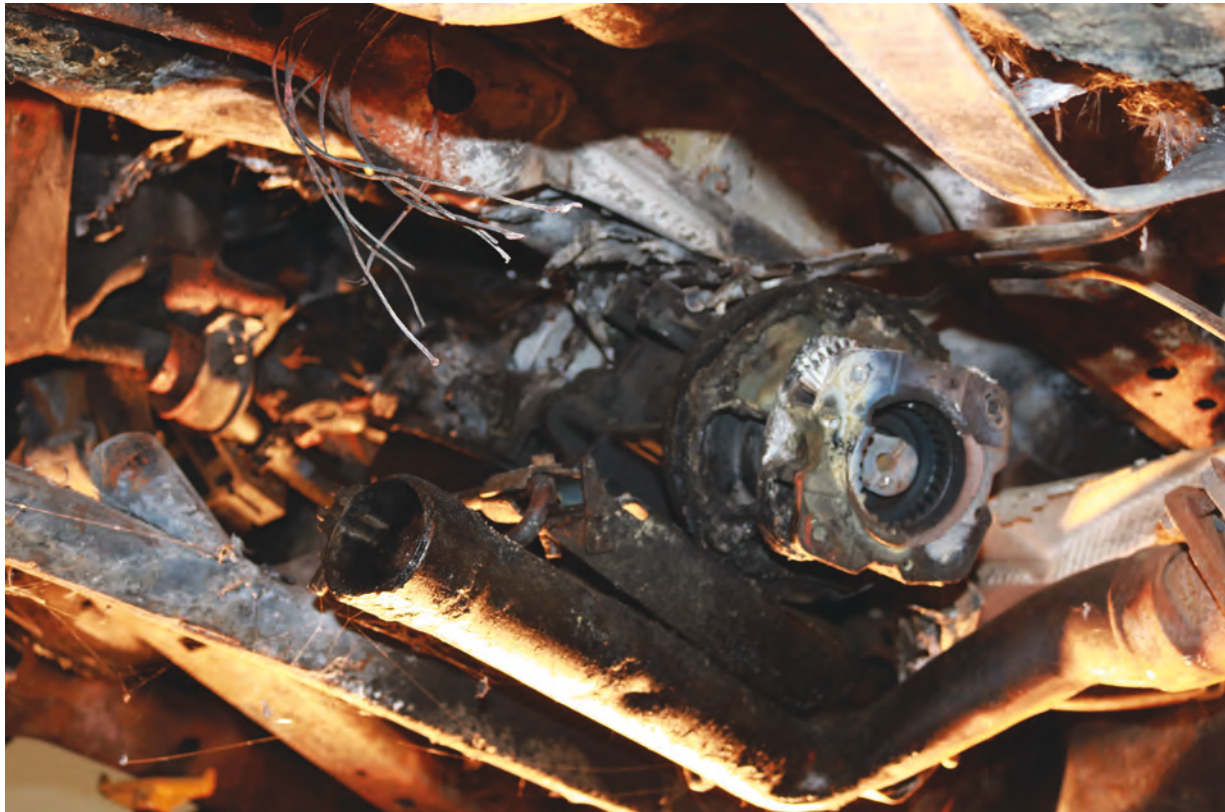
The drive shaft broke out of the transfer case at this location:

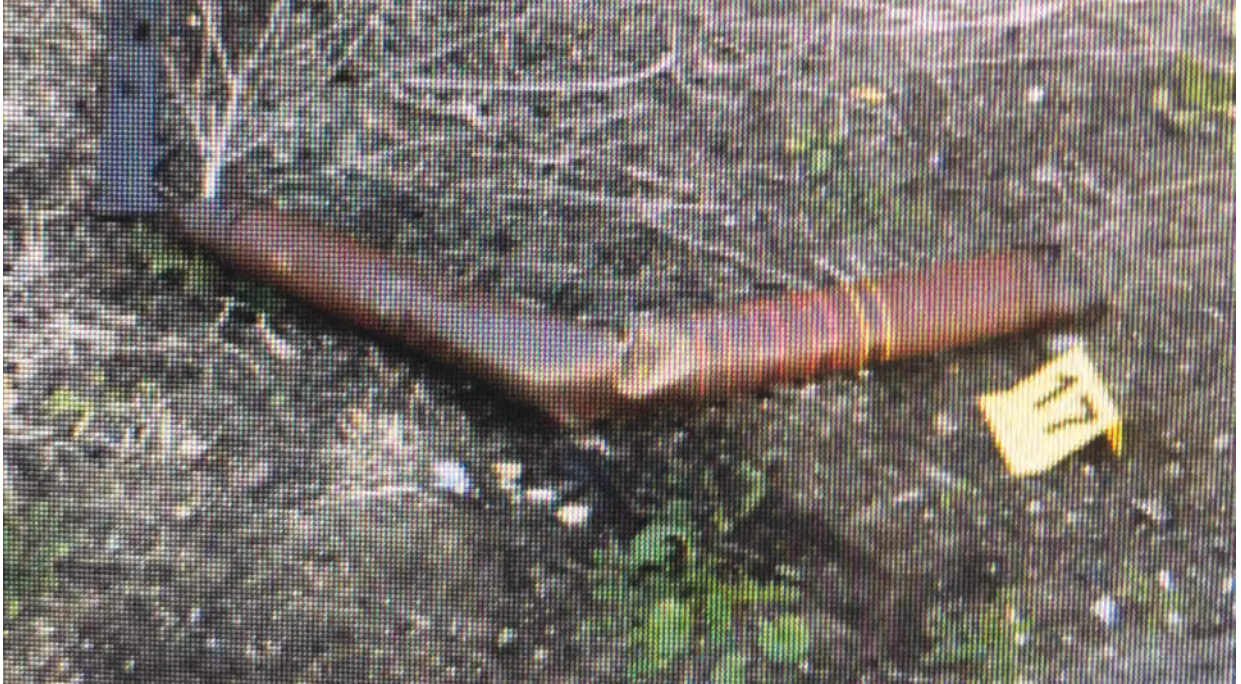
It was found several feet away from the Expedition and was severely bent:

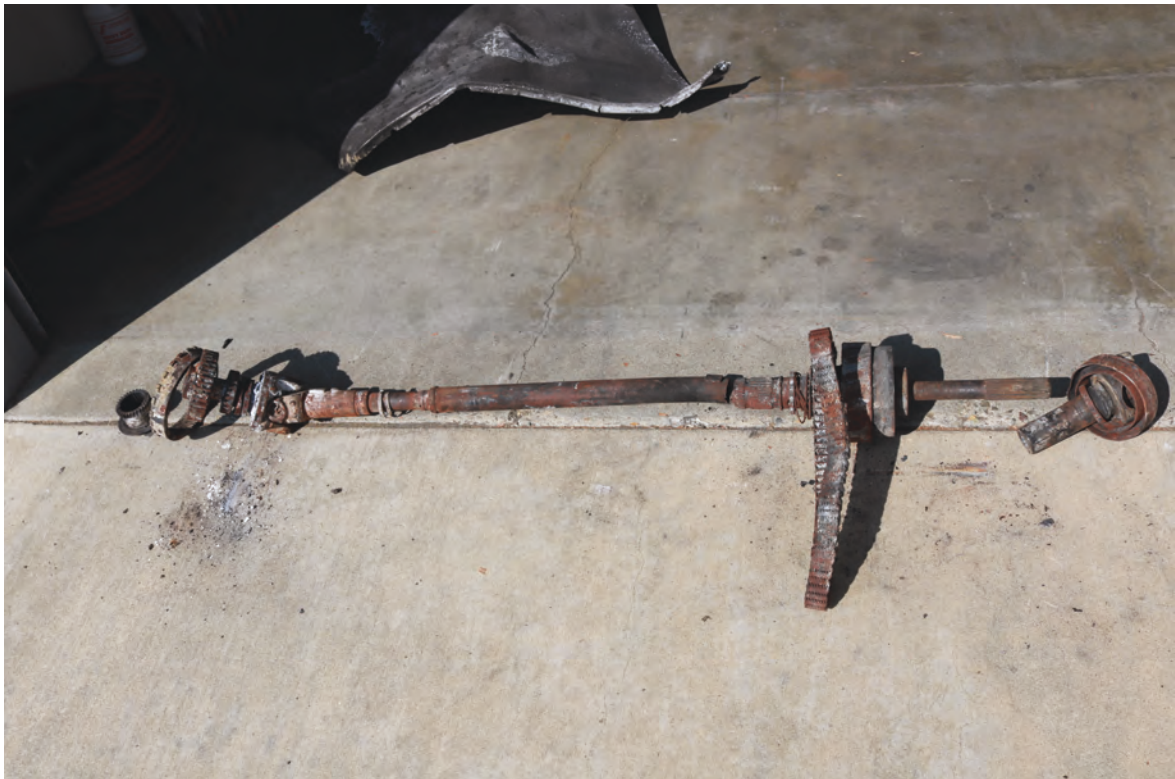
The front drive shaft tore off the transfer case:

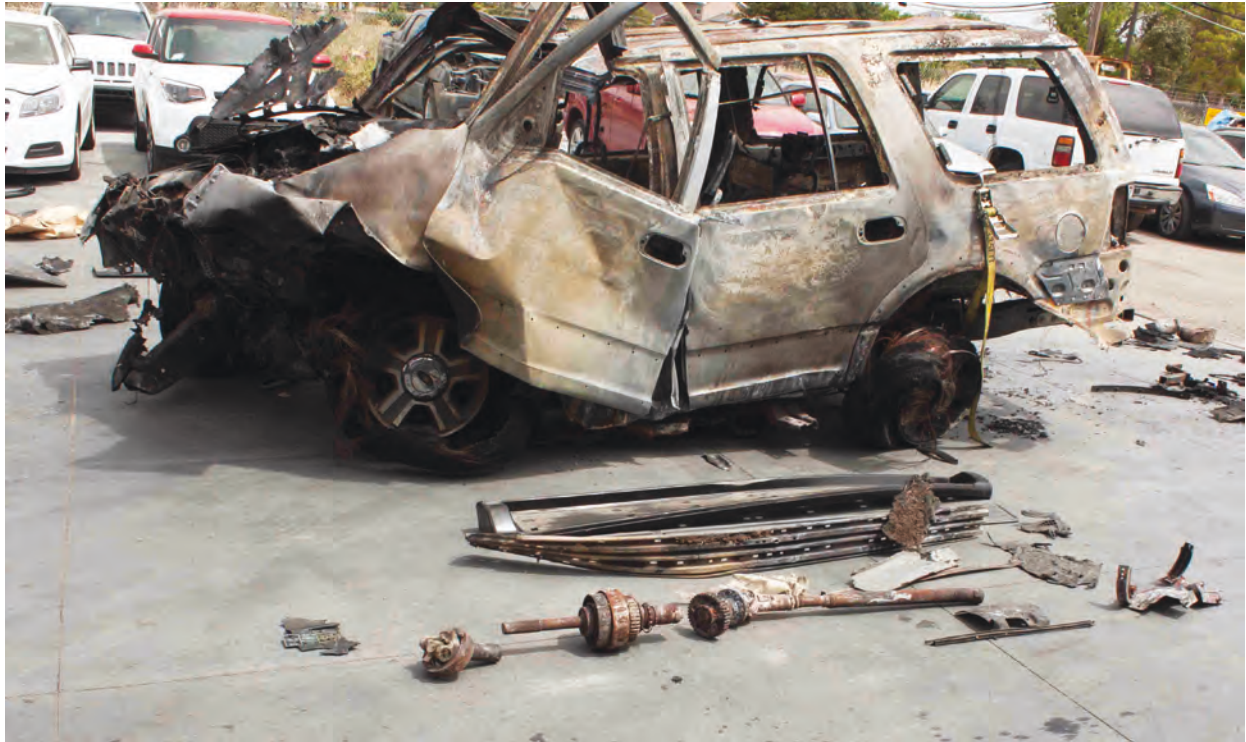
The entire drive shaft assembly was found ripped off of the expedition and on the roadway:

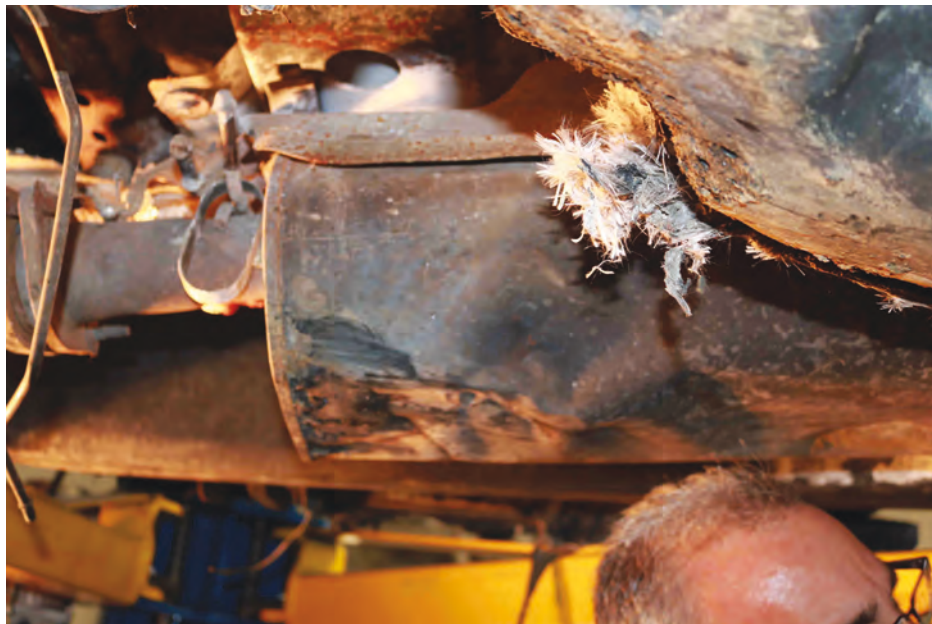
The muffler, adjacent to the gas tank, was damaged by the drive shaft:

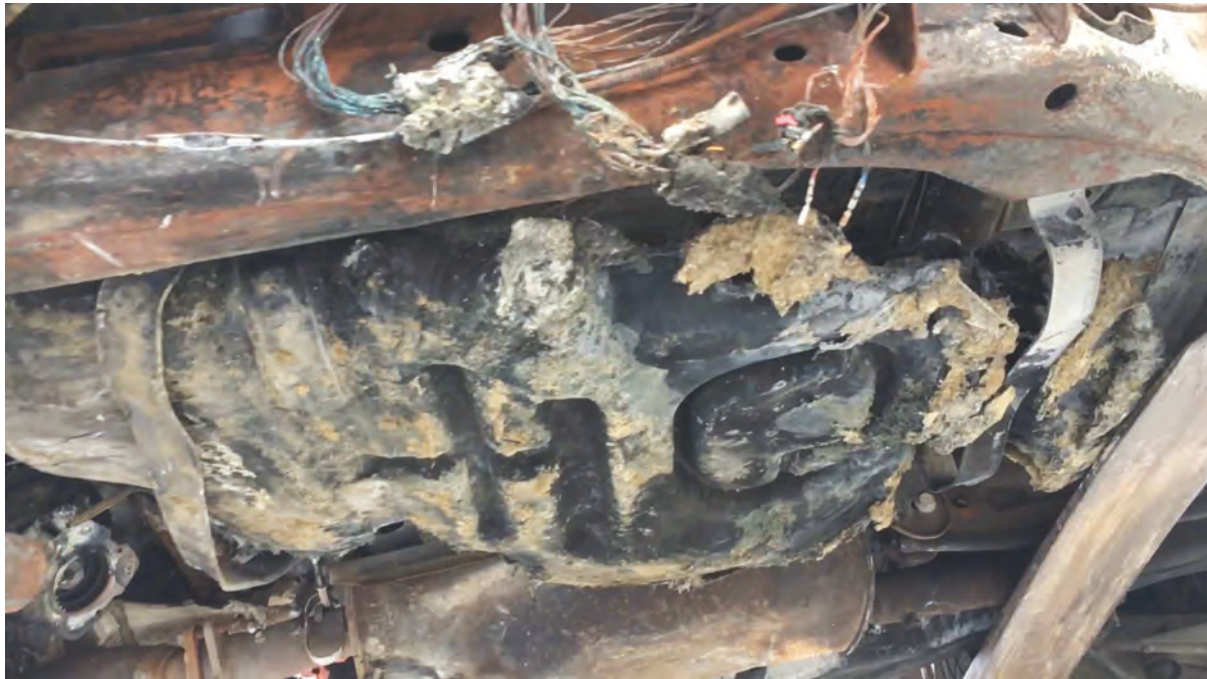
The fuel tank of the expedition was ripped to pieces by the driveshaft:

The entire top portion of the tank was destroyed by the shaft, spreading the fuel all over the roadway.

There is little doubt that the Second Generation Ford Expedition 4x4 suffers a design defect in that the fuel tank is located adjacent to the drive shaft, and it is foreseeable that in a frontal collision of sufficient impact the drive shaft shall break away from the transfer case and rip through the fuel tank, as it no doubt did in this collision.

Recall to install steel fuel tank deflector shield, or employ other effective measures to prevent the drive shaft from striking the fuel tank. Alternatively, install the fuel tank away from the drive shaft.

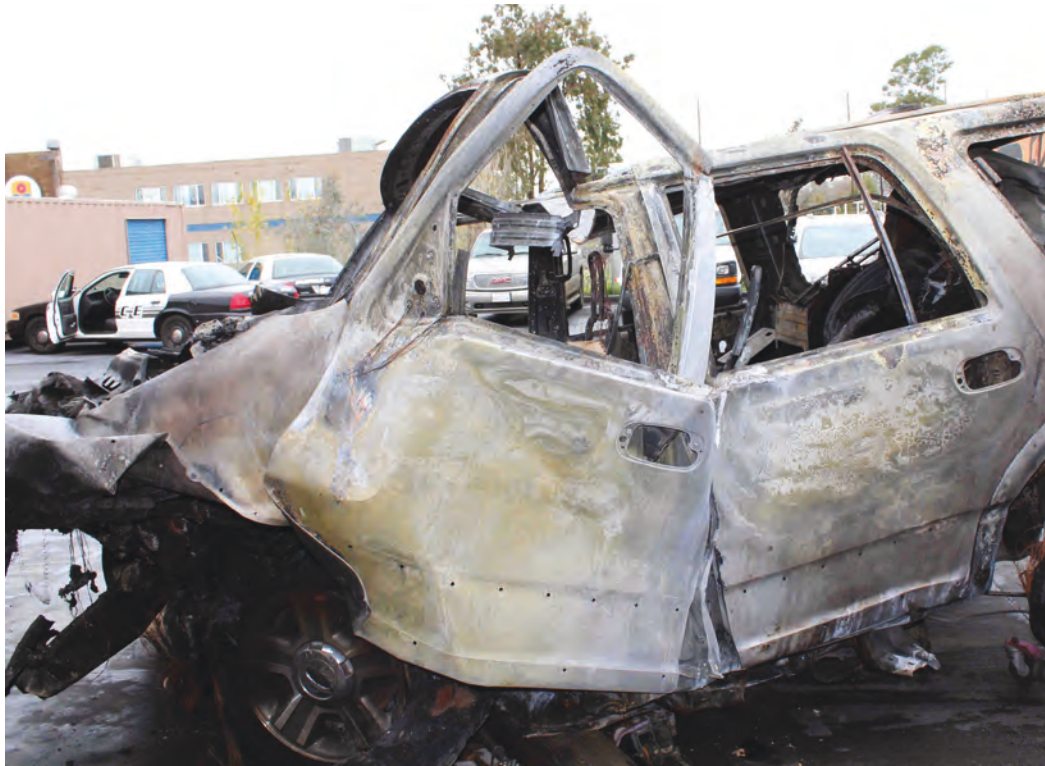
Arriaga Vehicle

collisions. The following are photos of Mr. Arriaga's Expedition, and another one suffering the same catastrophic fuel tank failure with several fatalities:
