Locality: HEYFIELD
Place address: GEORGE STREET
Citation date 2016
Place type (when built): Soldiers' Memorial
Recommended heritage protection: Local government level
Local Planning Scheme: Yes
Vic Heritage Register: No
Heritage Inventory (Archaeological): Yes

Place name: Heyfield Soldiers' Memorial and Pencil Pines

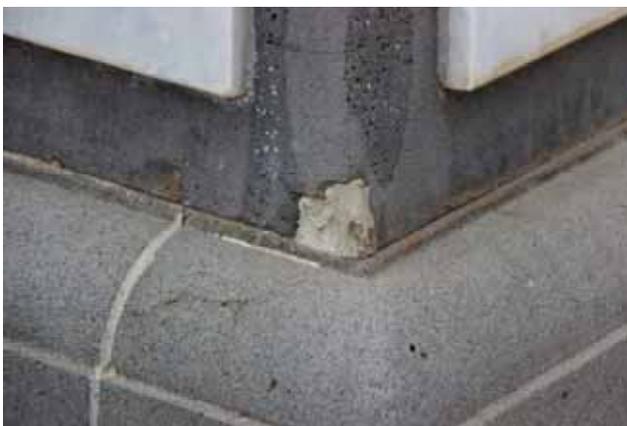
Figure D2. Detail of damaging repairs using a 'plastic type' substance in the joints instead of

lime mortar, and a hole in the bluestone.

- 2.4. This memorial is in good condition, but requires some maintenance and repairs.
- 2.5. **Water damage**
 - 2.5.1. Remove all the ‘plastic’ substance that has been squeezed into the joints (Fig D2). Never use modern products on these historic stone monuments as they will cause expensive

damage. Replace the plastic with lime mortar. Traditional mortar mixes were commonly 1:3, lime:sand. This work must be done by a skilled mason or bricklayer who is very experienced with historic masonry and knows how to make and apply the correct mortar, without cement.

- 2.5.2. The fact that mortar has fallen out is the “canary in the mine”. It is a warning that water is getting into the monument. The plastic will seal the water in, causing much more, long term damage. Never seal historic stone or bricks.
- 2.5.3. There is also water damage occurring at the intersection of the top of the cenotaph Orbost granite panels (Fig D3).
- 2.5.4. Cast iron column. This is rusting and the rust will run down the expensive and historic stone monument and lettering and cause very expensive damage. Repair the column (Fig D4).
- 2.5.5. Never sand, water or soda blast the stone as it will permanently pit the surface, remove the lettering and make the stone quickly become porous and dirty.

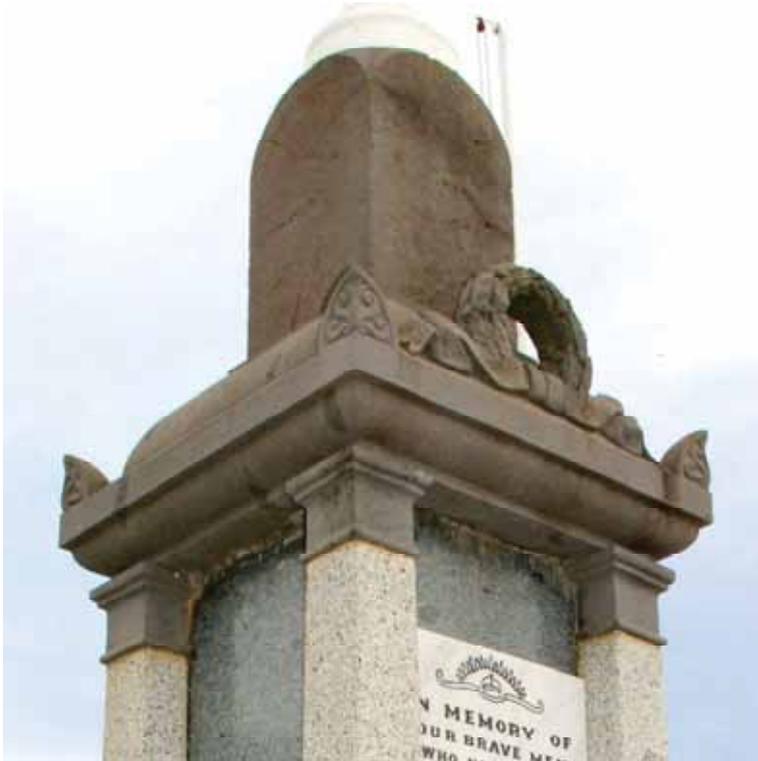
Figure D3. Detail of the top of the cenotaph showing finely tooled bluestone, polished Harcourt granite piers and Orbost granite panels, with some water damage occurring at the top of the panels.

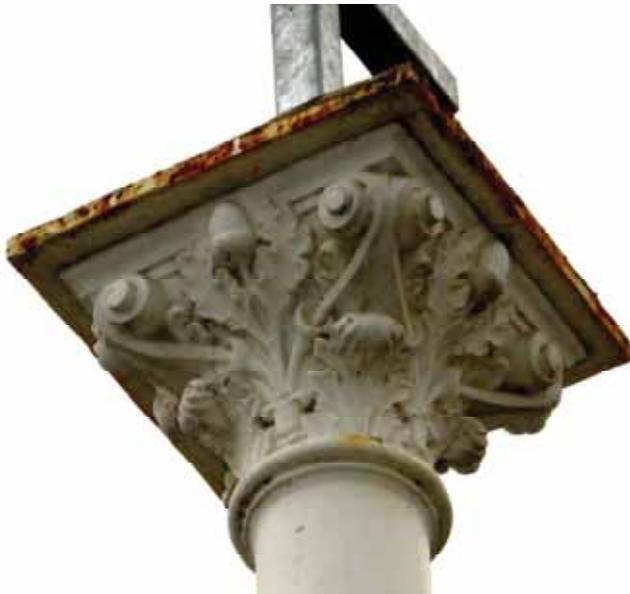
Figure D4. Detail of white painted rusting cast iron column with recent metal cross above.
