Mr. Jim Knocke Corrosion Innovations 4020 Strawberry Road Pasadena, TX 77504

SUBJECT: Physical Testing on Prepared Panels; KTA-Tator, Inc. Project No. 420023-R2

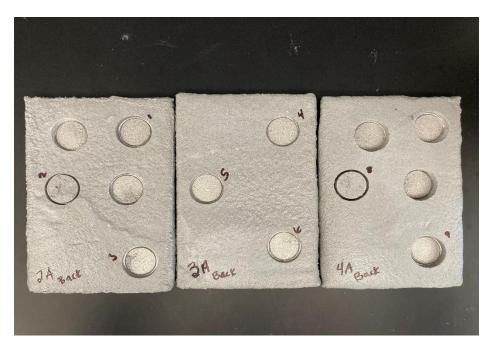
Post Adhesion Testing

| KTA ID | System ID | Coating DFT (mils) | Pull Stub ID | Pull-Off Strength (psi) | Location of Break | Average Pull-Off Strength (psi) | | | |
|---|---|---|---|---|--|---|--|--|--|
| KTA-2A Back | Blank | 135.4 | A | 534 | 95% adhesive to substrate, 5% cohesive within coating | 797 | | | |
| | | | В | 787 | 90% adhesive to substrate, 10% cohesive within coating | | | | |
| | | | С | 1071 | 75% adhesive to substrate, 25% cohesive within coating | | | | |
| KTA-3A | CorrZe-100 | 126.5 | A | 575 | 100% adhesive to substrate | 629 | | | |
| | Corr-Ze 200 + 100 | 250.2 | A | 386 | 100% adhesive to substrate | 860 | | | |
| KTA-4A Back | | | В | 989 | 100% adhesive to substrate | | | | |
| | | | С | 1204 | 90% adhesive to substrate, 10% | 000 | | | |

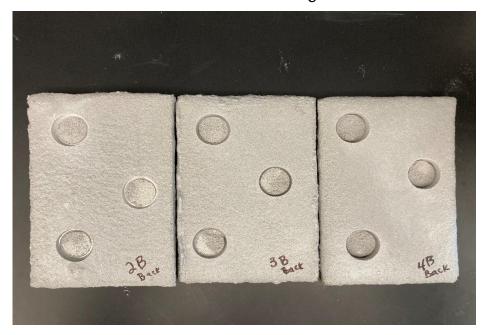
Post Immersion Testing

| KTA ID | System ID | Coating DFT (mils) | Pull Stub ID | Pull-Off Strength (psi) | Location of Break | Average Pull-Off Strength (psi) | | | |
|---|---|---|---|---|--|---|--|--|--|
| | Blank | 130.1 | A | 1741 | 75% adhesive to substrate, 25% cohesive within coating | | | | |
| KTA-2B Back | | | В | 1275 | 75% adhesive to substrate, 25% cohesive within coating | 1414 | | | |
| | | | С | 1227 | 50% adhesive to substrate, 50% cohesive within coating | | | | |
| KTA-3B Back | CorrZe-100 | 126.2 | A | 1662 | 90% adhesive to substrate, 10% cohesive within coating | | | | |
| | | | В | 1831 | 50% adhesive to substrate, 50% cohesive within coating | 1665 | | | |
| | | | С | 1502 | 50% adhesive to substrate, 50% cohesive within coating | | | | |
| KTA-4B Back | Corr-Ze 200 + 100 | 253.7 | A | 2185 | 100% cohesive within coating | 2064 | | | |
| | | | В | 1858 | 100% cohesive within coating | | | | |
| | | | С | 2149 | 100% cohesive within coating | | | | |
