# Engineering Meeting

Wednesday 16th December 2020

# **LOWER SEVERN (2005) INTERNAL DRAINAGE BOARD**

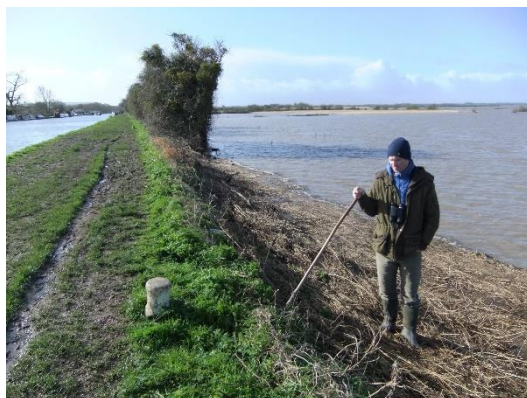
**Fig. 4 – Strand line at OP5 after the evening tide of 11 March 2020**

The strand line at OP5 (indicated by the bottom of the stick) was 20cm vertical height below the top of the towpath edge after the evening tide of 11 March 2020. Note that the towpath then slopes upwards towards the canal edge.

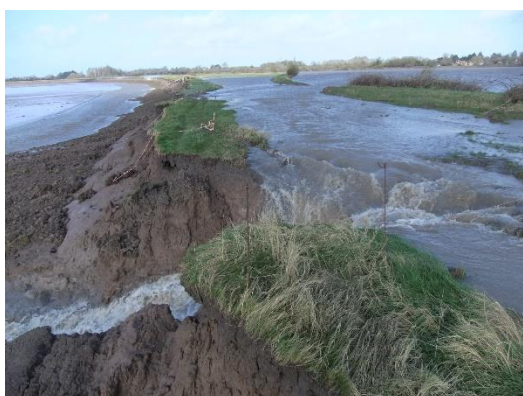
**Fig. 10 – 12 March 2020, shortly after the outer warth broke near MP2 'the new embayment'**

The outer warth broke through just before this photograph was taken as the cascading water was much less than this upon arrival. This is just south of the main breach at MP2.

Embayments such as this quickly enlarge when supplied by draining water, and the incoming tide. They wear away and allow access for lower tides onto the warth. This action has been observed at MP1 and MP3A during the last five years, both of which help to drain water during the ebb tides.<sup>19</sup> There is no reason to suppose that anything different will happen here.

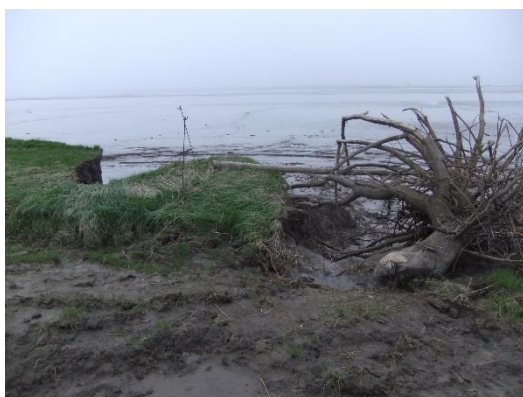
**Fig. 11 – 14 March 2020 – debris lying in 'the new embayment'**

The warth is likely to break through adjacent to this point within a short space of time. The loss of the outer warth in this way facilitates a more rapid draining of the inner warths, but this draining stops once the floodwater reaches a certain level.

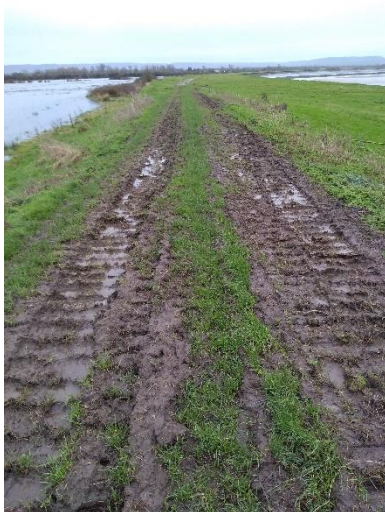
**Fig. 15 – Damaged sea wall beside Upper Saul Warth**

Upper and Lower Saul Warths retain water behind a sea wall that is no longer regularly mown or cleared of wrack by the EA.<sup>20</sup> Heavy plant tracking along this wall in December (first the EA's excavator and then the attempts to recover it) has reduced its crest. On big spring tides, this sea wall is overtopped at the southern end of Lower Saul Warth (near the Saul hedge). Much of the water retained here is fresh and results from the high water table and local land drainage.

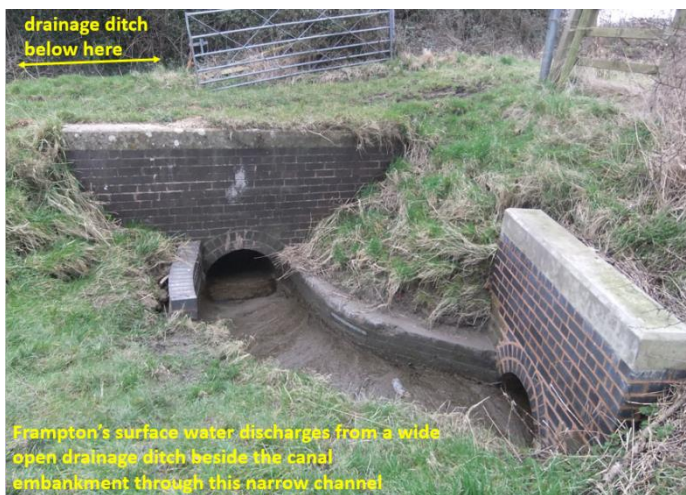
**Fig. 17 – The drainage bottleneck**

At the south end of the canal-side ditch, the water takes a 90° turn through a narrow, twisty part-open, part-culverted section.

The water is impeded through another 90° turn before being culverted through a bank and emerging through the EA's tide flap whereupon it flows into Frampton Pill.

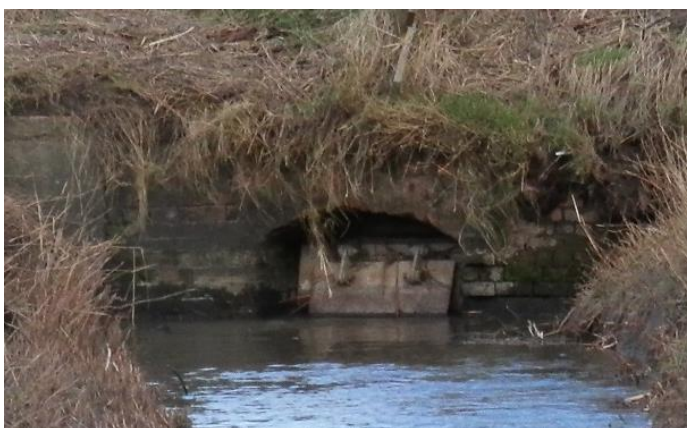
**Fig. 18 – The wooden tide flap at Frampton's outfall**

The tide flap is of uncertain age. It was still not visible on 16 March 2020, but flow could be detected as a disturbance in the water.

6. Install a new box culvert, outfall structure and tidal flap on the existing downstream field culvert over Frampton Pill to prevent back flow, silt and debris into the canal-side ditch. This would then act as the first line of defence should the Buckholdt siphon flap fail during normal tides.

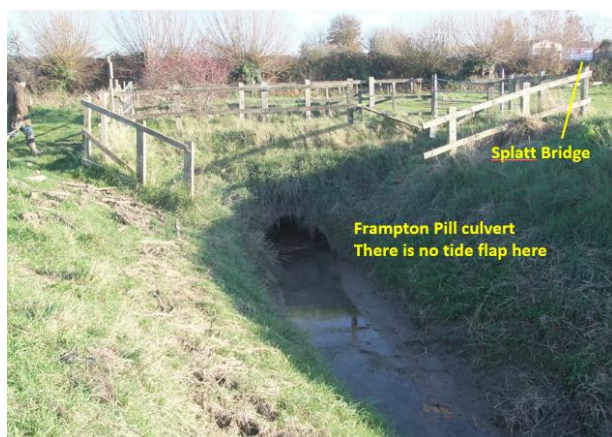
**Fig. 19 – Frampton Pill culvert**

Wrack frequently accumulates here and impedes the flow of drainage water through the small arched culvert. It also regularly accumulates about 85m downstream which can reduce outflow even more.

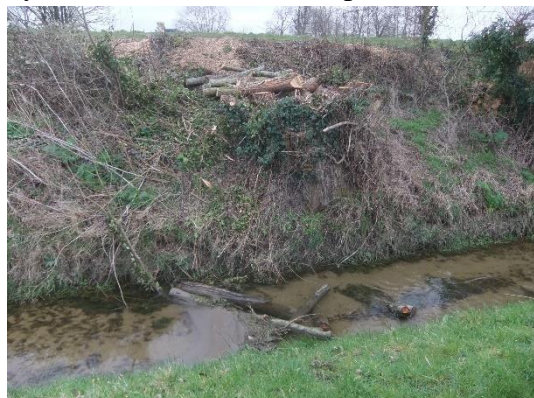
winter of 2018-19 remain on site, although much of it has been washed around by the recent tides. It is likely that the large piles of cordwood stacked behind some trees have exerted pressure on them while the bank remained under water.

**Fig. 21 – Scenes like this in March 2019 prompted CRT to confirm that an Embankment Management Plan was needed**

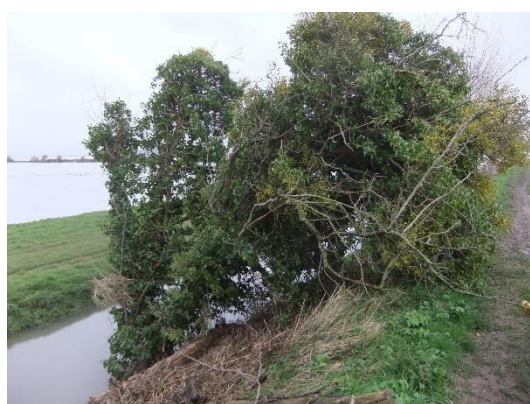
Brambles still cover the embankment, and one tree with spindly bare branches has become so heavy with ivy and mistletoe that it slipped during the recent prolonged saturation period. This is not an isolated case; other similar trees are in danger of becoming overladen in the same way.

**Fig. 22 – Ivy and mistletoe overwhelm the bare branches of spindly trees making them unstable, 12 March 2020**

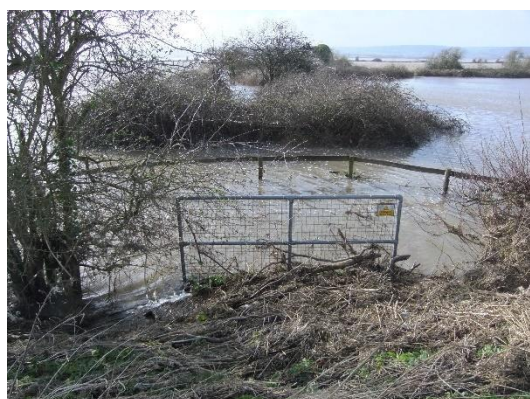
Virtually all the cordwood was under water on at least three of the March spring tides, and quite a lot was dislodged. Most remained somewhere on the bank, some of it has entered the canal-side ditch and is impeding drainage, and other lengths have found their way to the Buckholdt siphon.

**Fig. 23 – Lengths of cordwood and other wrack at the Buckholdt siphon, 12 March 2020, almost six hours after high water**

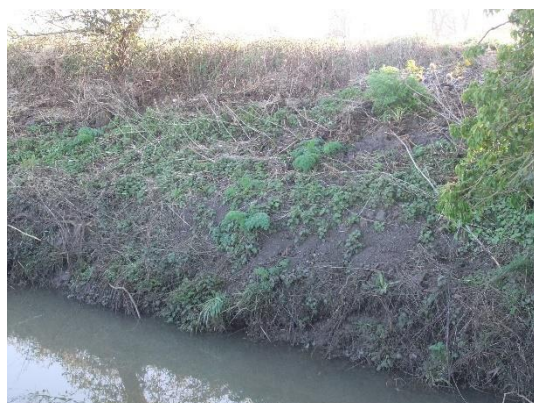
On 16 March 2020, it was still not possible to see the toe of the embankment, nor much of the embankment itself. It was not only covered in brambles, but also a large amount of straw-like wrack and other debris from the tides. However, where the earth was visible, it is clear that the wave-like action of water had weakened the topsoil and subsoil layers leaving loose material behind. This soil is vulnerable to being washed away during the next period of heavy rainfall or tidal saturation.

**Fig. 24 – Localised erosion, 16 March 2020**

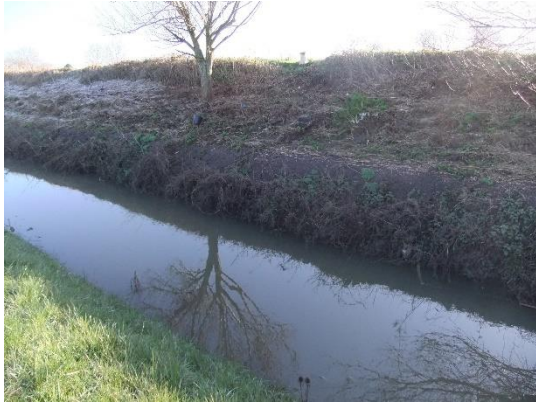
Of greater concern is this section of bank about 100m to the south of Buckholdt siphon where the mooring bollard has slipped and the embankment seems to have a strange hollowed shape and then a near vertical drop.

**Fig. 25 – 100m south of the Buckholdt siphon the embankment appears to be slipping, 16 March 2020**

**ATL and the LSIDB recommend that CRT manage the western embankment to a standard that ensures a full visual inspection is possible from both the towpath and the field below before the big September tides. ATL is willing to undertake local monitoring and seeks a better understanding of the standards associated with CG3. FFR members should be alerted if the embankment drops below CG3. We can, and should, work in partnership, not in isolation, particularly at this difficult time.**

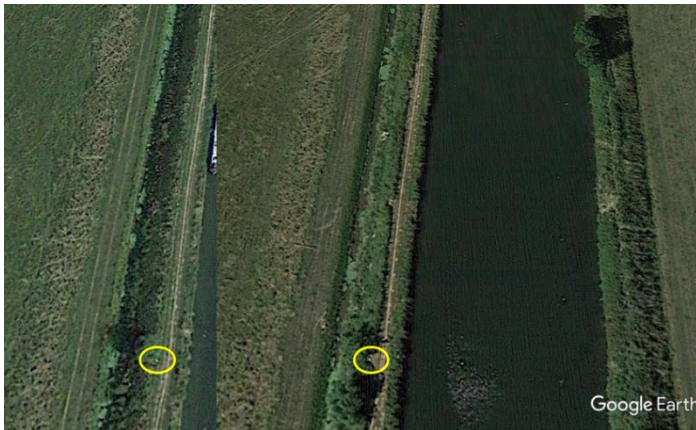
This slippage is also visually evident from the towpath and on Google Earth.

**Fig. 27 – The mooring bollard (ringed in yellow) has slipped towards the canal-side ditch**

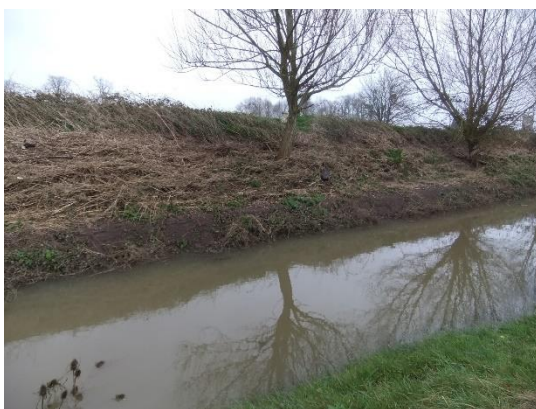
**Fig. 28 – The same slipped mooring bollard from the opposite direction, 14 March 2020**

Either side of the mooring bollard, from the towpath downwards initially there is firm, sloping ground. This then gives way to a what appears to be small vertical drop and a more hollowed out section, before another vertical drop towards the toe. (The toe is not yet visible due to the water level.) This embankment profile appears to be replicated elsewhere.

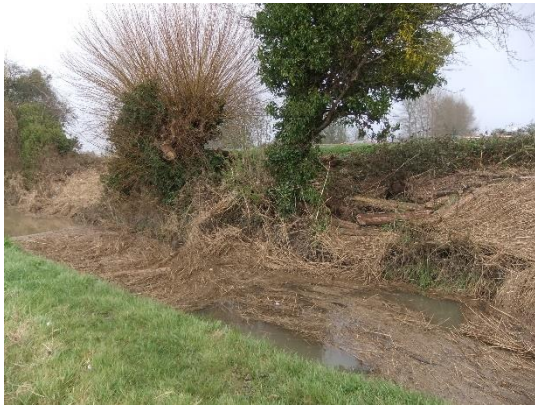
**Fig. 29 – Another location where the bank appears to have a similar hollowed out profile, especially behind the tree, 14 March 2020**

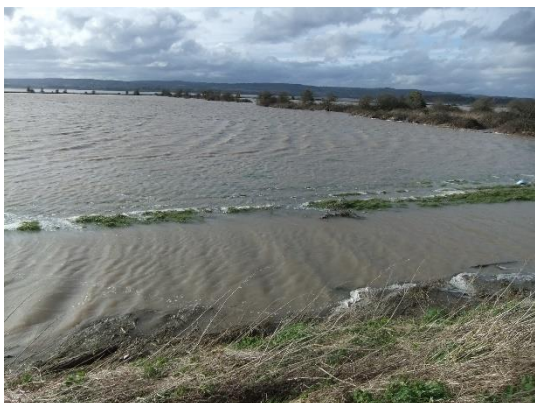
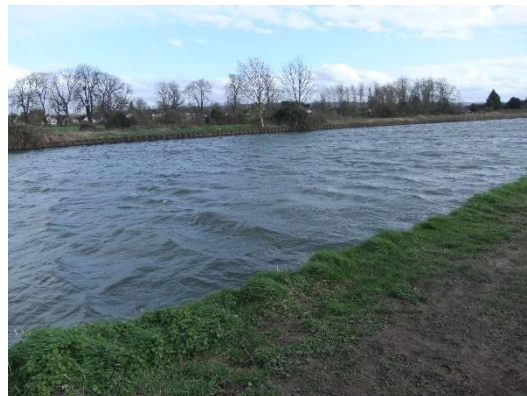
The action of the water against the embankment, even for short periods of time, should not be overlooked. Holding the camera still in a strong wind to take photographs from the particularly exposed OP5 can be difficult. Waves on the canal are replicated on the tidal waters over the inner warth, in the canal-side ditch and against the canal bank. This can happen for several hours, saturating the lower part of the bank making it susceptible to collapse, particularly given the lack of support at the toe. Annual maintenance of the drainage ditch for decades has significantly adjusted profile at the toe, and this tidal action is making it weaker every time this area is flooded.

**Fig. 31 – Waves near the Buckholdt siphon and also on the canal from the same place, six hours after high water on 11 March 2020**
