INTRODUCTION

The documentation provided herein was prepared in February 2020 by NJ TRANSIT and engineering consultant, STV, Incorporated, in partial satisfaction of the requirements of the National Historic Preservation Act for the Lackawanna Records Building Project. The persons involved in the authorship of this document have demonstrated experience with the evaluation of historic buildings and/or historic regulatory processes and documentation (refer to the attached resumes).

PROJECT PURPOSE

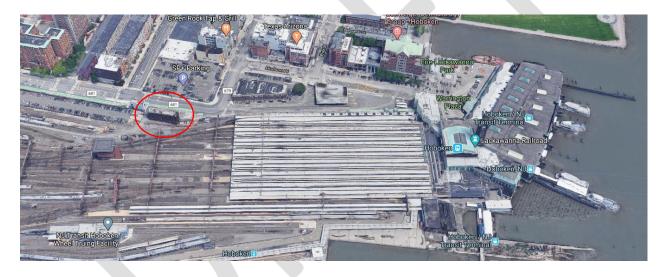
The Records Building is located at the northern border of the Hoboken Rail Yard, west of the Hoboken Rail and Ferry Terminal along Observer Highway in the City of Hoboken, Hudson County, New Jersey (circled in red in the aerial photograph provided below). The building was originally designed and built by the Delaware Lackawanna and Western Railroad, and has been owned by NJ TRANSIT since 1983. The project evaluated herein will be funded using state monies and, depending upon the work that is ultimately undertaken, New Jersey Department of Community Affairs permit(s) may be required. The project is being undertaken pursuant to the requirements of the National Historic Preservation Act (as explained under the Section entitled Regulatory Context below) with the Federal Transit Administration acting as the lead agency for this process.

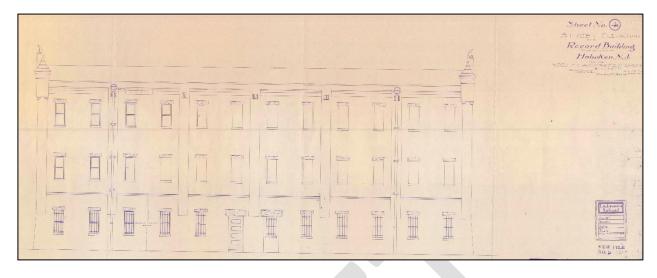
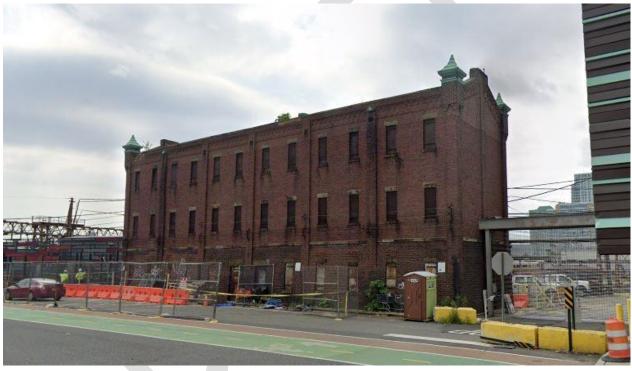
As BBB also notes in the 1996 Preservation Plan, the original drawings (see the example below) indicate that there was a single entrance to the building, fitted with a metal door, located near the center of the Observer Highway elevation. This entrance opened to a square, first-floor stair hall with the remainder of the floor area consisting of open space. The floor plans on the second and third floors had the same layout.

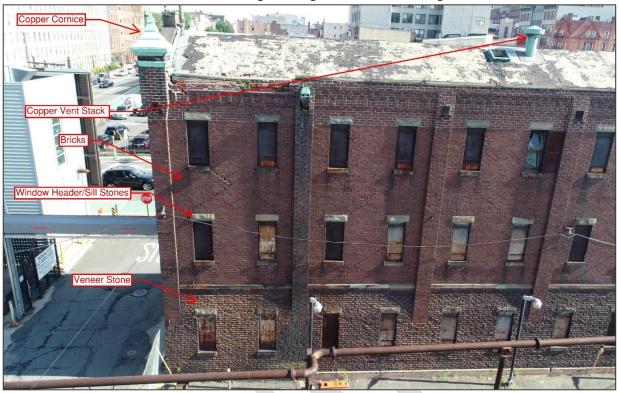
South Elevation Noting Building Elements Taken August 2019

The three-story red brick building is approximately 24 feet wide by 96 feet long. It has a heavy battered base with a contrasting concrete base course, and the corners are built out with piers that rise past the roofline to terminate in turrets supported by brick corbels and topped by molded copper cornices. The north and south elevations are separated into six equal bays by heavy pier pilasters; the east and west facades are each bisected by a single pier pilaster running from the base to the roofline.

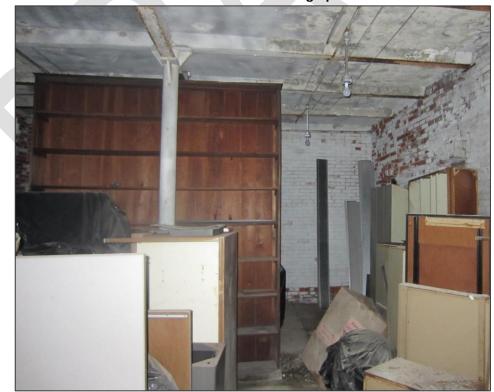
Undated Interior Photograph

At a past unknown date, the majority of the interior elements of the building were removed; during the period of NJ TRANSIT ownership the only known use has been for the storage of miscellaneous items. Due to long-standing concerns with general building safety, personnel have not been permitted to enter the building for a number of years. However, the building is known to contain at least one mahogany bookcase that may date to the Records Building's historic use, and likely still contains an original staircase with decorative iron railings and a dumbwaiter. NJ TRANSIT has no information regarding how the DL&W historically utilized the building in terms of how company documents were actually stored; however, the fully open space interior layout with no partition walls would seem to indicate that books and other documents were merely stored on shelves and were transported between stories using the dumbwaiter.

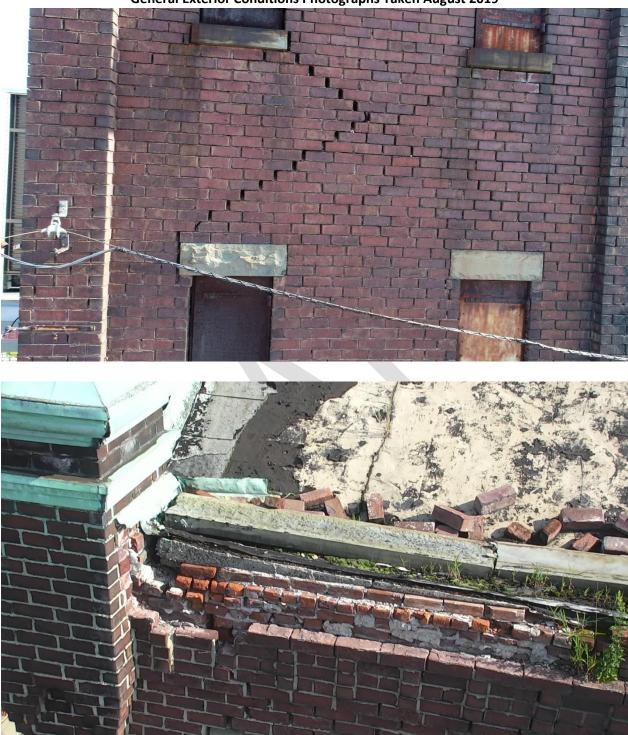
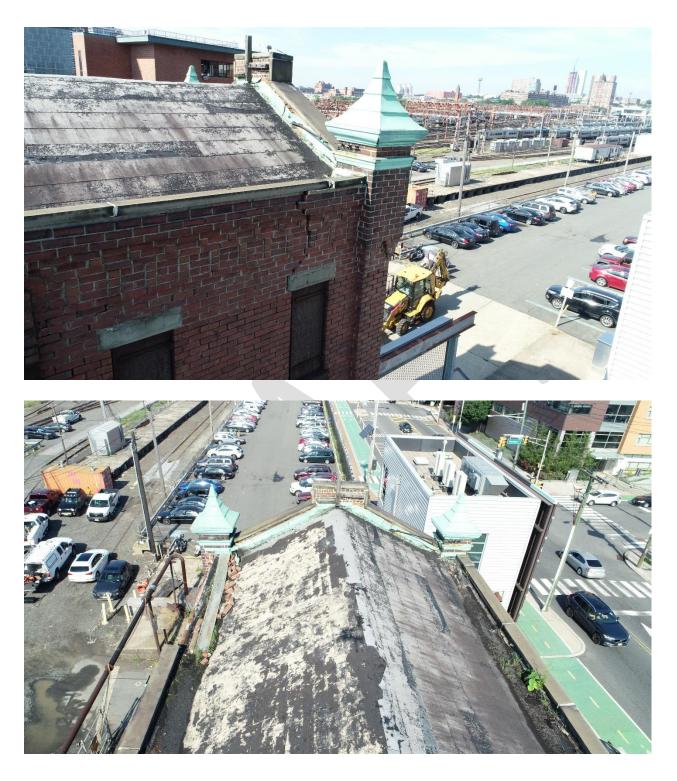
General Exterior Conditions Photographs Taken August 2019

The Records Building has been evaluated by structural engineers both from NJ TRANSIT's Capital Programs structural engineering staff and from an independent engineering consultant (STV Incorporated), and both engineers have identified a number of structural defects and safety hazards in the building's current condition. In addition, a New Jersey Department of Community Affairs inspector evaluated the Records Building and ordered that the building be demolished by June 30, 2020 determining that the building represents an unacceptable safety hazard to the public. The perimeter bearing walls display diagonal cracks which have formed in the mortar joints due to moisture infiltration and repeated freeze/thaw cycles. In addition to the cracks in the mortar, the freeze/thaw cycles are causing the walls to bow out, and the cornices have been pushed out and are moving away from the building. The other types and extent of building deterioration are noted in the earlier sections of this document. The several engineering assessments of the structure indicate that attempts at repair, rehabilitation or stabilization have the considerable potential to result in further loss of material and/or destabilization of the structure either in whole or in part. The observed structural defects also make it infeasible to pick up the entire building as an assembled unit and move it to a new location.

Given the current condition of the building, and due to structural conditions that have been worsening over the past years and were exacerbated by both water infiltration from the roof level and flooding from past storm events, the NJ TRANSIT Office of System Safety has determined that it is unsafe for any person to enter the Records Building. As some of the proposed activities associated with the alternatives discussed below would require construction personnel to enter the Records Building to perform the work, this restriction significantly impacts the feasibility of some of the evaluated actions.

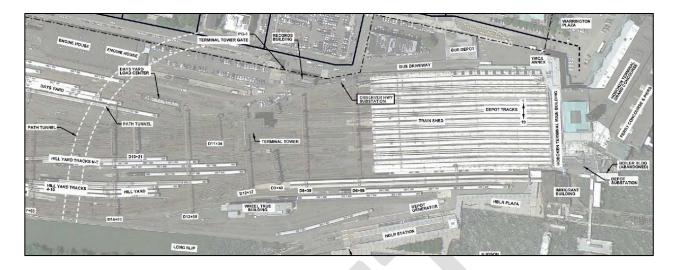
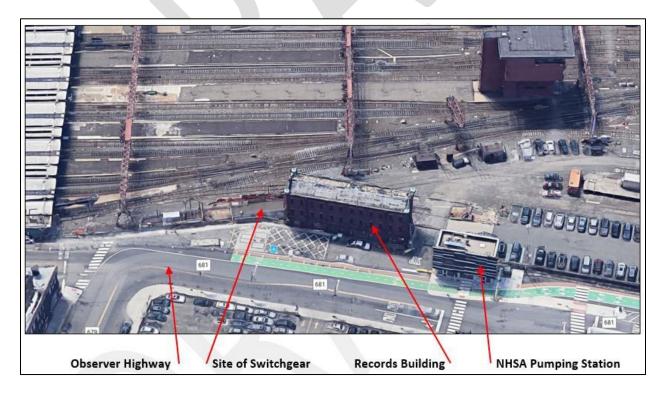
The NHSA facility (discussed in the Project History section above) is situated approximately 25 feet west of the Records Building on Observer Highway, and NHSA manholes used for access to their pumping equipment are located less than 15 feet from the building's north façade. The near edge of the eastbound travel lane of Observer Highway is approximately 35 feet from, and parallel to, the Records Building. The bicycle path is located approximately 25 feet from the building, and a pedestrian walkway is located approximately 20 feet from the building. The Port Authority [of New York and New Jersey] Trans-Hudson (PATH) system tubes run under the Hoboken Rail Yard approximately parallel to and 60 feet south of the property on which the Records Building is situated. An additional site constraint is presented by there being no available property in the general vicinity of the Records Building to accommodate vehicular parking that would be important to repurposing the structure for non-rail use.
